Fire Risk Assessment Astbury Court

Hereford Road, Oldbury, B68 0QG

Date Completed: 07/05/24.

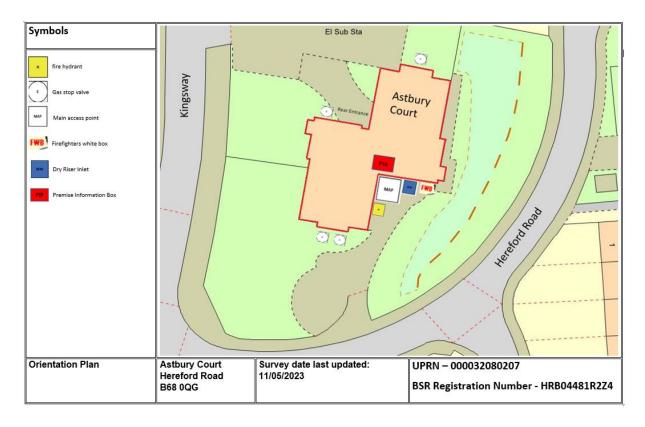
On arrival Information (for WMFS)

The firefighter's white box is located to the right-hand side of the main entrance to the building. The box contains all keys for the building and is secured with a bridge-door padlock.

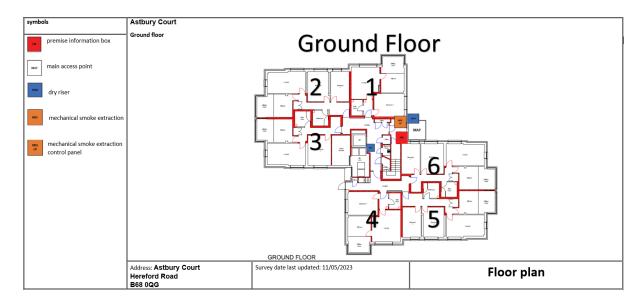
Ground Floor

A typical floor layout showing horizontal lines of compartmentation, emergency lighting, fire detection is attached and AOVs etc.

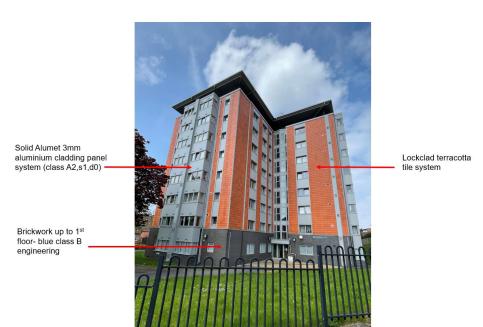
Below is a breakdown of the materials believed to be used within the external envelope and, as part of the external wall system. This is based on the information available at the time of this FRA, and with limited onsite resources.

It is deemed that the combination and application of these materials in conjunction with a non-combustible mineral wool insulation present an acceptable level of fire risk.

- 1. Astbury Court has 3 separate areas of cladding consisting of.
 - Brickwork up to 1st floor blue class B engineering.
 - Solid Alumet 3mm aluminium cladding panel system (class A2,s1,d0).
 - Lockclad terracotta tile system.
- 2. The pitched roof was installed during 2007 refurbishment works and consists of a steel frame & aluminium standing seam mineral wool core construction.
- 3. Windows to flats are composite timber framed with external powder coated aluminium finish. Communal windows are powder coated aluminium.
