Fire Risk Assessment Moorlands Court

Reservoir Road, Rowley Regis, B65 9PB.

Date Completed: 30/07/2024.

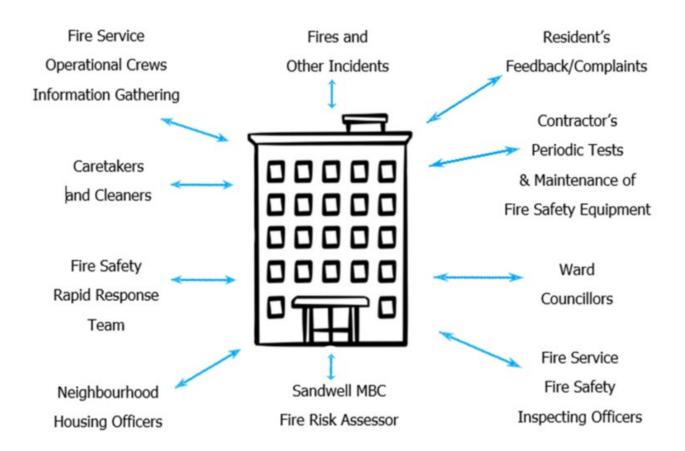
The following diagrams illustrate those procedures and persons that support the effective planning, organisation, control, monitoring, and review of the preventive and protective measures. This information is provided as required under the RR(FS)O.

The above processes and procedures are overseen by the Fire Safety, Facilities and Premises Manager who reports to the Business Manager - Surveying and Fire Safety.

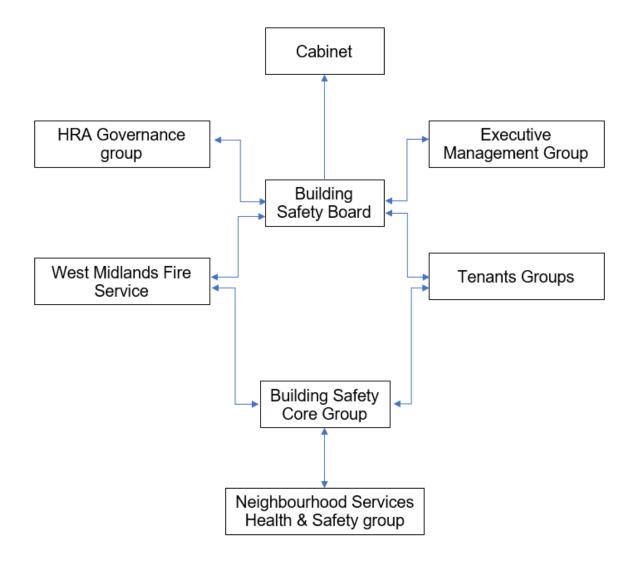
These managers attend the Fire Safety Core Group for scrutiny which is part of the governance structure below.

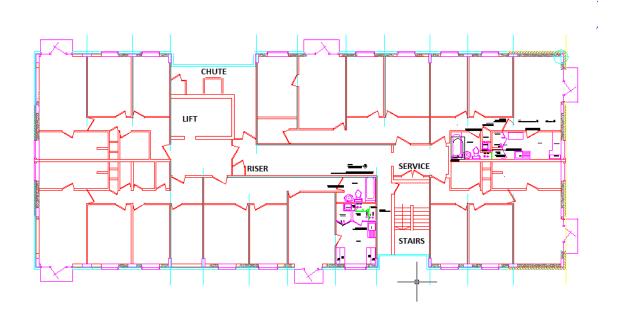
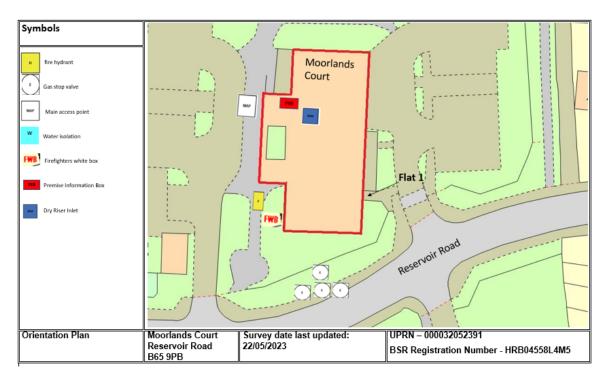
Building Plan

A typical floor layout showing horizontal lines of compartmentation, lift, chute, dry riser, stairs, and service cupboard location.

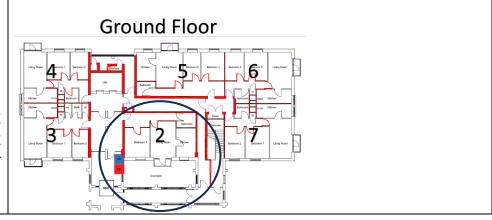
One observation made was around the small courtyard accessible by the residents of flat 2. The courtyard area has no early warning measures to warn occupants of a fire situation within this room. I would suggest early warning is provided to the courtyard (i.e., sounder and beacon) and an alternative escape route potentially into the front corridor extension. This work should be considered as part of the major refurbishment that is planned in the near future.

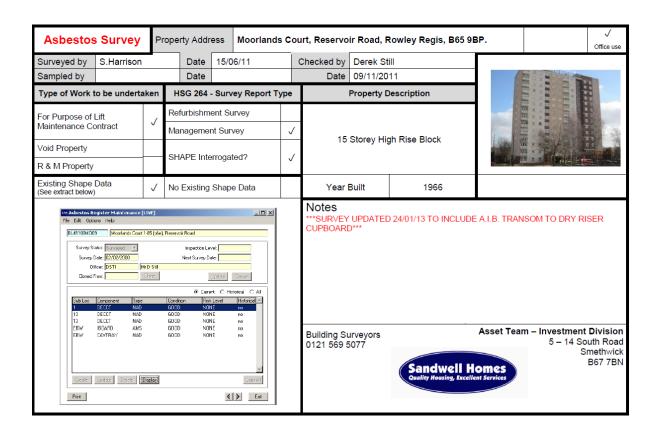
Sample Locations	Property Address		Moorlands Court, Reservoir Road, Rowley Regis, B65 9BP.					
LOCATION	MATERIAL		EXTENT (approx)	SURFACE TREATMENT	SAMPLE REF	RESULT	HSE NOTIFY	ACTION TAKEN ON CONTRACT
IF DURING THE COURSE OF W	ORK SUSPECTED	ACM'S A	RE IDENTIF	IED THAT ARE N	OT CONTAINED	WITHIN THIS REPO	ORT STOP	WORK & SEEK ADVICE
MOTOR ROOM – EXTERNAL FLUE TO SIDE ELEVATION	CEMENT		-	UN-TREATED	PRESUMED	CHRYSOTILE	NO	
ROOF ACCESS LOBBY - CEILING & WALLS	TEXTURED COATING		-	SEALED	PRESUMED	CHRYSOTILE	NO	
FLOORS 3/5/9/13 - COMMUNAL WALLS	TEXTURED COATING		-	SEALED-PAINT	DS 6218	NO ASBESTOS DETECTED	NO	
DRY RISER CUPBOARD TRANSOMS TO ALL FLOORS EXCEPT GROUND, 8 TH , 9 TH & 13 TH .	BOARD		-	PAINT SEALED	DS 6218	AMOSITE	YES	
ITEMS SHOWN BE	LOW HAVE BEEN	ASSESS	ED ON SITE	BY THE ASBEST	OS SURVEYOR	& ARE CONFIRME	D NOT TO	BE ACM's.
LOCATION DESCRIPTION	MATERIAL	LOC	ATION DES	CRIPTION	MATERIAL	LOCATION DESCRIPTION MATERIAL		ON MATERIAL

MOTOR ROOM CEILING	CONCRETE	MOTOR ROOM – EXTERNAL DRIP MOULD TO DPC			GRP			
MOTOR ROOM FLOOR	CONCRETE	MAIN ROOF PARAPET WALL		PET WALLS	GLASS			
MOTOR ROOM WALLS	BRICK	8 [™] FL0	OOR DRY RISE TRANSO		PLYWOOD			
MOTOR ROOM – WALL BOARD BY LIFTING GEAR	TIMBER
