# Fire Risk Assessment

## 1-6 Richards House

**Kempsey close, Oldbury,  
B69 1BN**

**Date Completed: 29/07/2022**

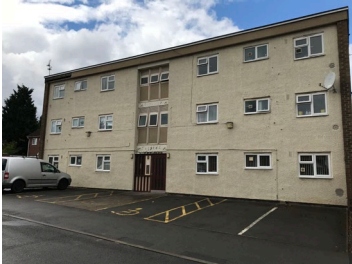
The low-rise block was constructed in 1964. The block consists of 3 storeys (inclusive of the ground floor). Each floor contains 2 number dwellings which are accessed by a single central staircase.

The block is of traditional masonry and concrete construction with a flat roof (no internal roof access).

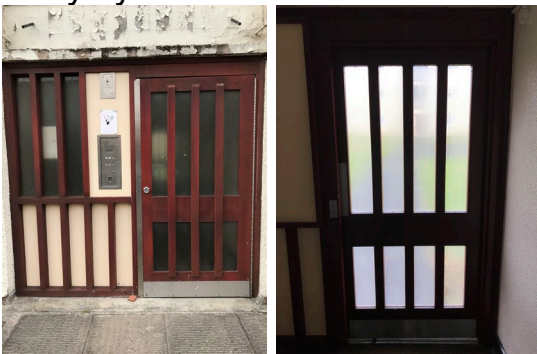
The block has a main entrance to the front elevation and a further exit located on the rear elevation. Both front and rear entrances have a door entry system with a fob reader installed.

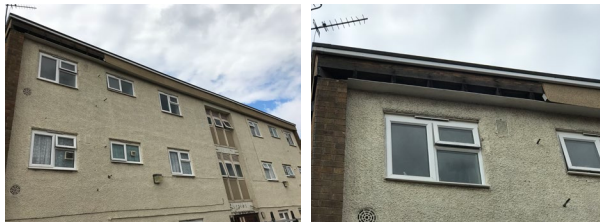
- 2) **A portion of the fascia board on the top left-hand side of the front face of the building is damaged/missing. Resolved**  
03/04/23

Question/ Ref No	Required Action	Supporting photograph	Risk Rating	Timescale and Person Responsible	Date Completed
06/02	A portion of the fascia board on the top left-hand side of the front face of the building is damaged/missing. In need of replacement/repair	 	1	Repairs September 2022	03/04/2023

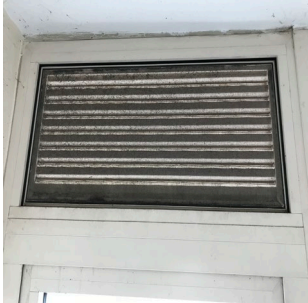
- 5) The communal stairwell also has ventilation provided by louvred vent above windows at the front of the property.

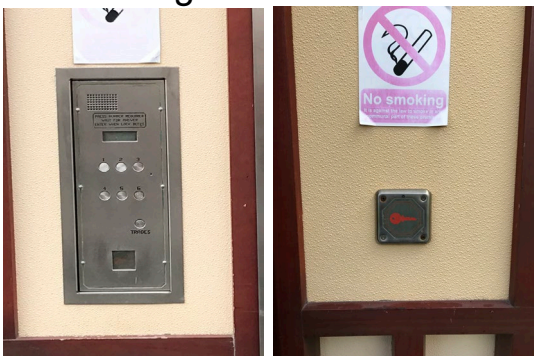
- 7) All corridors are of adequate width (at least 1050mm) and will be maintained clear to that width as a minimum.
- 8) There are no corridors within the means of escape that form a dead end.
- 9) The means of escape are protected to prevent the spread of fire and smoke.
- 10) The final exit doors are fitted with automatic closing devices that are checked on a regular basis by Caretaking Teams as part of their checks. Defective closing devices are replaced either by the Caretaking Team(s) or the in-house repairs team(s).
- 11) The final exit doors have door entry systems installed. These systems are designed to fail safe i.e. door unlocked in the event of a power failure. This prevents residents being locked in or out of the building.

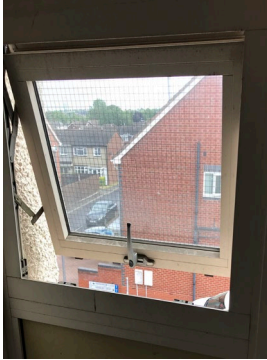
13) Fire rating of Individual floor mats outside flat entrance doors is unknown.

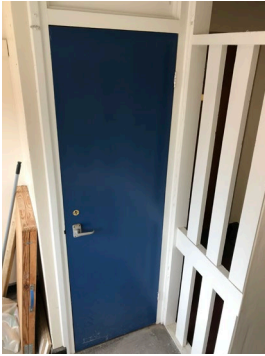
- 16) Service cupboards are FD30s rated, secured with type 54 suited mortice locks.

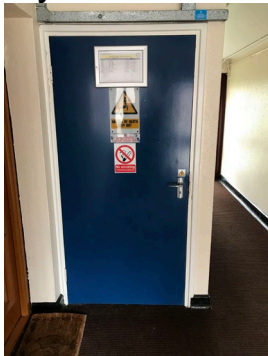
- 17) Electric meter cupboard doors are FD30s rated, secured with a type 138 suited mortice lock. Residents have been provided with a key for access to their electricity meters.

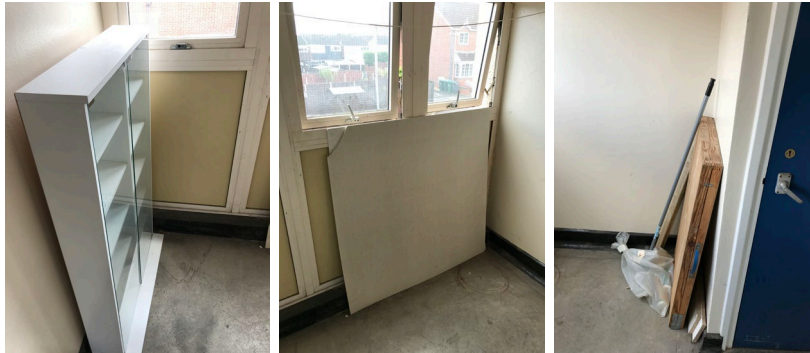
**23) The First and second floor landing areas have communal 'drying rooms' separated from the communal landing by timber beams. Other items have been left in this area and are too be removed as the staircase should be a sterile area.**

**A- First floor 'drying room' has a timber /glass storage unit and other discarded items to be removed. *Resolved 08/11/22***

<p>07/23, A</p>	<p>timber /glass storage unit and other discarded items to be removed.</p>

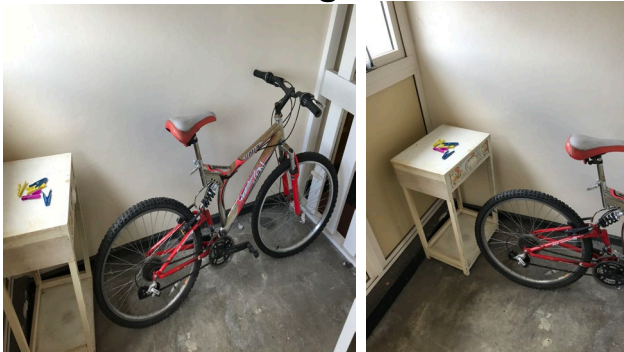
**B- Second floor 'drying room' has a table and a bike that needs removing. *Resolved 08/11/22***

<p>2</p>	<p>Housing manager August 2022</p>	<p>08/11/2022</p>
<p>07/23, B</p>	<p>Table and bike to be removed from 'drying area'</p>

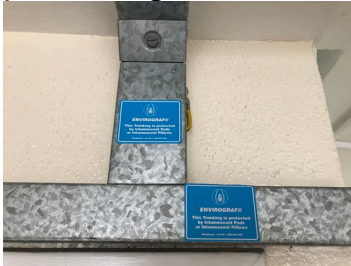
- 25) Metal trunking has been used in communal areas for cable runs this is a Envirograf product and has intumescent pads or pillows protecting it.

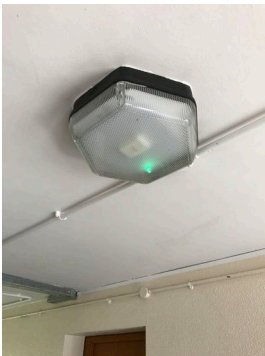
- 1) The premises have a sufficient emergency / escape lighting system in accordance with BS 5266 and has test points strategically located.
- 2) The self-contained units are provided to the communal landings, stairs.

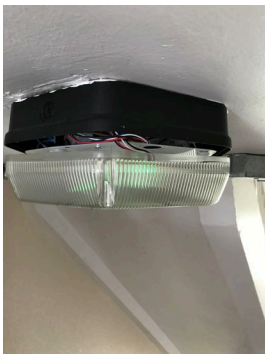
- 4) One of the self-contained units on the first floor is loosely fitted and need repairing.

09/04	<b>One of the self-contained units on the first floor is loosely fitted and need repair/ replacement</b>

1	Repairs Electrical August 2022 emailed JN JM9311213	20/10/2022

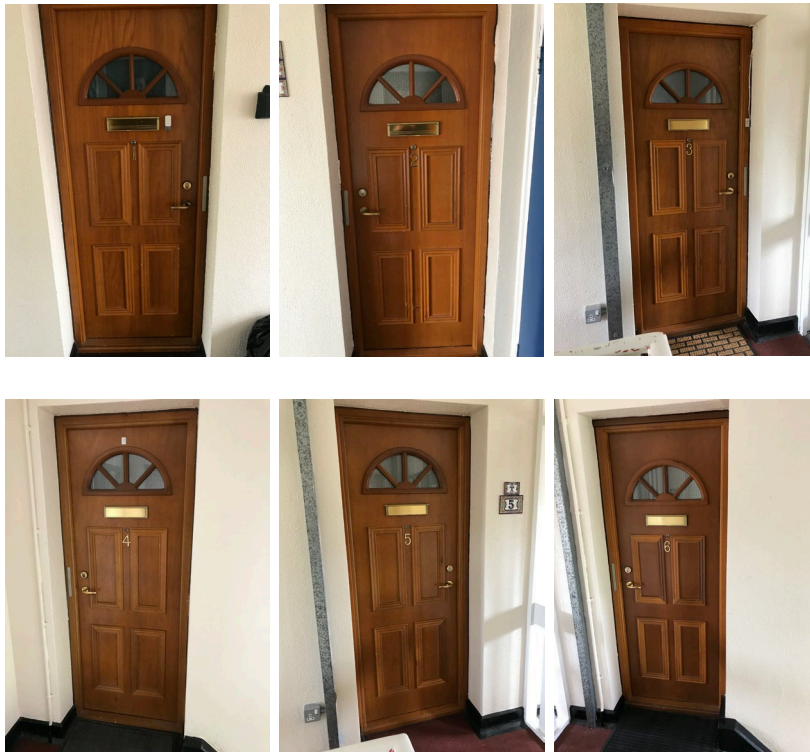
Refer to door sheet below:

BL27280RI02	1 Richards House; Kempsey Close; Oldbury; West Midlands;	Composite Carolina	Glazed
BL27280RI02	2 Richards House; Kempsey Close; Oldbury; West Midlands;	Composite Carolina	Glazed
BL27280RI02	3 Richards House; Kempsey Close; Oldbury; West Midlands;	Composite Carolina	Glazed
BL27280RI02	4 Richards House; Kempsey Close; Oldbury; West Midlands;	Composite Carolina	Glazed
BL27280RI02	5 Richards House; Kempsey Close; Oldbury; West Midlands;	Composite Carolina	Glazed
BL27280RI02	6 Richards House; Kempsey Close; Oldbury; West Midlands;	Composite Carolina	Glazed

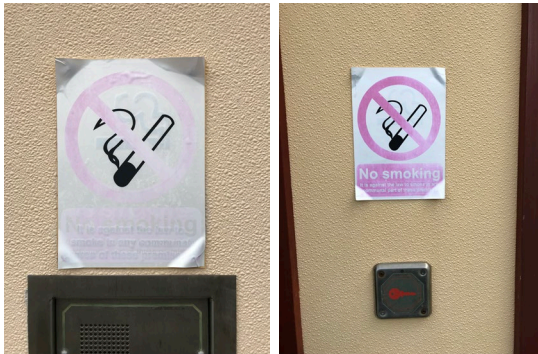
- 1) All fire doors display 'Fire door keep shut' signs where appropriate.
- 2) Fire Action Notices are not displayed throughout the building. The signs are not necessarily due to the building not having a complex layout.
- 3) Yellow LPG warning signs are not displayed within the block. [refer to section 18](#)
- 4) Smoking is prohibited within any communal parts of the building in line with Smoke Free England legislation. Signs are displayed at the rear and front entrances it is noted that the signs are Faded

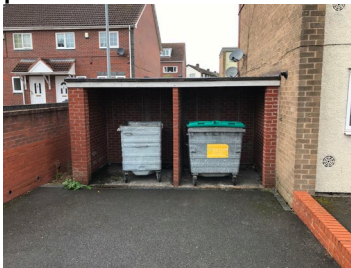
2) A sheltered bin storage area is attached to the side of the premises. Refuse containers are emptied regularly.

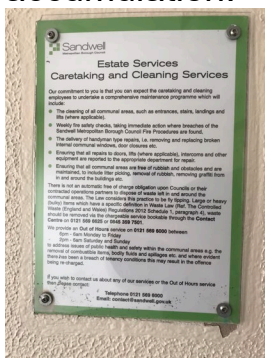
3) Regular checks by Caretakers minimise risk of waste accumulation.

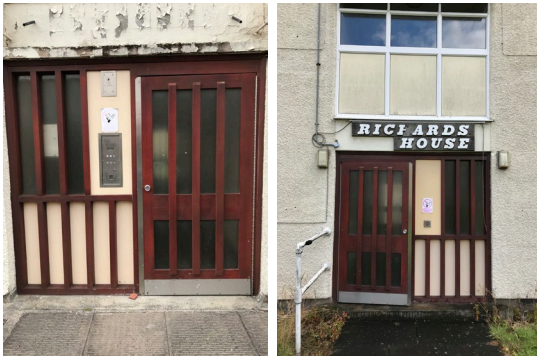
- 1) Regular checks are undertaken by Caretakers / Cleaning Team(s) 365 days per year which helps reduce the risk of arson.
- 2) Restricted access to the premises by means of a door entry system.

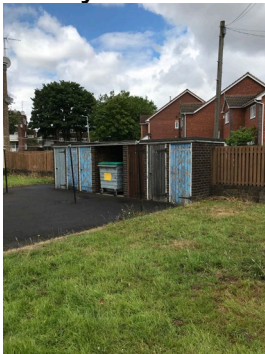
- 1) Residents instructed not to bring L.P.G cylinders into block.
- 2) The tenancy conditions, Section 7 – Condition 5.6 stipulates “If you live in a flat or maisonette, you, people living with you and any visitors to your property must not keep or use paraffin oil, petrol, bottled gas appliances or any other explosive, FLAMMABLE or dangerous material in the property. This restriction also applies to any storage facility situated in or attached to the block, which has been provided for your use.”
- 3) Residents have access to lockable storage facilities located in the rear yard.

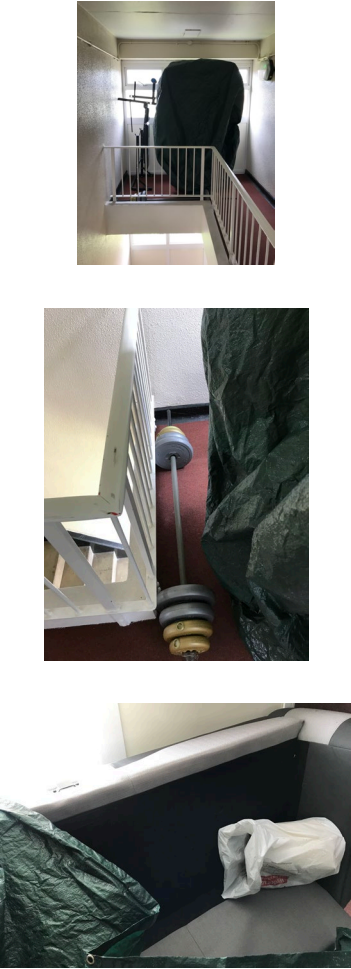
<p>07/ 24</p>	<p>Gym equipment and sofa with tarpaulin on the communal staircase to be removed</p>

<p>The first photograph shows a view down a staircase where a large piece of dark equipment is completely covered by a green tarpaulin. The second photograph is a closer view of the same area, showing a white staircase railing, a blue and silver dumbbell, and the green tarpaulin covering the equipment. The third photograph shows a white sofa also covered in a green tarpaulin, with a white plastic bag on the floor next to it.</p>	<p>3</p>	<p>Housing manager August 2022</p>	<p>08/11/2022</p>
---------------	--	--	----------	--	-------------------
