# Fire Risk Assessment

## Elmcroft

**Windmill Lane,  
Smethwick, B66 3JN**

**Date Completed: 25/09/2023**

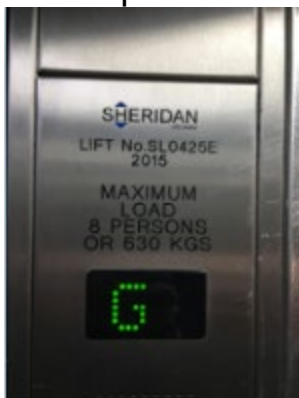
There are two lift cars that serve alternate floors. The capacity for each lift is 8 persons or 630kg.

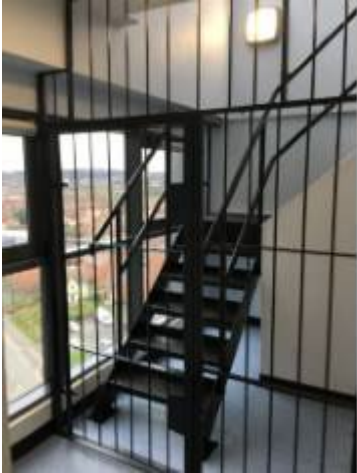
The motor room is located within the main roof void.

Access to motor room via a steel gate secured with suited 54 lock

Then utilise the metal stairs leading from 14<sup>th</sup> floor, then through a full height door (secured with suited 54 locks) into roof space.

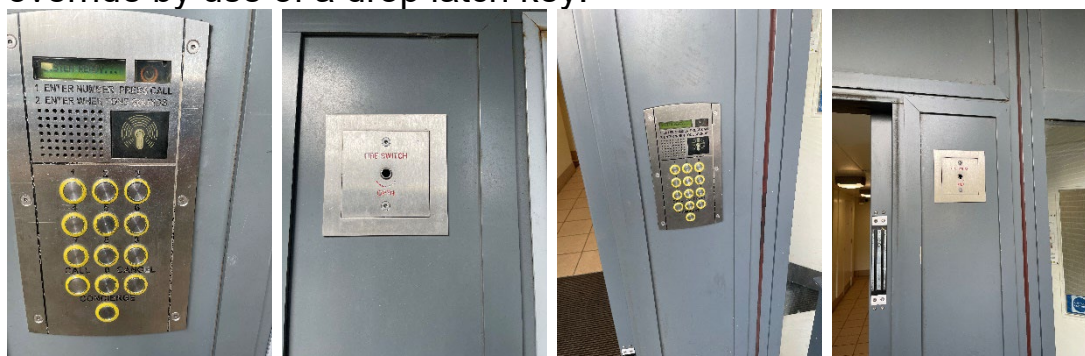
The main entrance to the front elevation has a door entry system with a fob reader installed. The entrance to the rear elevation is accessed by the installed fob reader. The front and rear entrance has a firefighter override by use of a drop latch key.

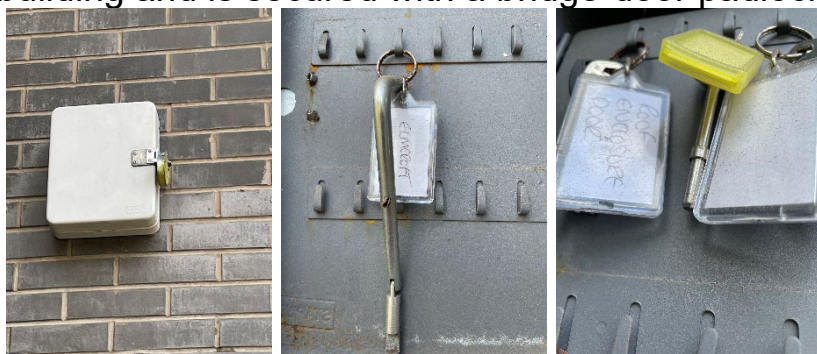
There is a firefighter's white box externally to the right-hand side of the main entrance to the front of the building. The box contains keys for the building and is secured with a bridge-door padlock.

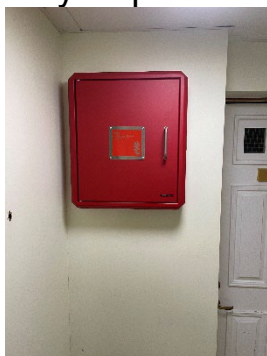
There is a Secure Premise Information Box (PIB) located on the ground floor adjacent to the lifts. It is a Gerda box that utilises a standard WMFS suited key. The PIB contains floor plans, vertical plans, orientation plans, information for WMFS and documents for those with vulnerabilities who may require additional consideration if there is a fire incident (PEEP).

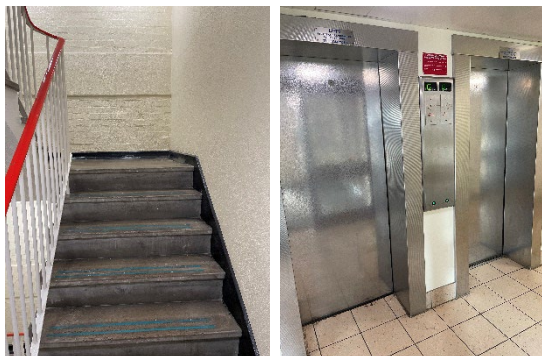
All floors are served with one of two lift cars and one staircase. The lift motor room is within brick masonry construction within the roof void.

Access to the lift motor room is obtained via a steel gate secured with suited 54 lock. Then utilise the metal stairs leading from 14<sup>th</sup> floor, then through a full height door (secured with suited 54 locks) into roof space.

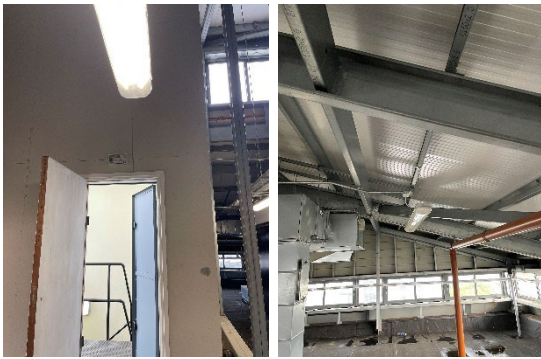
Access to the roof area is gained via doors from top of the metal staircase.

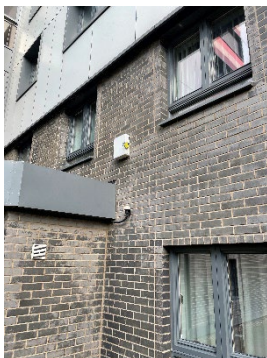
- Rockwool (non-combustible) insulated brickwork ground to first floor.

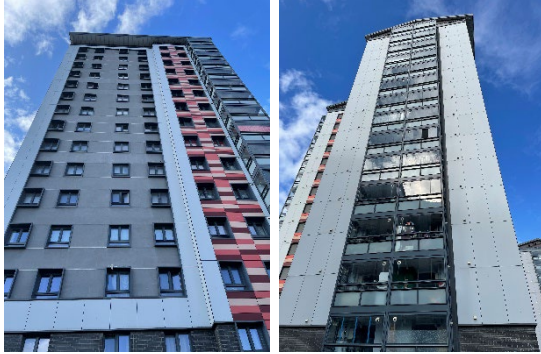
- Wetherby mineral wool render ( Fire Classification A1) and high density Rockpanel panels ( Fire Classification A1)

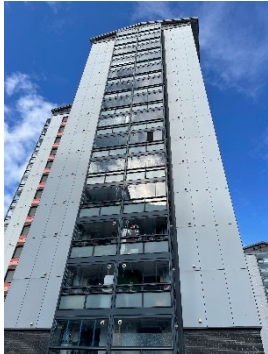
- 2) Each flat within the block has access to an individual winter garden balcony. These are cantilevered concrete floors with an aluminium and glass construction.

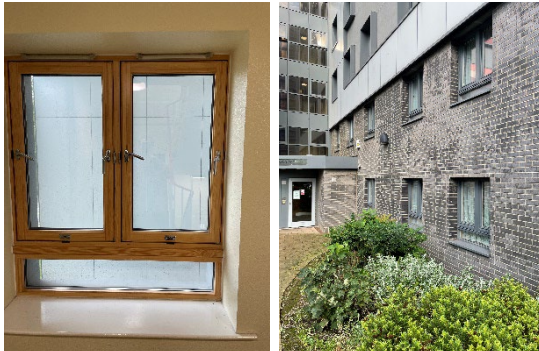
- 3) All windows are double glazed units housed in aluminium frames. Timber frames were noted internally within the staircase.

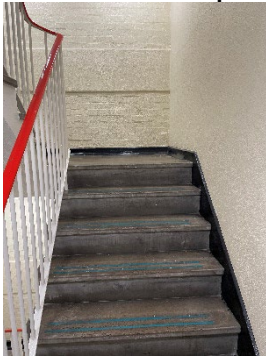
- 1) The site has a single staircase, of width 1050mm, that provides a means of escape.

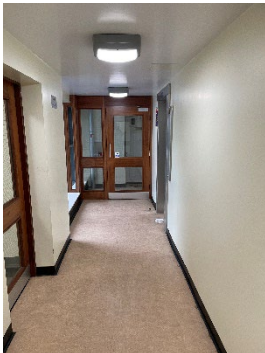
- 2) All corridors are of adequate width (at least 1050mm) and will be maintained clear to that width as a minimum.

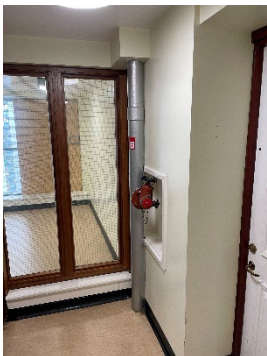
- 3) The means of escape from flats are dead ends. The un-ventilated corridors are less than 4.5 metres.

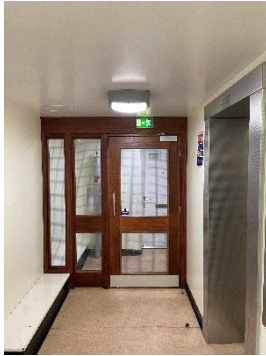
- 5) The communal landing / staircases are protected by use of self-closing 44mm nominal timber 30 minute fire doors with vision panels & intumescent strips / cold smoke seals.

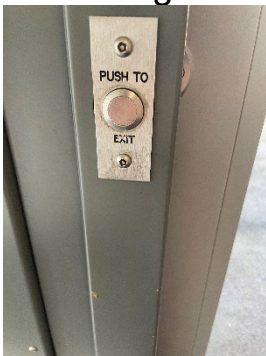
- 6) All communal doors are fitted with automatic closing devices that are checked on a regular basis by Caretaking Teams as part of their checks. Defective closing devices are replaced either by the Caretaking Team(s) or the in-house repairs team(s).
- 7) All communal fire doors are subject to a 12-week check by the Fire Safety Rapid Response Team.
- 8) The final exit doors have door entry systems installed. These systems are designed to fail safe i.e. door unlocked in the event of a power failure. This prevents residents being locked in or out of the building.

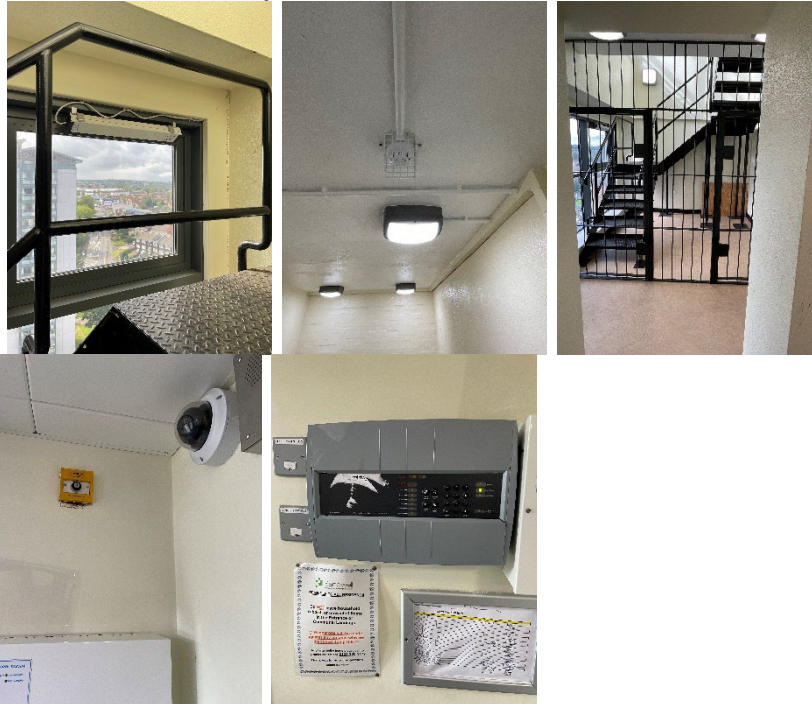
- 9) Automatic smoke ventilation is employed. This is tested, inspected and maintained by a competent procured contractor in accordance with BS7346. The frequency for the maintenance checks are twice per year (April and October) of each calendar year.
- 10) Automatic smoke ventilation is installed to the two windows at the head of the staircase on the 14<sup>th</sup> floor. The controls and repeater
-

panel are located in the ground floor lobby. A further reset switch is located at the top of the stairs on the 14<sup>th</sup> floor.

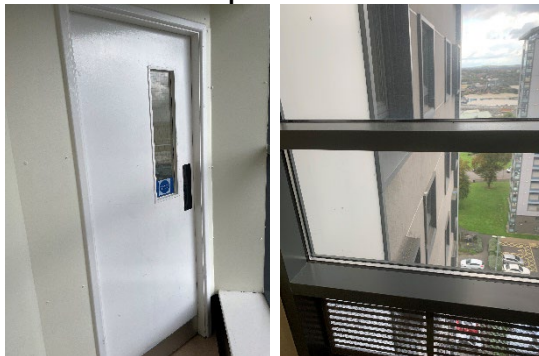
11) The chute room doors on each floor are 44mm nominal 30 minute fire doors with combined intumescent strips & cold smoke seals and overhead self-closing devices. The chute room on each floor has louvres to provide natural ventilation.

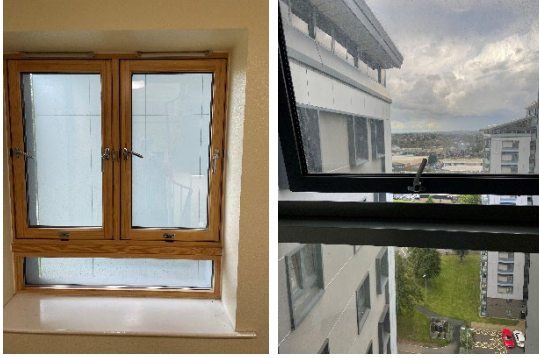
12) Communal windows can only be opened with the use of a key or by operating the automatic smoke vents. The timber windows to the staircase do not require a key.

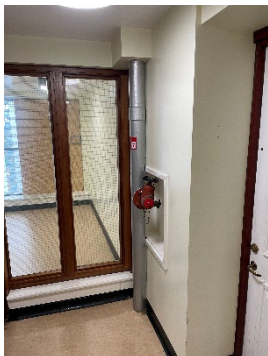
16) Dry riser outlets on lobbies are not housed in service cupboards but deliveries are secured by cable tie.

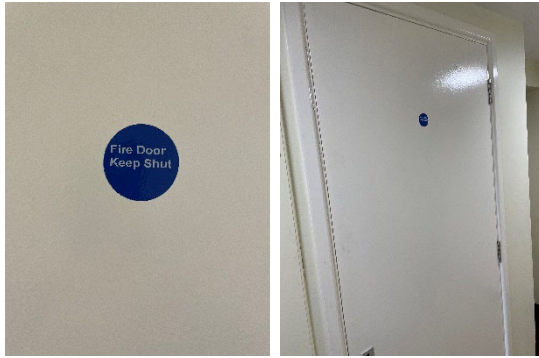
17) Service cupboards located within the corridors are 54mm nominal fire doors with intumescent strips and cold smoke seals secured with type 54 suited mortice locks.

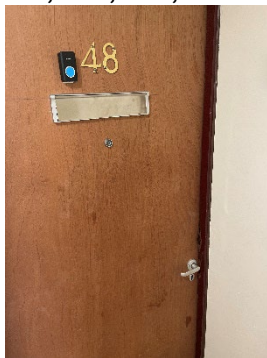
- 18) The surface coatings to the communal areas are Class 0 rated.
- 19) The building has sufficient passive controls that provide effective compartmentation in order to support a Stay Put-Unless Policy. Therefore, residents are advised to remain in their flat unless the fire directly affects them or they are asked to leave by the emergency services.
- 20) Individual flat doors are self-closing nominal 30-minute composite fire door sets with intumescent strips, cold smoke seals and self-closing devices. Doors are manufactured by Permadoor or Nationwide. Timber doors were noted to flats: 88, 83, 78, 57, 48, 47, 46, 29, 9 and 3.

<b>Observations</b>	
<p>Section 7/20 -Timber doors to Flats: 88, 83, 78, 57, 48, 47, 46, 29, 9 and 3. To be replaced with certified self-closing FD 30s door sets as part of future door programme.</p>

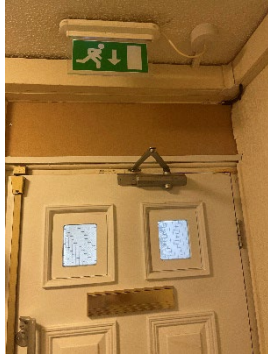
- 21) Access is gained to a sample of properties as part of the fire risk assessment to ensure the doors have not been tampered with by residents etc. Flats accessed were: 5, 8, 27, 40, 63, 71, 82
- a) Flat 5 – Door not positively shutting against latch. Self-closer requires adjustment.**
-

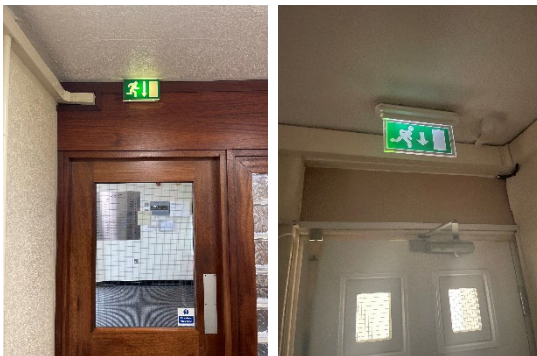
- 1) The premises has a sufficient emergency / escape lighting system in accordance with BS 5266 and has test points strategically located.

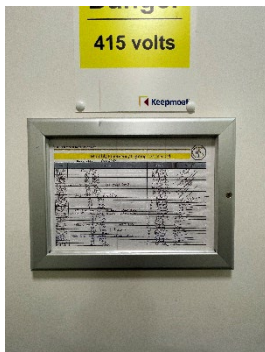
- 2) The self-contained units are provided to the communal landings, stairs and lift motor room and meeting room at ground floor..
- 3) All installed equipment is checked and tested on a monthly basis by Sandwell MBC in house electrical team or approved contractor, in accordance with current standards.

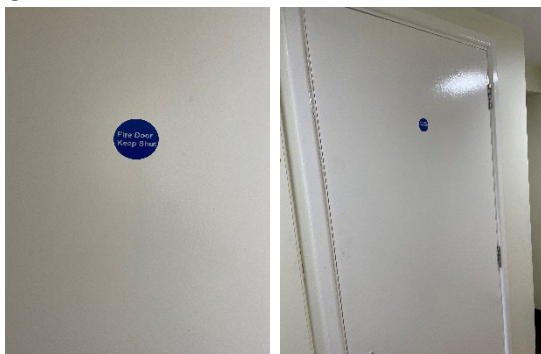
- 4) All communal fire doors are subject to a 12-week check by the Fire Safety Rapid Response Team.
- 5) All service cupboards to communal landings are locked with suited 54 mortice locks.

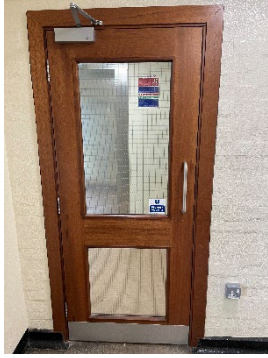
- 7) The fire stopping / compartmentation is subject to a 12-week check by the Fire Safety Rapid Response Team.
- 8) Any remedial works arising from the fire stopping / compartmentation check(s) will be actioned immediately by the Fire Safety Rapid Response Team.
- 9) Individual flat doors are nominal 44mm self-closing fire doors of composite construction with intumescent strips, cold smoke seals and self-closing devices. These doors are manufactured by Permadoor or Nationwide. Flats: 88, 83, 78, 57, 48, 47, 46, 29, 9 and 3 are currently nominal timber fire doors.
-

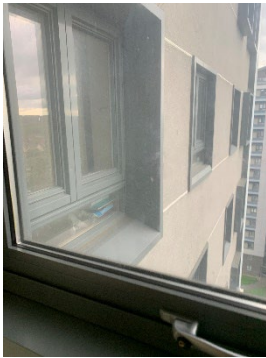
- 11) Glazing between the flatted accommodation and the staircase is in close proximity. Compensatory measures should be considered for a future works programme such as a sprinkler system to the flats.

<p>Section 10/11. As part of a future works programme a sprinkler installation to the flats should be considered due to proximity of glazing.</p>

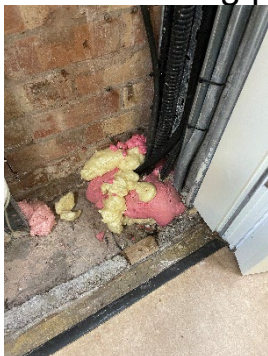
- 12) Fire foam was evident in most service risers on most floor levels. This should be removed and replaced with suitable fire stopping material during programmed works.

Section 10/12. Foam has been heavily used in all risers. This should be replaced during any future fire stopping programme.

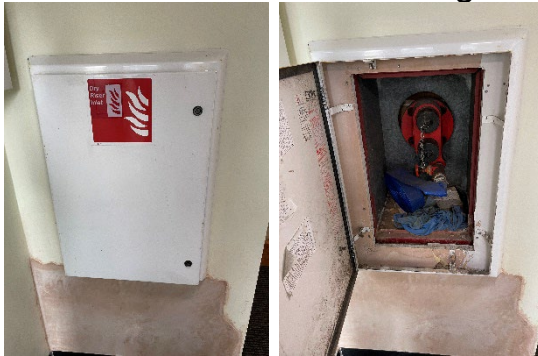
- 1) The dry riser inlet cabinet is located in the entrance lobby. The cabinet is secured with a budget lock.

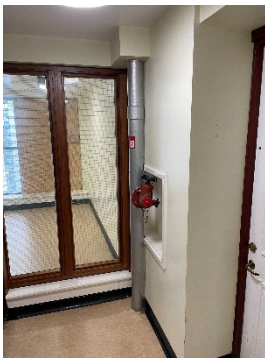
- 2) There is a dry riser that serves the building. The outlets are exposed and located on the communal lobby of each floor. Each exposed valve is secured with a cable tie. The caretakers check the cable tie is intact as part of their weekday inspections.

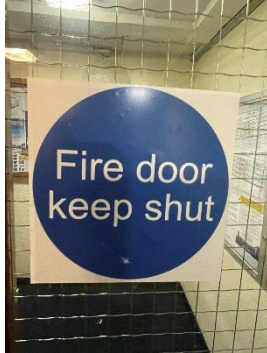
- 1) All fire doors display “Fire Door Keep Shut” where appropriate.

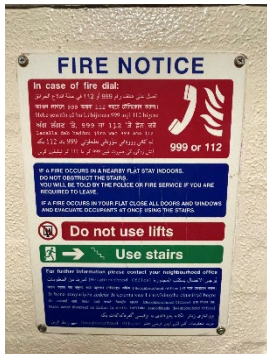
- 2) Fire Action Notices are displayed throughout the building.

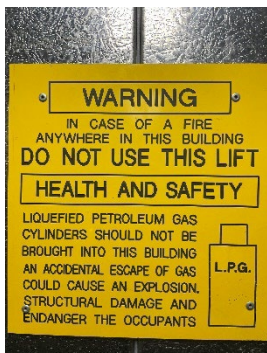
- 3) Yellow LPG warning signs are displayed within the lift cars.

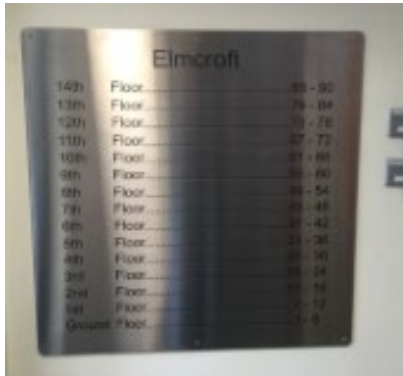
- 4) Signage depicting the floor location of each flat is fitted to the ground floor lobby wall.

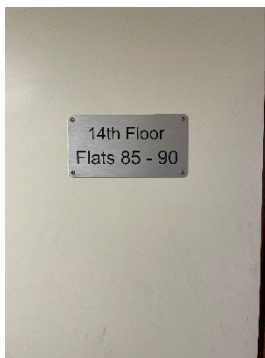
- 5) Wayfinding Signage depicting floor level and flat numbers are fitted to the corridor walls adjacent the lift.

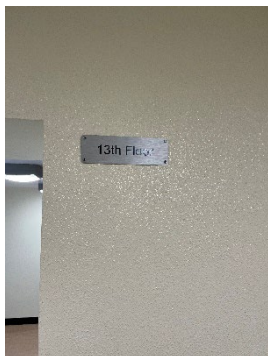
- 6) Wayfinding Signage depicting floor level are fitted to wall of each floor on the communal staircase.

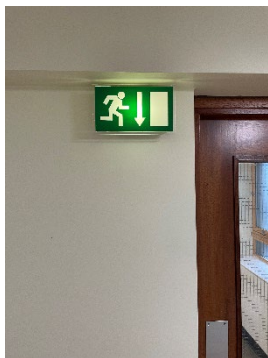
- 7) The fire escape routes do use directional fire signage.
-

*Please note that the Wayfinding signage will be replaced with Photoluminescent signage that meets the requirement of ADB and Fire Safety (England) Regulations 2022. The provision for the signage has been procured and we are awaiting delivery of the signage)*

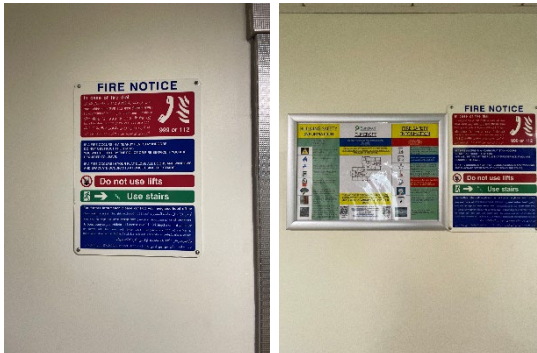
- 7) Building safety and evacuation notices are displayed in common areas and lift cars.

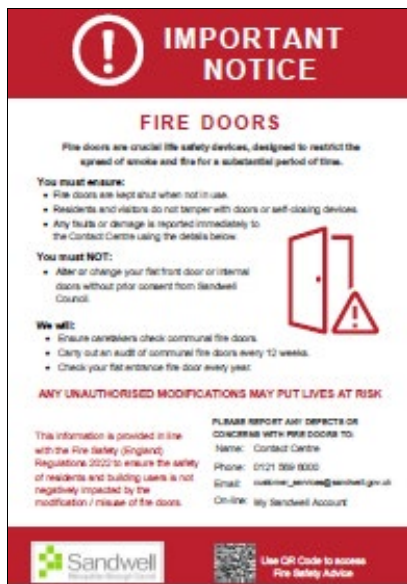
- 8) Information regarding use of fire doors is provided to residents

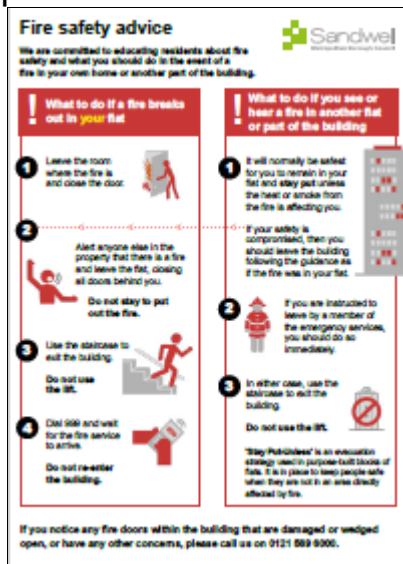
- 9) Information regarding the Stay Put unless fire evacuation strategy is provided to residents

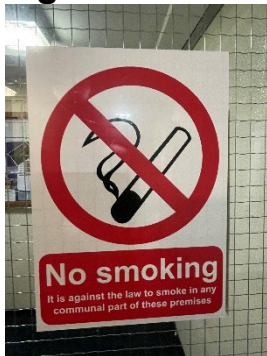
- 1) Smoking is prohibited within any communal parts of the building in line with Smoke Free England legislation. However signs of smoking were evident within the staircase.

P2	Fire Rapid Team 1-3 Months JM:12140371	Pass back broken hinges on window. 31/10/2023
14/1	Evidence of smoking witnessed on several floors of staircase. Tenants to be reminded of their tenancy agreement	No Image	P2	Housing Manager 1-3 Months	02/11/2023

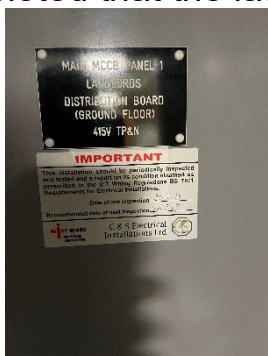
- 2) Hot working is not normally carried out. If essential maintenance requires the use of hot work processes, then corporate policies and procedures are to be followed.
- 3) Portable electrical equipment used as part of the Caretaking / Cleaning regime is subject to annual PAT Testing. This information is held by the Estate Services Manager Bryan Low.
- 4) The fixed electrical installation shall be tested every 5 years. It was noted that the last inspection was 20/07/23.

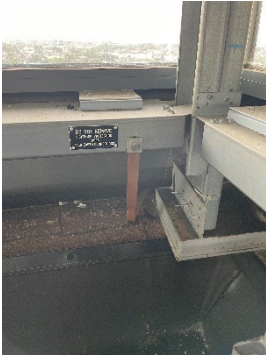
- 6) There is lightning protection installed to the block. Maintenance contracts are in place for lightning conductor testing in accordance with BS 6651.

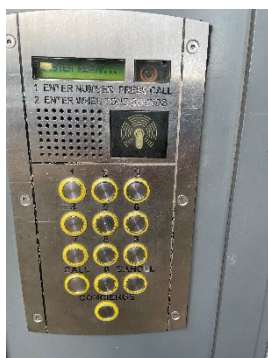
- 1) Regular checks are undertaken by Caretakers / Cleaning Team(s) 365 days per year which helps reduce the risk of arson.
- 2) Restricted access to the premises by means of a door entry system.

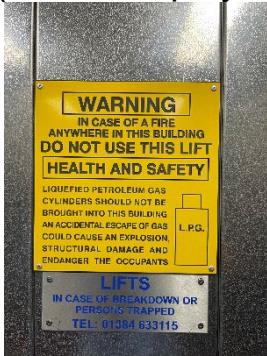
- 1) Residents instructed not to bring L.P.G cylinders into block.  
(Notice displayed in lifts see point)
