# Fire Risk Assessment

## Arden Road

**Flats 18 - 34 Arden Road,  
Smethwick,  
B67 6AA.**

**Date Completed: 07/05/2024.**

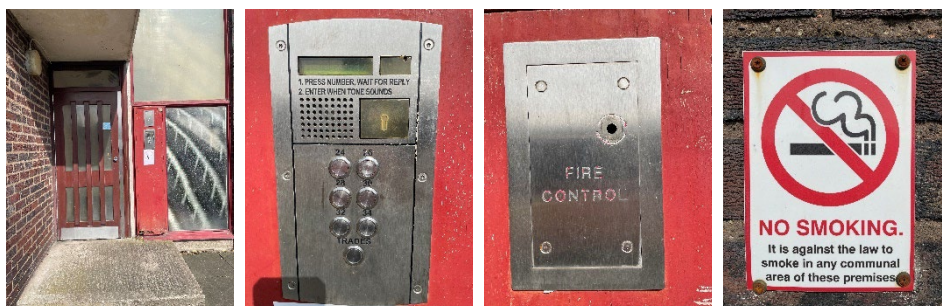
The residence has 1 entrance to deck access flats on the upper levels, this access is located at the side of the premise. The access door to the staircase has a door entry system with a fob reader installed. A firefighter override drop latch key is provided for local authority staff and Fire & Rescue Services.

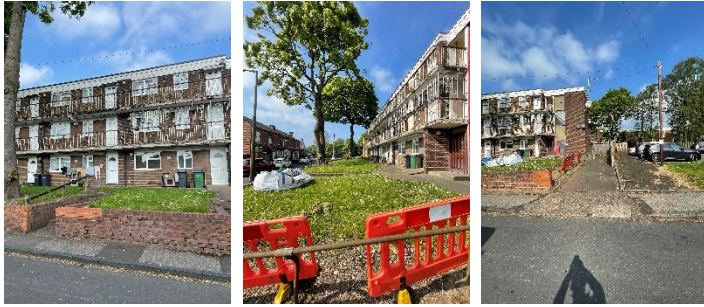
The building is of traditional Brick, concrete construction, double glazed UPVC window frames surmounted by a flat bitumen roof.

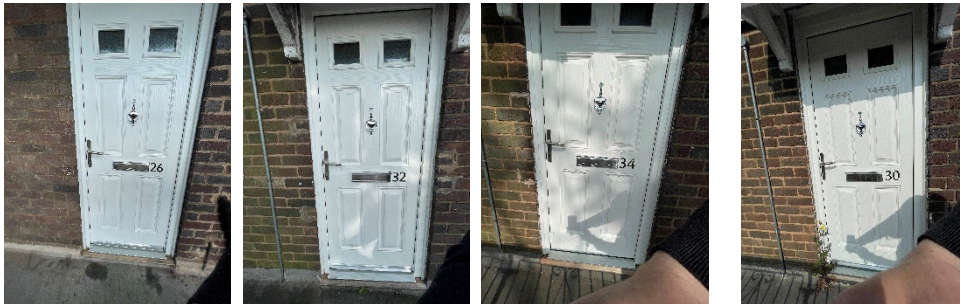
At the time of the assessment front doors to flats appeared to be in good condition, it is understood most front doors are Permadoor constructed doors.

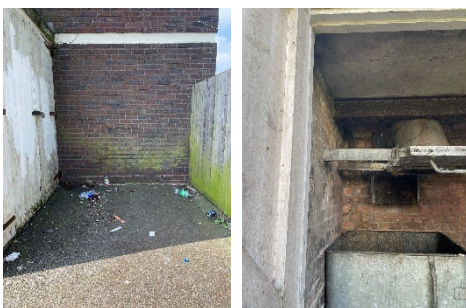
There is a refuse chute provided for residents to dispose of rubbish. The bin room is located at the rear of the premise, the doors are wooden in construction & maintained locked by a padlock.

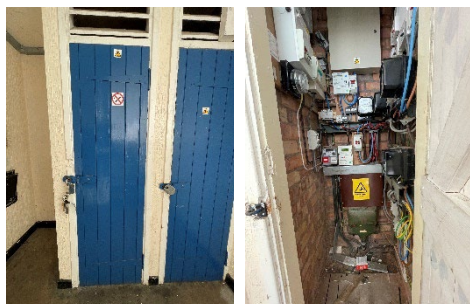
Electrical service cupboards are provided within the staircase.

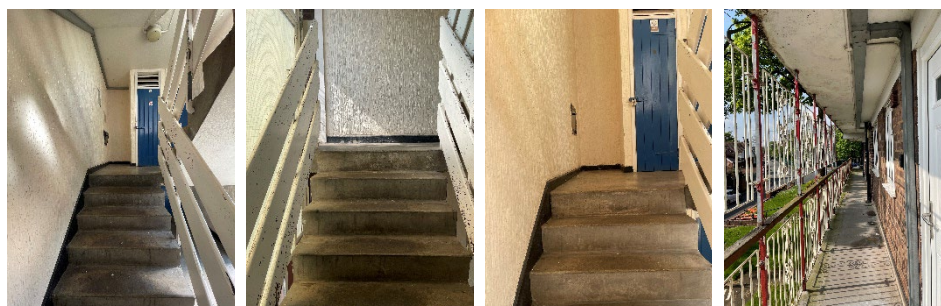
- 2) The First and Second floor access staircase is open at each level & provides access to open deck balconies.

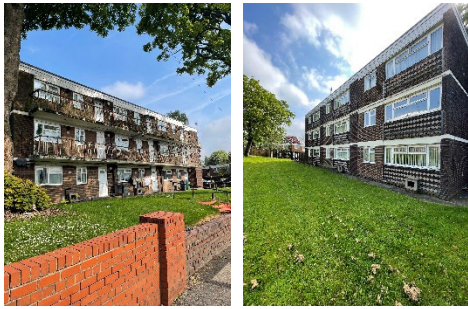
- 3) UPVC Facia type boarding is framed around the top edge of the building.

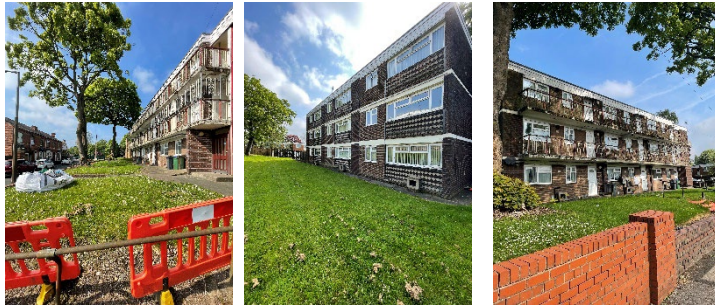
- 4) There are lawned areas to the rear and front elevation of the building.

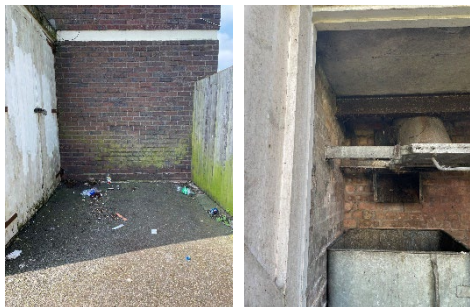
- 5) A bin chute room is provided and lies at the rear right hand side of the premise.

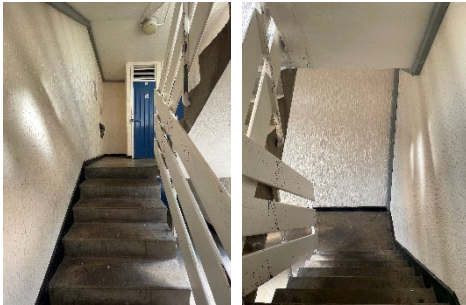
- 1) The premise has a single staircase that provides a means of escape from the building.

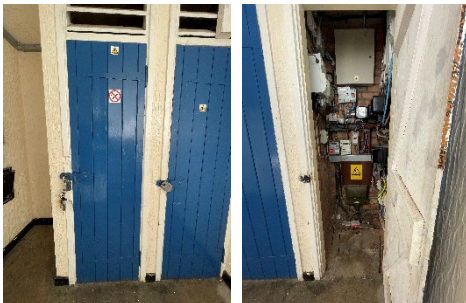
- 2) Electrical service cupboards are located on the staircase. These doors are maintained locked. These doors & transoms should be upgraded to fire doors FD30's as part of any future improvement works.

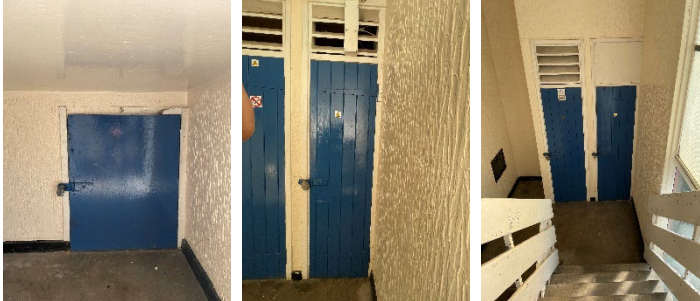
- 7) All service cupboards to communal landings are maintained locked. It was noted that service cupboard doors, and the wooden louvred transoms above doors, do not provide a min of 30 mins fire resistance.

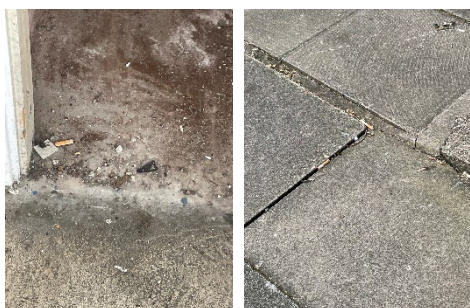
- 1) Smoking is prohibited within any communal parts of the building in line with Smoke Free England legislation. It was noted that cigarettes had been disposed of in the service cupboards of this premise. It also appears that smoking is taking place outside of the main access door. (Email sent to Housing Management Team). This has the potential to compromise the means of escape.

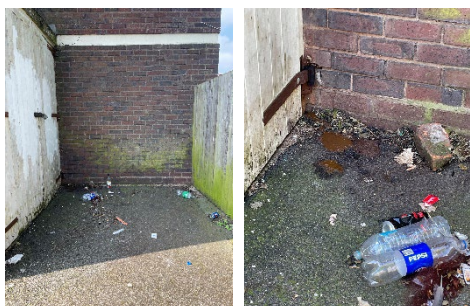
- 2) It was evident that an area adjacent to the Bin Store was being used for Anti-Social Behaviour, there were several empty alcohol bottles, cigarette ends and what appeared to be Human Faeces. (Email sent to Housing Management Team).
