Fire Risk Assessment Albert Street Princess End Tipton

Albert Street, Tipton, DY4 9JY Date Completed: 20/04/2024. Review Period: 3 years Officer: Louis Conway Fire Risk Assessor Checked By: J Blewitt Team Lead Fire Safety & Facilities

Current Risk Rating = Tolerable

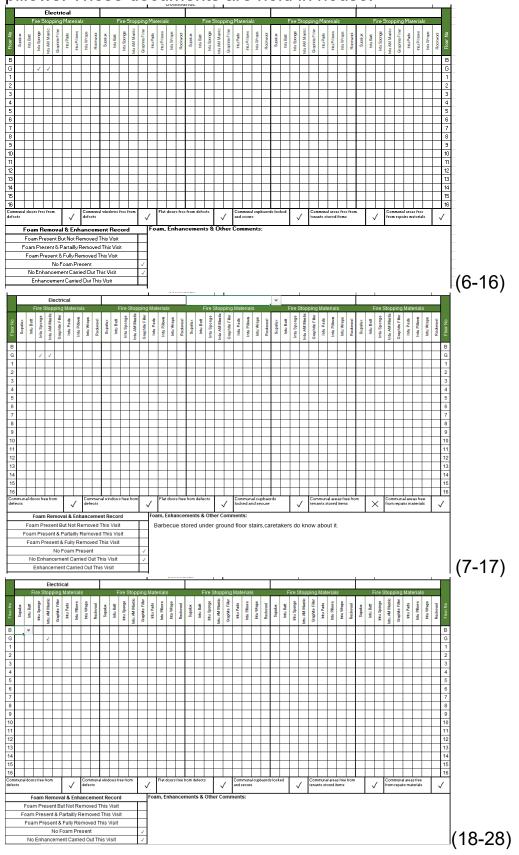
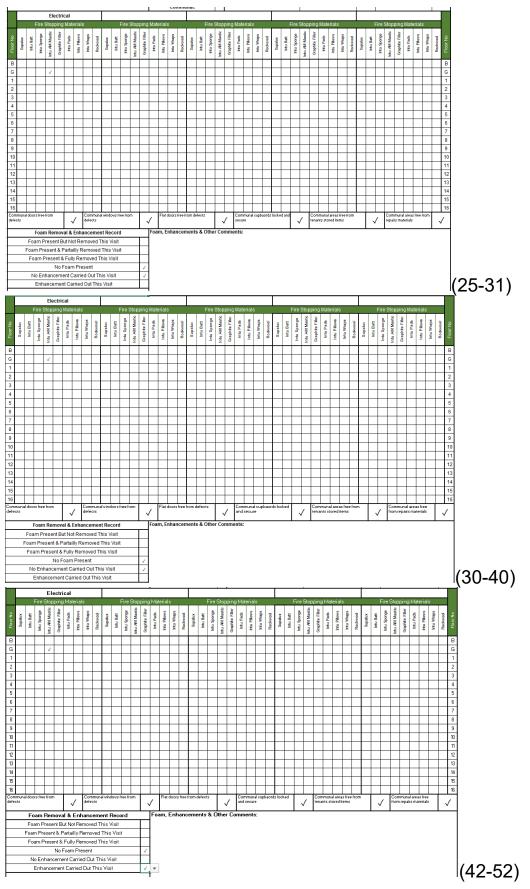
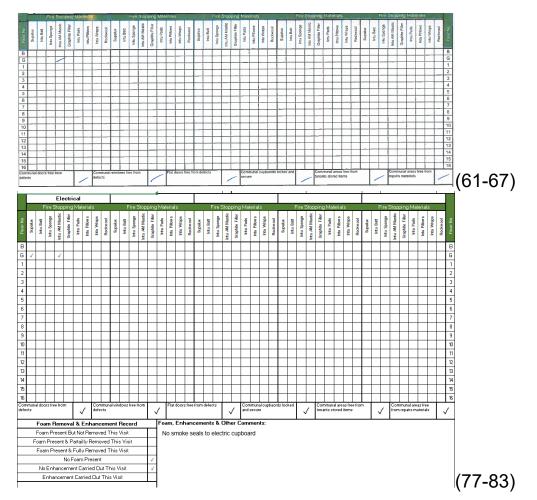
5) A variety of methods / materials have been used to achieve firestopping including Rockwool, fire rated sponge and intumescent pillows. These documents are held in house.

- 6) The fire stopping / compartmentation is subject to a annual check by the Fire Safety Rapid Response Team
- 7) Any remedial works arising from the fire stopping / compartmentation check(s) will be actioned immediately by the Fire Safety Rapid Response Team.
- 8) Individual flat doors are a mixture of nominal Timber & composite door sets.

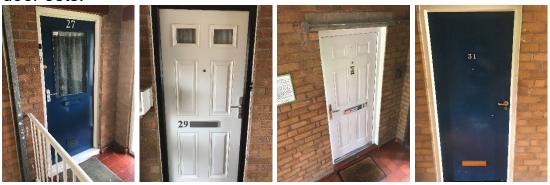
Refer to door sheet below.
