# Fire Risk Assessment

## Grace Road

**Flats 33 - 55.  
Grace Road.  
Tipton,  
DY4 0PG.**

**Date Completed: 03/06/2024.**

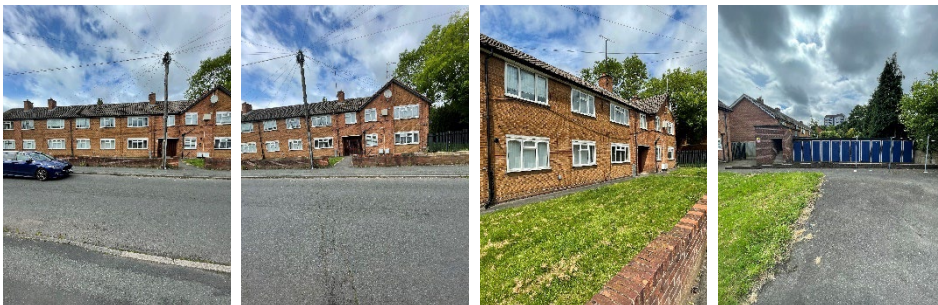
They are of traditional brick, concrete construction, double glazed UPVC window frames surmounted by a pitched roof.

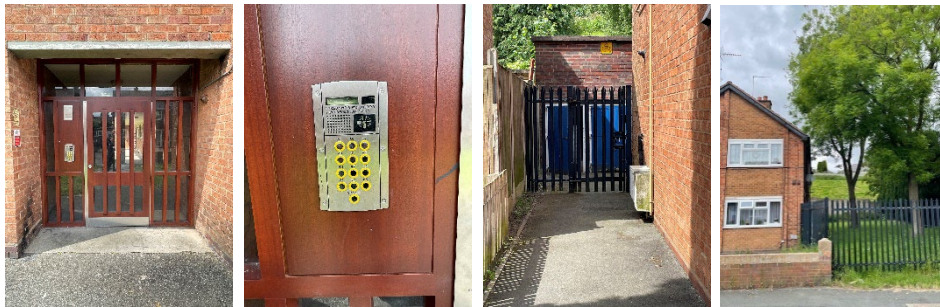
The building has a single staircase with access gained at the front elevation. The site is secured by palisade fencing, access to the rear of the building is gained via the front entrance door or by a suited padlock to the bin area at the side of the building. The main front access is controlled via a door entry system and rear access is via an electronic fob to prevent unauthorised access.

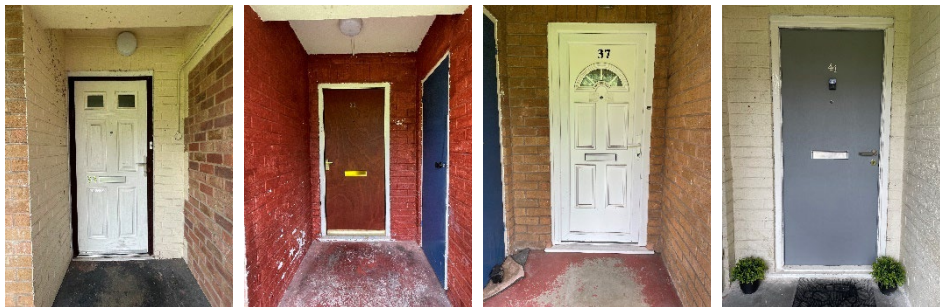
At the time of the assessment front doors to flats appeared to be in good condition. However, it was noted that several front entrance doors were timber doors and two doors appeared to be UPVC doors.

As part of any future door replacement programme replace timber & UPVC front entrance doors. This should be inclusive of Leaseholder properties. (Email sent to door replacement team).

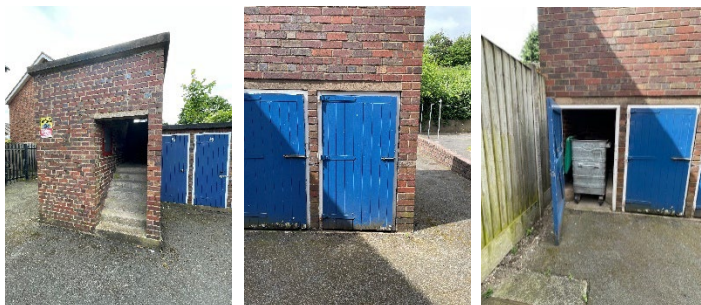
To dispose of rubbish, residents utilise a refuse bin store located on the ground floor at the rear of the building.

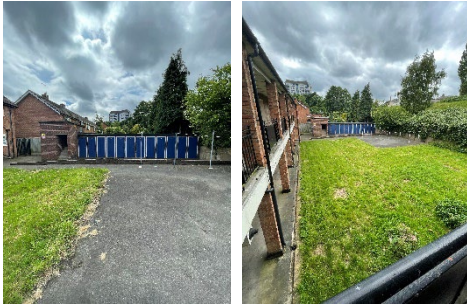
There are several external store cupboards for use of residents, these appeared to be in good condition.

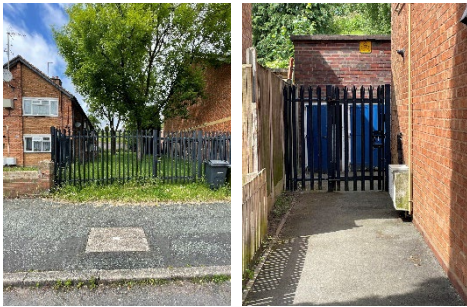
It was observed from the front elevation that the side of the building was secured by palisade fencing and padlocked shut.

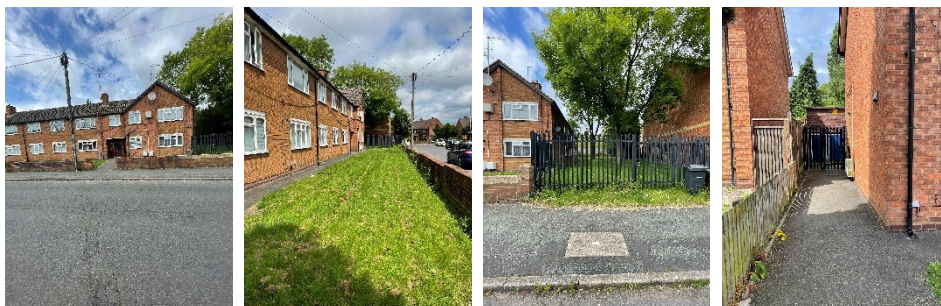
- 1) The external envelope of the premise is predominantly traditional brick, concrete construction, UPVC double glazed window frames surmounted by a pitched tiled roof.

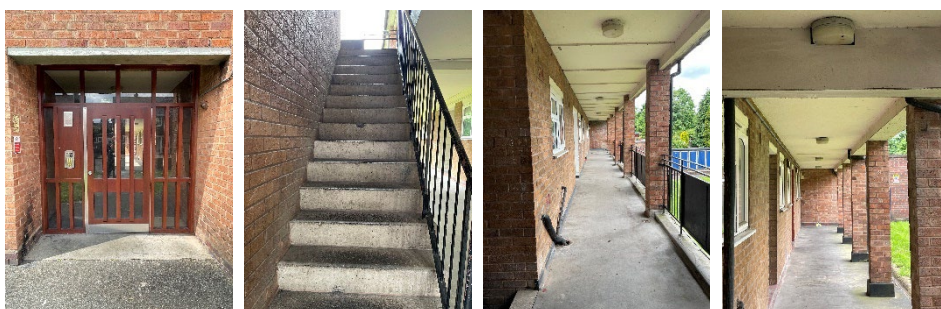
- 2) Access is gained to all flats from the ground floor using the access door leading to the staircase. The rear of the building is open plan with deck access on the first floor.

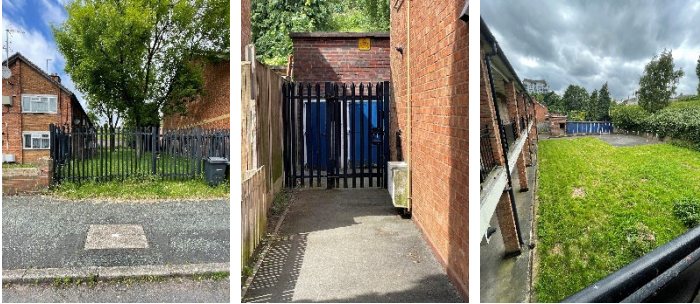
- 3) There is no provision for off road car parking facilities for residents.
- 4) External store cupboards and Bin stores are located at the rear of the premise.
- 5) The rear gardens are secured by palisade fencing and locked shut. There is a small grassed area provided for residents.

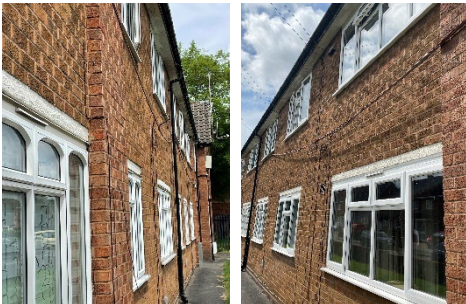
- 6) It was noted that a number of comms cables at the front elevation had become detached from the building. These cables should be refixed to the wall of the main building to prevent any further damage or incidents involving the public. (Email sent to Electrical).

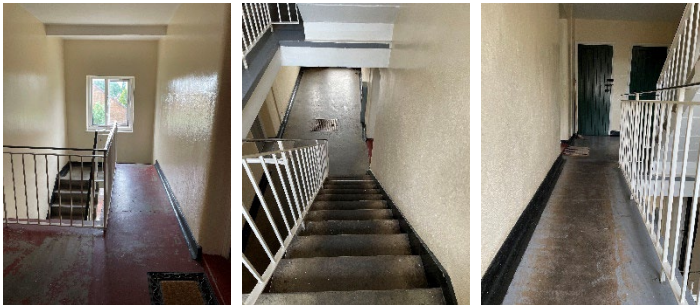
- 1) The building has a staircase that provides the means of escape. All open deck corridors are of adequate width (at least 1400mm) and should be maintained clear to that width as a minimum. The staircase provides a 980mm width as a minimum.

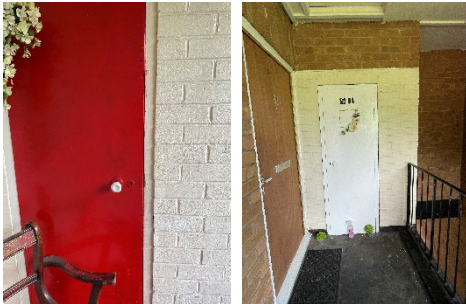
- 2) Internal store cupboard doors should be upgraded as part of any refurbishments, these should be upgraded to certified to FD30's fire rated as part of future works.

As part of any future refurbishments internal store cupboard doors should be upgraded to fire doors. (FD30 doors) to provide adequate protection. (Email sent to door replacement team).

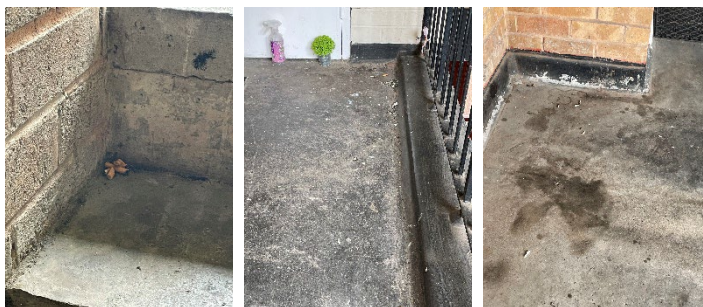
- 6) There is also an out of hour's service that allows combustible items of furniture / rubbish to be removed.
- 7) It was noted that surreptitious smoking was taking place on the staircase and the first-floor deck area. This should cease immediately. (Email sent to housing).

Smoking is taking place in the first-floor staircase area, this should be managed and monitored by the caretaker/cleaning team. Smoking should not take place in any communal areas of Local Authority Buildings. (Email sent to Housing and Caretakers team).

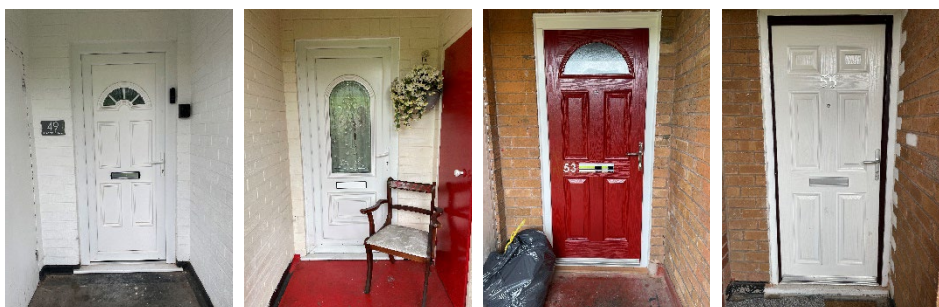
- 8) Automatic smoke ventilation is not employed.
- 9) The means of escape are protected to prevent the spread of fire and smoke with a combination of nominal FD30s doors consisting of composite, timber & UPVC front doors. No internal access to flats was gained during the fire risk assessment. Where applicable, sub-standard doors should be replaced when the fire door replacement programme commences.

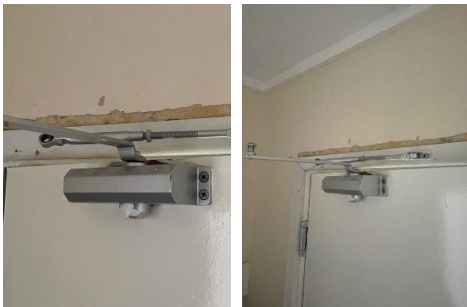
- 11) No internal access to flats was gained during the fire risk assessment to ensure the doors have not been tampered with by residents etc. The resident at flat number 39 did allow an inspection of the flat entrance door, the self-closer was defective.

Question/ Ref No	Required Action	Supporting photograph	Priority	Timescale and Person Responsible	Date Completed
07/11	Repair or replace the self-closer to flat number 39.

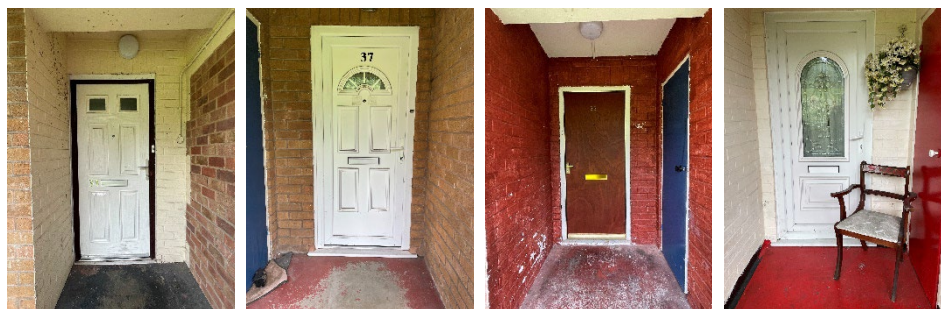
- 4) The fire stopping / compartmentation of the premises is subject to an annual inspection by the Fire Safety Rapid Response Team.
- 5) Generally, the means of escape is protected from flats with the use of nominal FD30s doors.
