# Fire Risk Assessment

## Southdene

**Flats 1 - 8, 9 - 17 & 18 - 25.  
Southdene  
South Road.  
Smethwick,  
B67 7DB.**

**Date Completed: 30/05/2024**

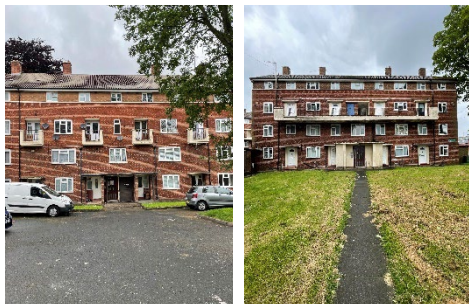
They are of traditional brick, concrete construction, double glazed UPVC window frames surmounted by a pitched roof.

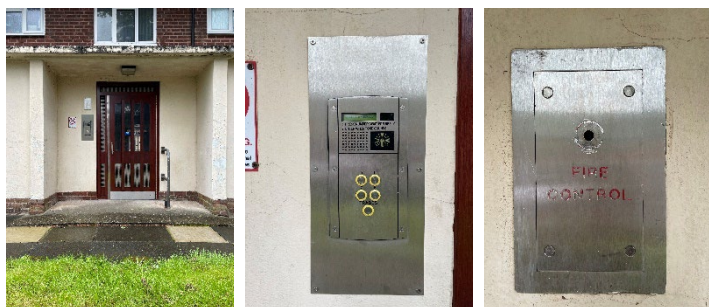
All blocks of maisonettes have one front and one rear entrance. These are controlled by a door entry system to prevent unauthorised access.

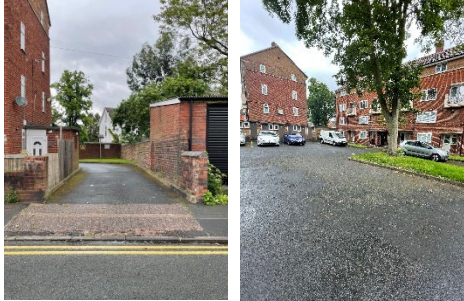
There is limited car parking facility at the rear of the premises, this will satisfy approx. 8 vehicles. This area is accessed from a driveway in Broomfield.

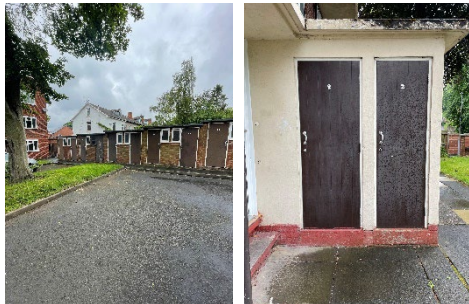
There are also several external store cupboards for use of residents, these appeared to be in good condition.

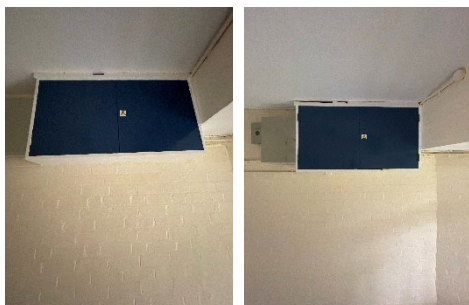
Electrical distribution boards were provided in the communal areas of each block, these were located at ceiling height. Construction of these units appeared to be standard timber. As part of any future upgrade, these should be replaced for a fire resisting cabinet.

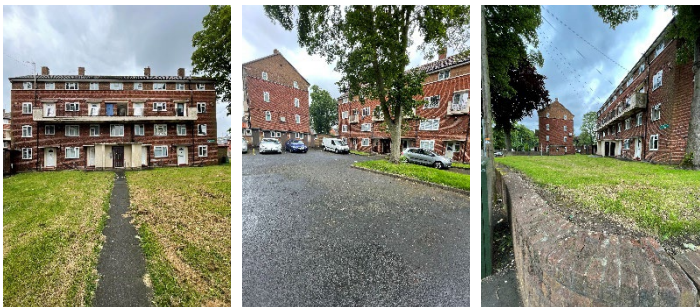
- 1) The external envelope of the premise is predominantly traditional brick, concrete construction, UPVC double glazed window frames surmounted by a pitched tiled roof.

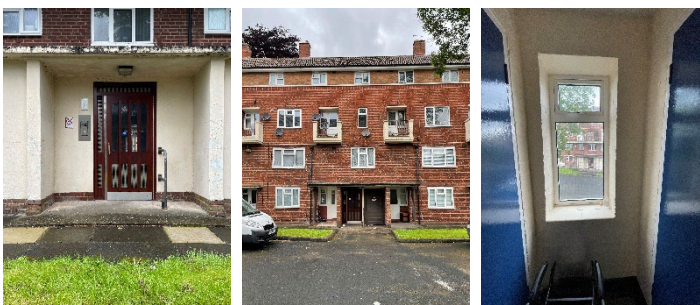
- 2) Access is gained to second floor maisonettes from the ground floor using the main staircase, there are several single glazed windows in the staircase which could be used for ventilation if necessary.

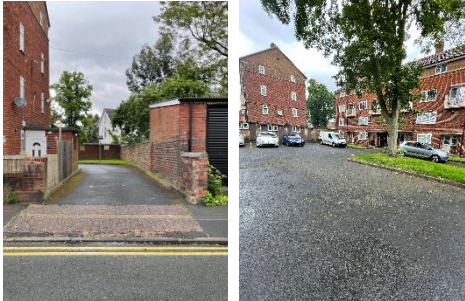
- 3) Limited car parking facilities for residents are available at the rear of the premise, this will satisfy approx. 8 vehicles. This area is accessed from a driveway in Broomfield. It should be ensured that motor vehicles are parked a safe distance from any building stock.

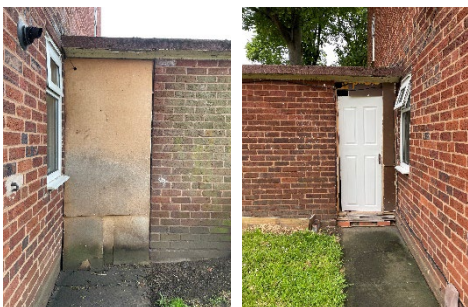
- 5) It was noted that two doors/wooden panels had been fitted to secure premises. Although these do not present a fire risk, they appear to have been vandalised and look an eyesore to the building.

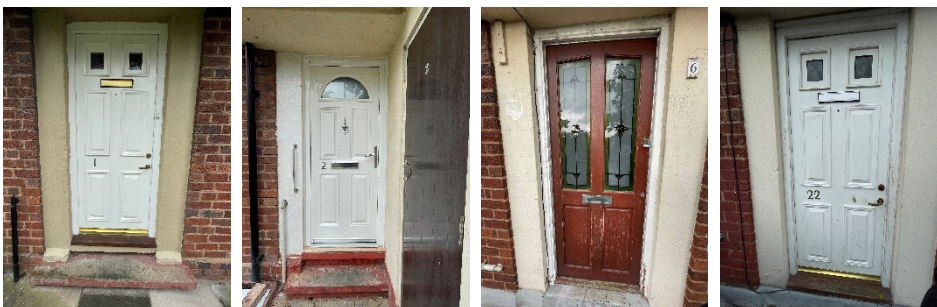
- 8) The means of escape are protected to prevent the spread of fire and smoke with a combination of Permadoor & Nationwide nominal FD30s doors. No internal access to flats was gained during the fire risk assessment.

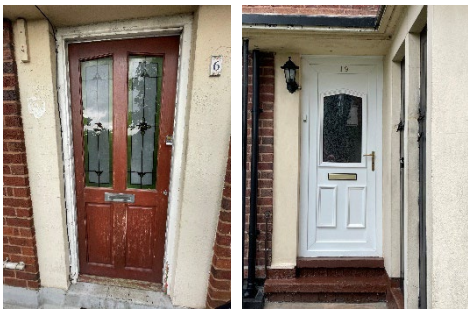
- 11) Flat 9 – The self-closer requires maintenance as the door is closing too quickly. This could be a finger trap for young or elderly people. Replace missing screw in hinge of the front door.
- 12) Flat 15 - There are no issues with the front door.
- 13) Leaseholders occupy several flats within these blocks. Front doors appeared to be sub-standard flat doors consisting of timber glazed and UPVC glazed doors. When the new door replacement programme commences, these doors should be upgraded to Fire Doors FD30.

Question/ Ref No	Required Action	Supporting photograph	Priority	Timescale and Person Responsible	Date Completed
07/09	Flat 9 – Repair self-closer to ensure the door closes correctly. Replace missing screw in hinge on front door. (Leaseholder).

When the new replacement door contract is in place replace front doors in flats 6, 19 & 21 with adequate fire rated doors. Fire Door FD30. (Leaseholder Team).

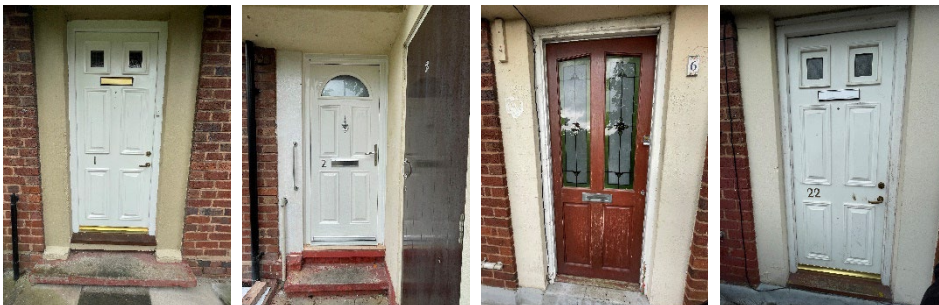
- 1) The building is designed to provide as a minimum 1-hour vertical fire resistance and 1-hour horizontal fire resistance around flats. All flat entrance doors are 30-minute notional/nominal doors, including those in 1-hour rated walls.
- 2) Access was not gained to any roof voids. It is understood that access is gained via resident's individual properties.
- 3) The premises do not have sufficient compartmentation to limit the travel and effect of smoke and flame in event of a fire in communal areas due to the open plan staircase.
- 4) The fire stopping / compartmentation of the premises is subject to an annual inspection by the Fire Safety Rapid Response Team.
- 5) Generally, the means of escape is protected from flats with the use of nominal FD30s doors, there are store cupboard doors on the first floor that require updating to fire doors when future upgrades take place.
