Fire Risk Assessment

Swancroft Road

**Flats 2 - 24
Swancroft Road.
Glebefields
Tipton,
DY4 0TJ.**

Date Completed: 12/06/2024.

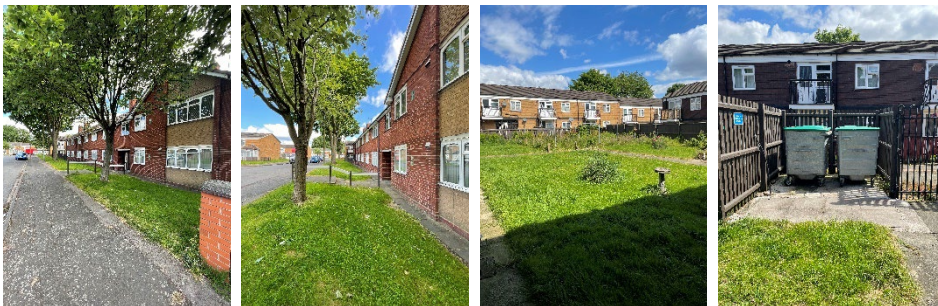
They are of traditional brick, concrete construction, double glazed UPVC window frames surmounted by a pitched roof.

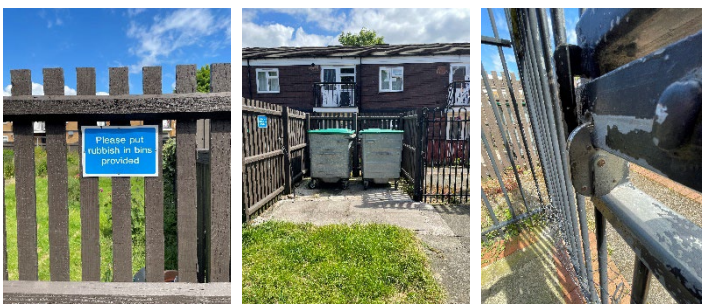
To dispose of rubbish, residents utilise waste containers secured in the rear garden, these are maintained locked using a suited key.

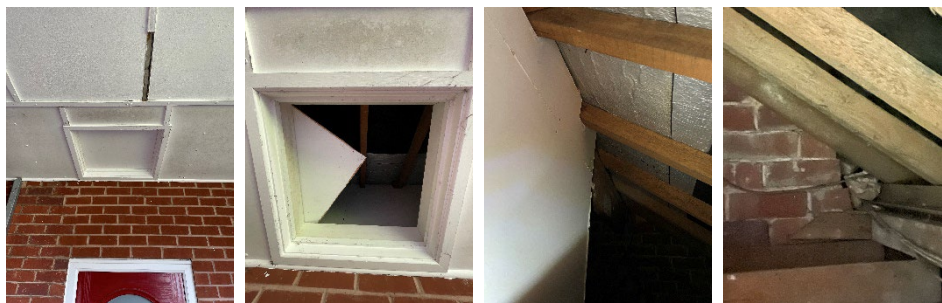
There is access to the roof space from the first floor landing area. It should be noted that this is a restricted space covering approx 3 mtr² above the concrete staircase of the communal area.

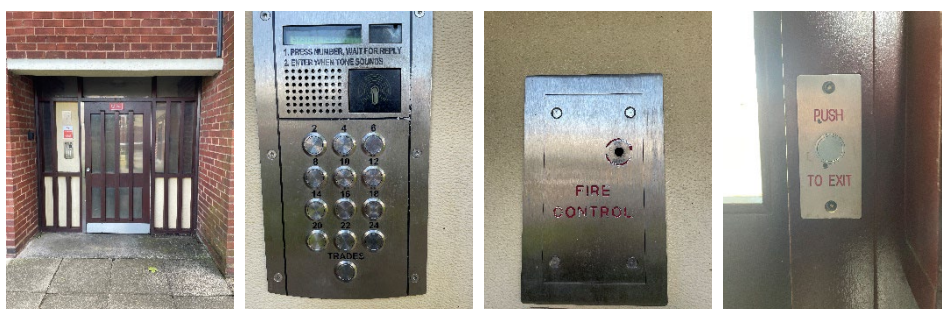
The building has a single staircase with access gained at the front elevation. The side of the site is secured by fencing and padlocked, access to the rear of the building is gained via the front entrance door or by a suited padlock to the bin area at the side of the building. The main front access is controlled via a door entry system and rear access is via an electronic fob to prevent unauthorised access.

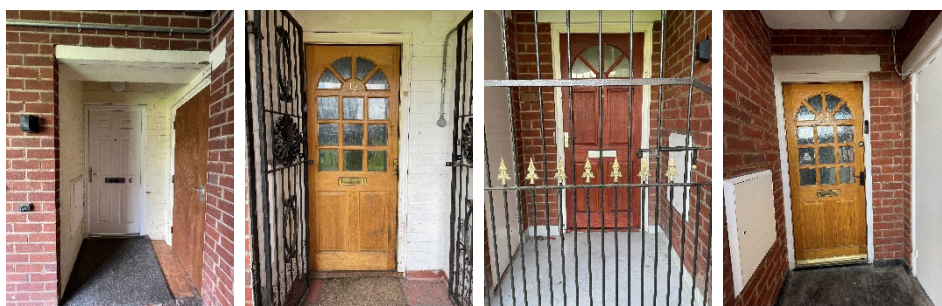
At the time of the assessment, it was noted that several flat front entrance doors were of timber construction. It was noted that several doors had metal gated security fixed.

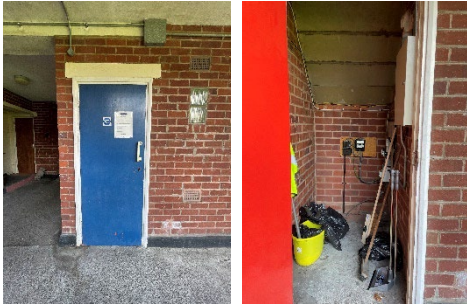
There is a ground floor electrical cupboard that contains an electrical equipment for the building. As part of any future refurbishments this door should be upgraded to an FD 30.

The door to the electrical cupboard should be replaced to a FD30s when the door replacement programme commences.

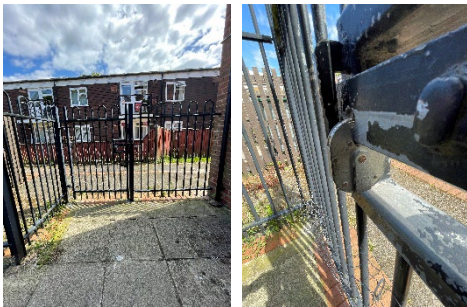
The rear of the garden is secured by a combination of wooden and metal fencing, there is an access gate fitted to enable refuse to be managed. The gate is secured by chain and suited padlock when not in use.

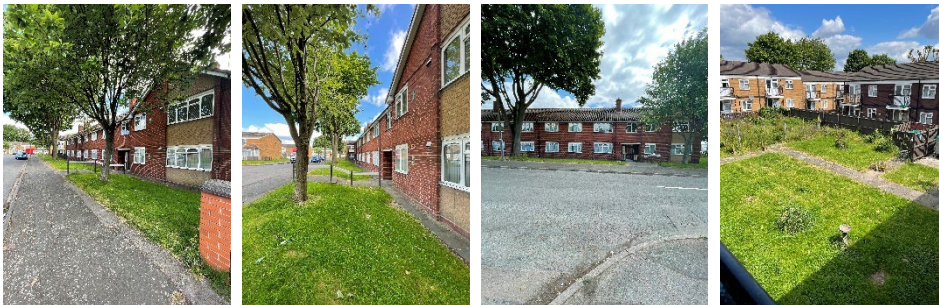
- 1) The external envelope of the premise is predominantly traditional brick, concrete construction, UPVC double glazed window frames surmounted by a pitched tiled roof.

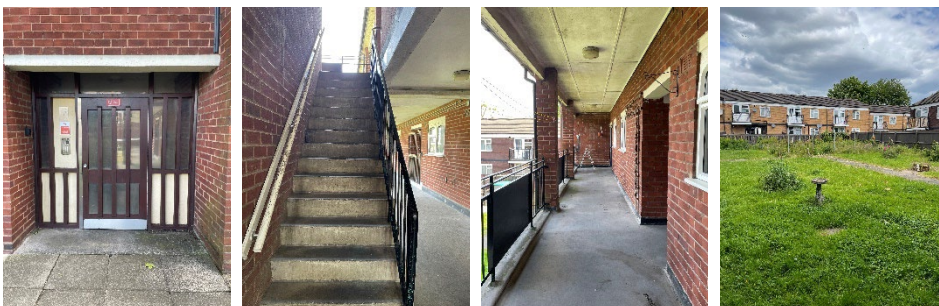
- 2) Access is gained to all flats from the ground floor using the main access door leading to the staircase. The rear of the building is open plan with deck access on the first floor.

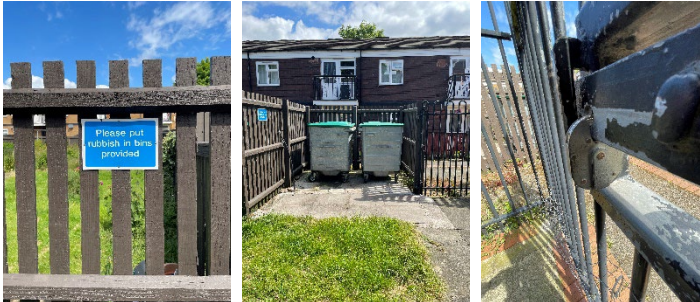
- 3) There is no provision for off road car parking facilities for residents.
- 4) A waste area is provided at the rear of these premises.

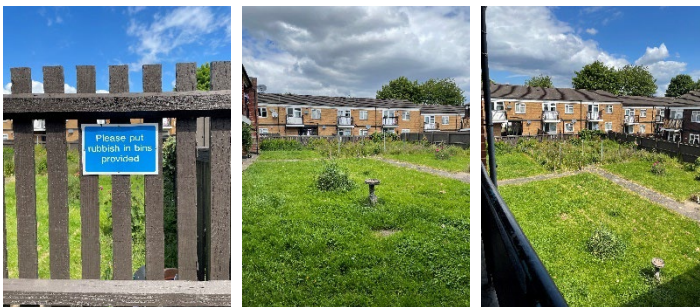
- 5) The rear gardens are secured by a combination of wooden and metal fencing which is locked at all times. There is a small lawned area provided for residents.

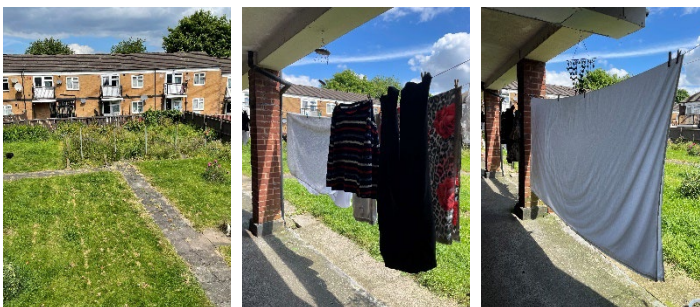
- 6) It was evident that a section of the lawned area had not been maintained for some time. This area was used by residents to hang washing. As a consequence of not being able to access this area, residents were using washing lines outside of individual flats.

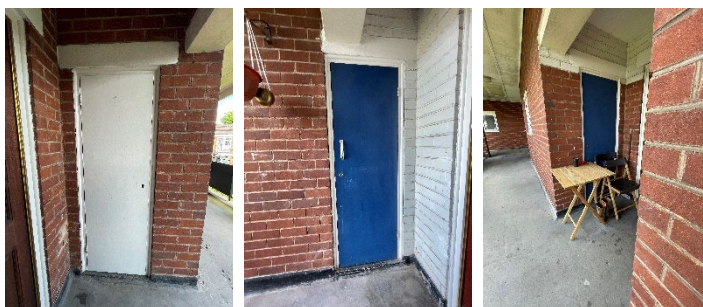
- 1) The building has a staircase that provides the means of escape. All open deck corridors are of adequate width (at least 1500mm) and should be maintained clear to that width as a minimum. The staircase provides a 980mm width as a minimum.
- 2) Internal store (adjacent flat entrance doors) cupboard doors should be upgraded as part of any refurbishments, these should be upgraded to certified to FD30's fire rated as part of future works.

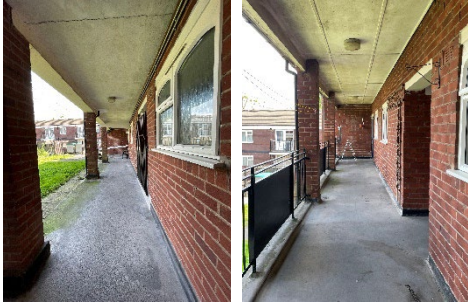
- 6) There is also an out of hour's service that allows combustible items of furniture / rubbish to be removed.
- 7) Automatic smoke ventilation is not employed as all areas are open plan.

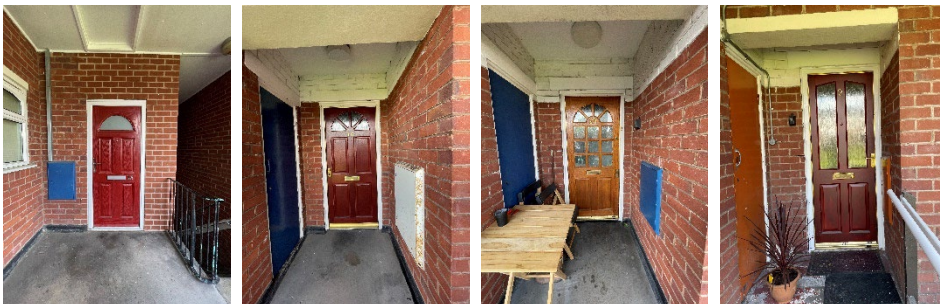
- 8) The means of escape are protected to prevent the spread of fire and smoke with a combination of nominal FD30s doors consisting of composite and timber front doors. Where applicable, timber flat entrance doors should be replaced when the fire door replacement programme commences.

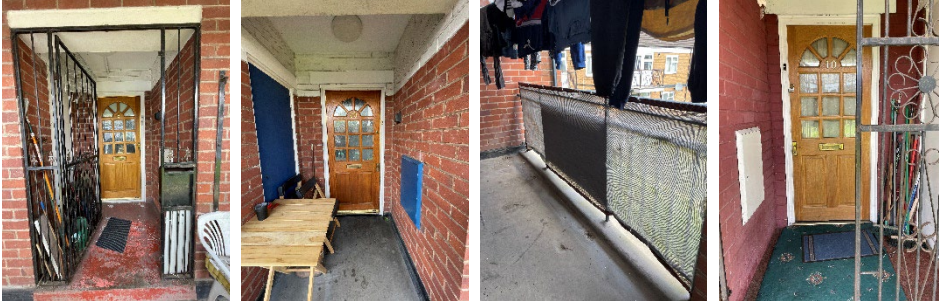
- 10) In cases, there were combustible items left outside flat entrance doors, in one case (flat 24) netting on the first-floor balcony. All means of escape areas should be maintained as sterile areas. (Email sent to housing).

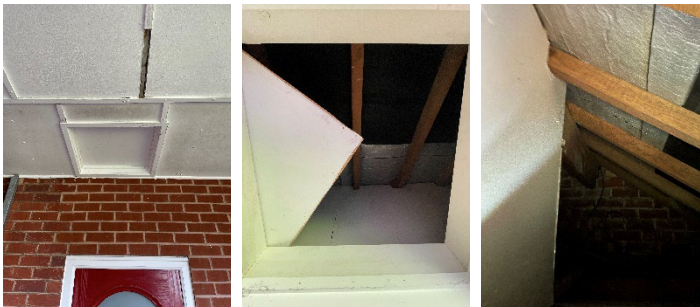
- 1) The building is designed to provide as a minimum 1-hour vertical fire resistance and 1-hour horizontal fire resistance around flats. All flat entrance doors are 30-minute notional/nominal doors, including those in 1-hour rated walls.
- 2) There is access to the roof space from the first floor landing area. It should be noted that this is a restricted space covering approx 3 mtr² above the concrete staircase of the communal area. A resident confirmed that access to other areas of the roof space is gained through individual flats. Therefore, an inspection of other areas of the roof void was not undertaken at the time of the fire risk assessment.

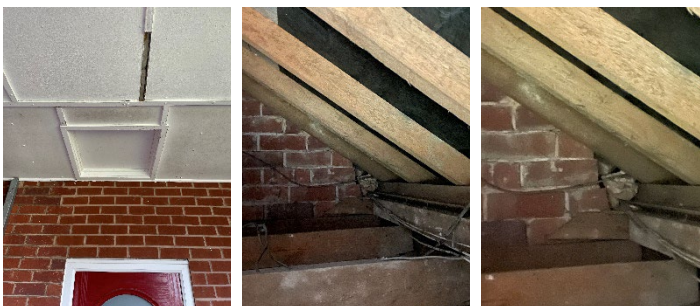
- 3) On inspection of the communal roof void on the first floor, it appeared that brickwork had become detached from the compartmentation wall. This should be further assessed and if necessary suitable fire stopping materials applied.

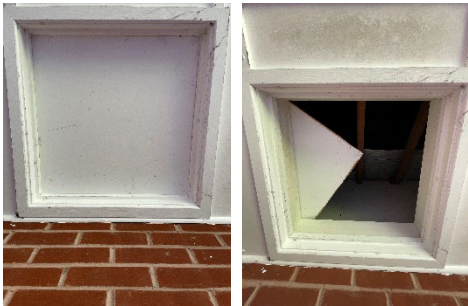
- 4) The communal loft hatch should be secured using a hasp, staple, and a suited padlock.

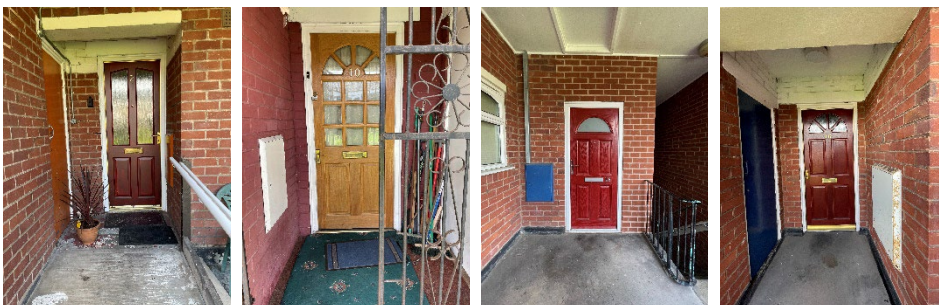
- 5) The premises do not have sufficient compartmentation to limit the travel and effect of smoke and flame in event of a fire in communal areas due to the open plan staircase & deck access area.
- 6) The fire stopping / compartmentation of the premises is subject to an annual inspection by the Fire Safety Rapid Response Team.
- 7) Generally, the means of escape is protected from flats with the use of nominal FD30s doors. These doors should be upgraded to FD30's when the door replacement programme commences.

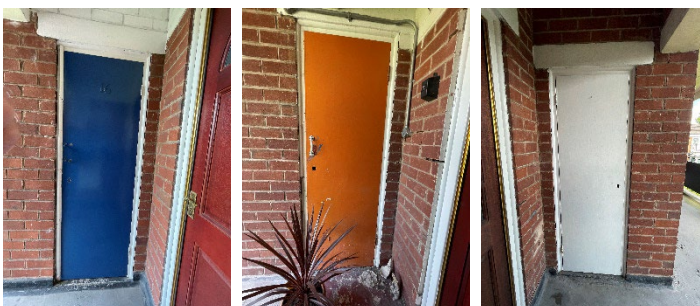
- 8) There are store cupboard doors adjacent to flat entrance doors that require updating to fire doors when future upgrades take place. No other communal doors to the blocks other than final exit doors.

As part of any future refurbishments internal store cupboard doors should be upgraded to fire doors. (FD30 doors) to provide adequate protection.

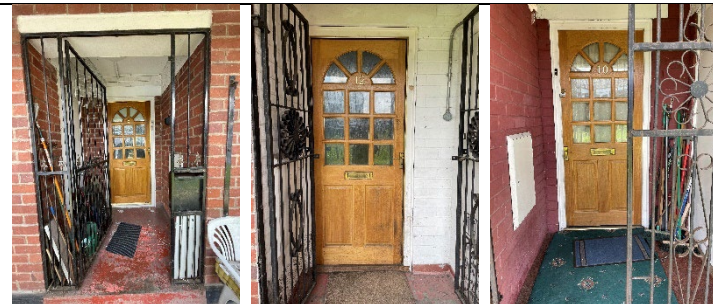
It was noted that several properties had front entrance doors protected by metal security gates. This is not ideal, consideration should be given to removing all metal gates. From an access and egress point of view any delay in gaining access to a property could delay a resident receiving critical treatment in an emergency situation. Also, any resident trying to escape in an emergency, particularly a fire situation could find themselves overcome by smoke.
