Fire Risk Assessment

**24 – 29 Providence Street
Great Bridge
Tipton,
DY4 7DT.**

Date Completed: 14/06/2024.

Officer: A Jones Fire Risk Assessor.

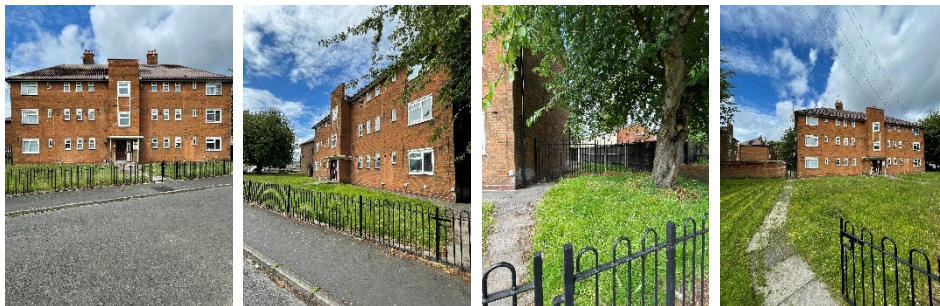
They are of traditional brick, concrete construction, double glazed UPVC window frames surmounted by a pitched roof.

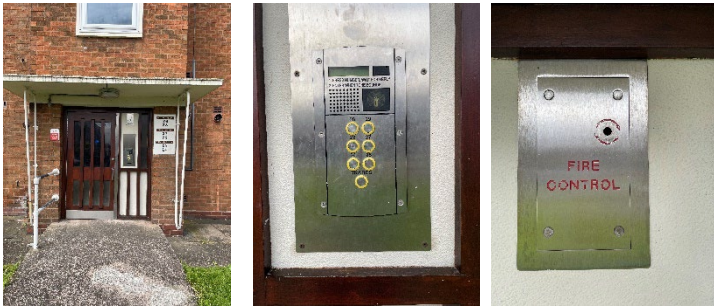
The main front access is controlled via a door entry system and rear access is via an electronic fob to prevent unauthorised access.

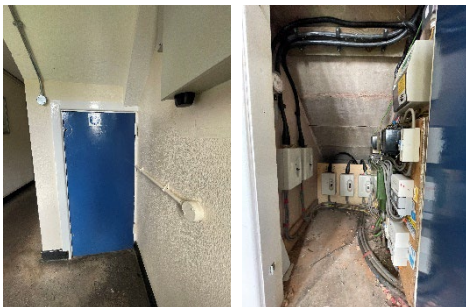
There is a ground floor electrical cupboard that contains electrical equipment for the building.

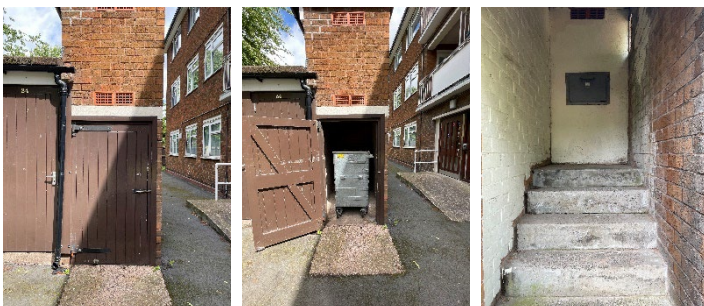
To dispose of rubbish, residents utilise waste containers located in the rear garden, these are maintained locked using a suited key.

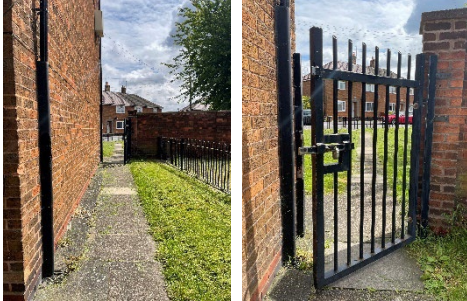
The rear of the garden is secured by a combination of wooden and metal fencing, there is an access gate fitted to enable refuse to be managed. The gate is secured by chain and suited padlock when not in use.

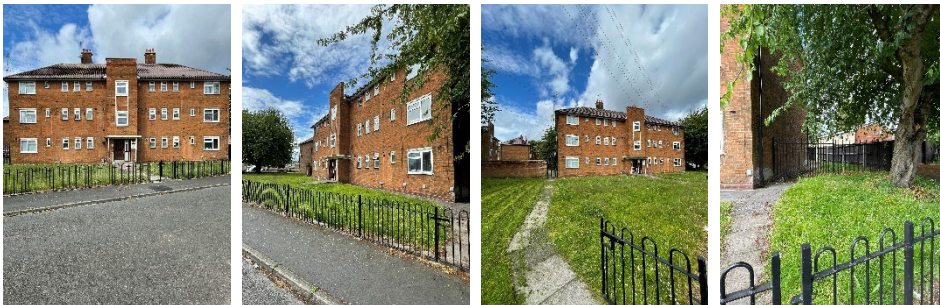
- 1) The external envelope of the premise is predominantly traditional brick, concrete construction, UPVC double glazed window frames surmounted by a pitched tiled roof.

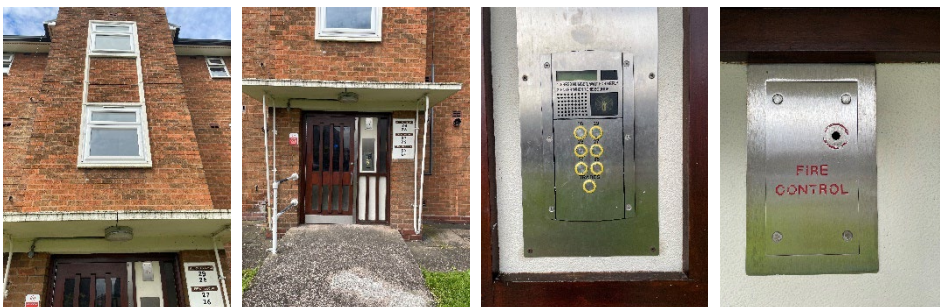
- 2) Access is gained to all flats from the ground floor using the main access door leading to the staircase area.

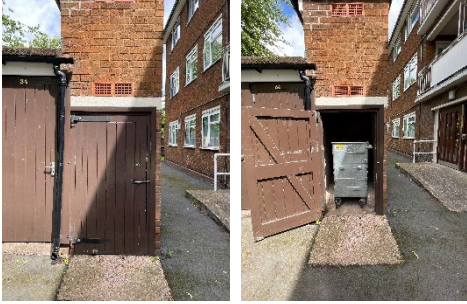
- 4) A waste area is provided for residents at the rear of these premises.

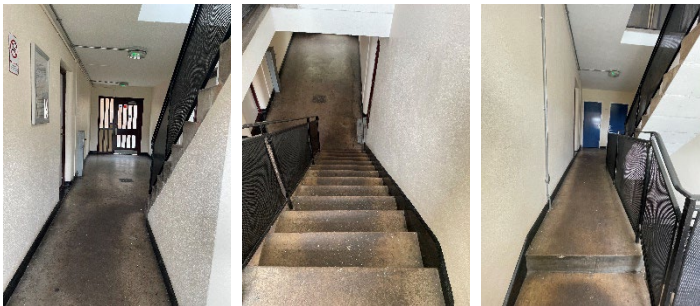
- 1) The building has a staircase that provides the means of escape. All staircases are of adequate width (at least 850mm) and should be maintained clear to that width as a minimum.

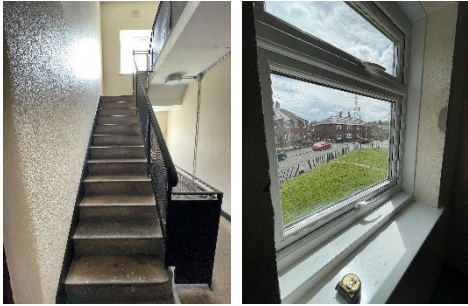
- 6) At the time of the assessment the means of escape was being maintained as sterile.
- 7) Automatic smoke ventilation is not employed, landing windows are openable and can be used for forced ventilation.

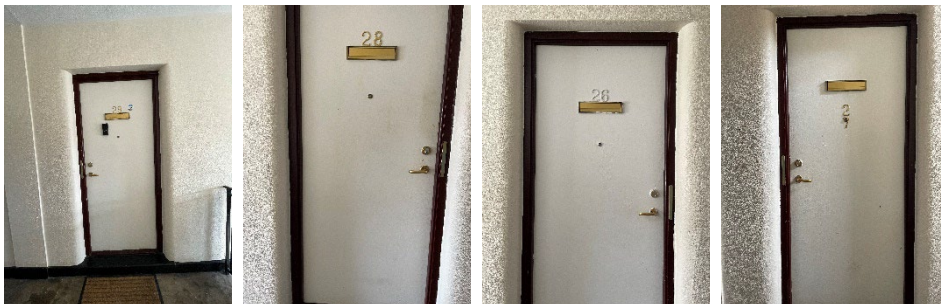
- 8) The means of escape are protected to prevent the spread of fire and smoke with a combination of nominal FD30s doors consisting of timber front doors. Where applicable, timber flat entrance doors should be replaced when the fire door replacement programme commences.

As part of any future upgrades or door replacement programme replace timber flat entrance doors for FD 30s.

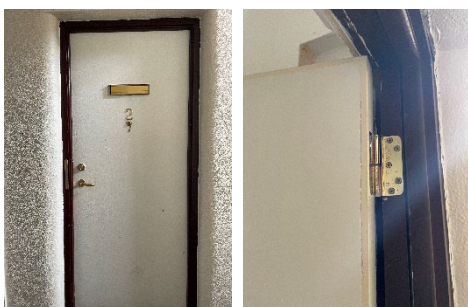
The resident at flat number 27 provided information on the flat entrance door. Although this was a nominal timber door, there was no self-closer fitted. This should be rectified when the door replacement programme commences.

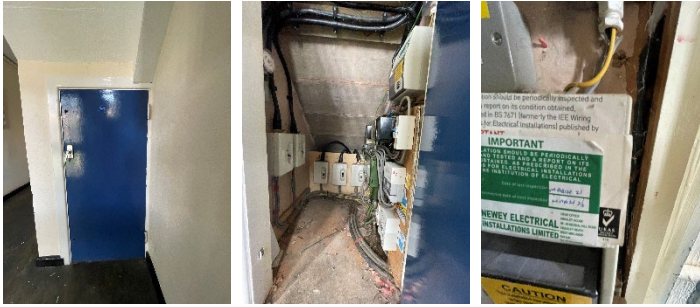
- 10) The electrical cupboard for the building is located on the ground floor, it opens onto the means of escape corridor.

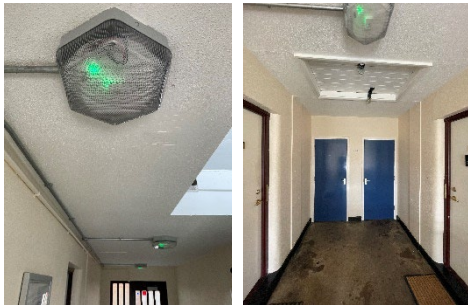
- 1) Emergency lighting is provided throughout the communal landings/staircases. This is tested at frequent intervals and is compliant with BS 5266.

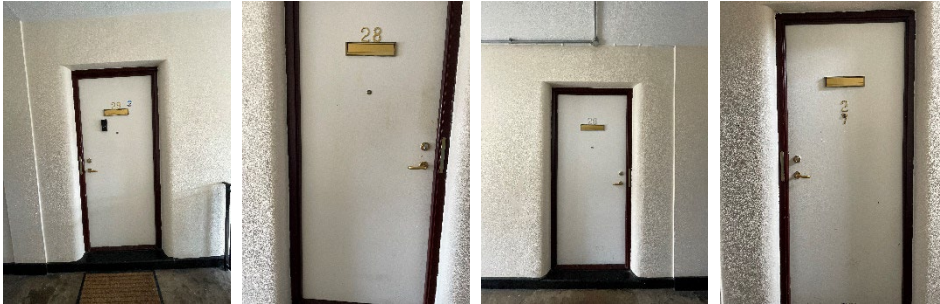
- 6) Generally, the means of escape is protected from flats with the use of nominal rated timber doors. These doors should be upgraded to FD30's when the door replacement programme commences.
