Fire Risk Assessment

Cobden Close Blocks

1-11, 2-12, 13-23

Princes End, Tipton
DY4 9JX

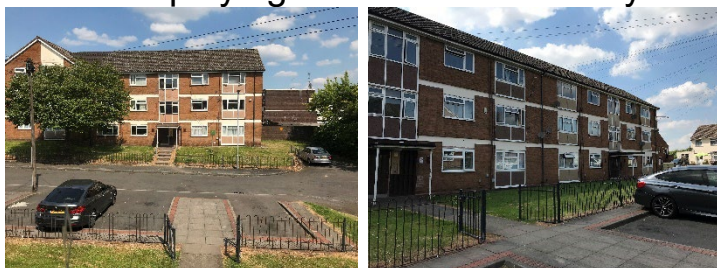
The Low-rise Blocks were constructed in approx. 1969 of predominantly traditional concrete brick construction with a pitched roof, the three blocks displaying the same internal layout and single staircase.

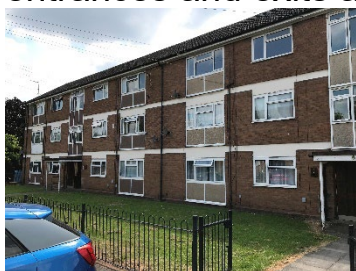
1-11 & 13-23 are adjoining blocks however both have separate entrances and exits and cannot be accessed to each other internally.

Each block has entrance/exit to the front and rear of the block,. Access is gained via a fob system or via a firefighters drop latch.

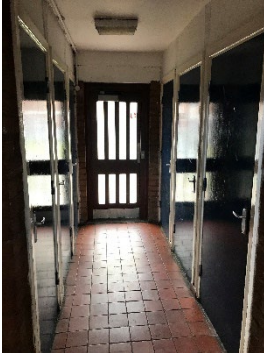
Ground floor contains storage cupbards within the communal area

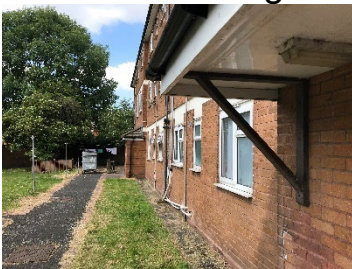
The blocks have access to a gated rear yard area (per block) in this area is also the storage of bins.

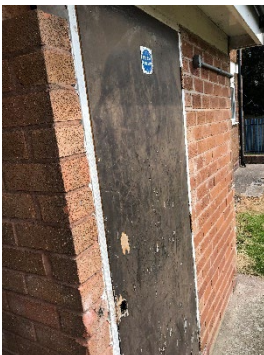
Electical service cupbards/ residents meter cupbaords are locacated externally on the rear elevation of the blocks secured with nominal timber doors.

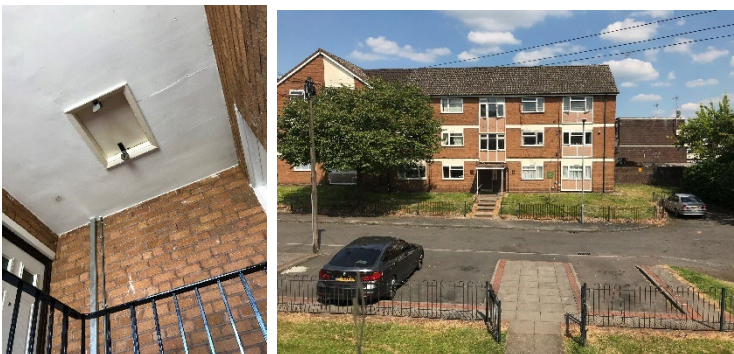
The blocks have a pitched roof with each block having access within the communal area via a loft hatch on the 2nd floor.

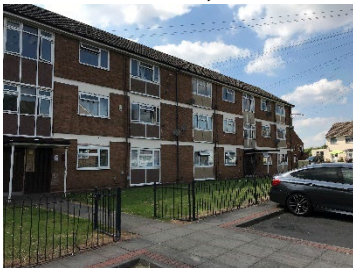
- 1) The original construction of the blocks was a concrete masonry construction, and the external envelope reflects this.

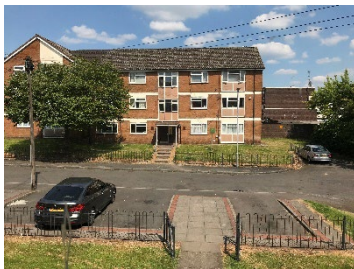
- 2) The blocks have a tiled Pitched roof accessed internally.

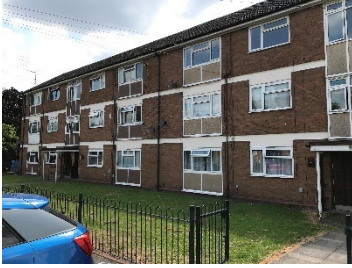
- 3) Double Glazed UPVC units with a cladded lower section are used along the communal stairs and residents' flats.

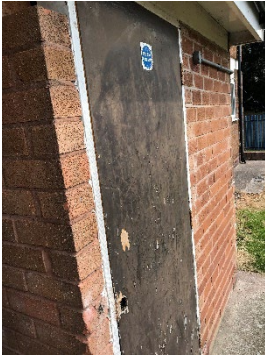
- 4) Electric meter cupboard is located externally on the rear elevation to the blocks secured behind nominal timber doors.

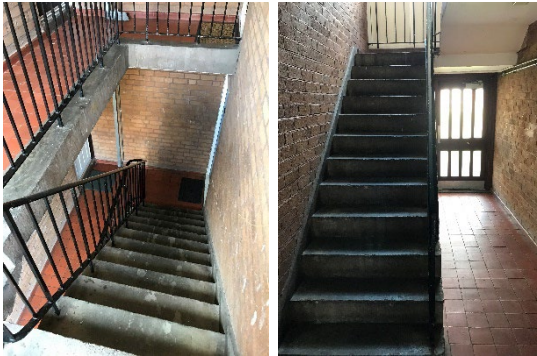
- 1) Each block has a single staircase that provides a means of escape and is between 900mm in width providing a sufficient escape route.

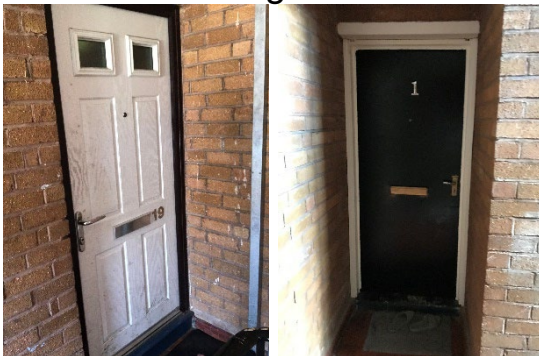
- 2) All corridors are of adequate width and will be maintained clear to that width as a minimum.
- 3) There are no corridors within the means of escape that form part of a dead end.
- 4) The means of escape are protected to prevent the spread of fire and smoke using nominal/notional doors off dwellings.

- 5) The only communal doors within the blocks are the final exit doors and these are fitted with automatic closing devices that are checked on a regular basis by Caretaking Teams as part of their checks. Defective closing devices are replaced either by the Caretaking Team(s) or the in-house repairs team(s).

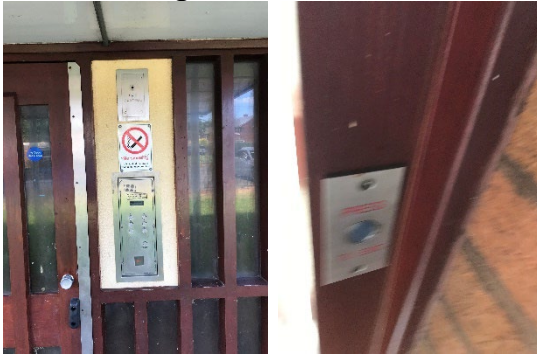
- 6) The final exit doors have door entry systems installed. These systems are designed to fail safe i.e., door unlocked in the event of a power failure. This prevents residents being locked in or out of the building.

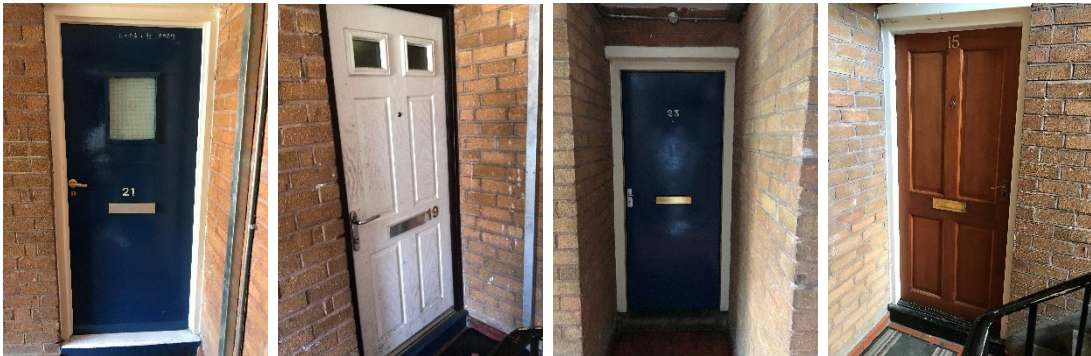
- 11) The surface coatings to the communal areas are Class 0 rated.
- 12) The building has sufficient passive controls that provide effective compartmentation to support a Stay Put-Unless Policy. Therefore, residents are advised to remain in their flat unless the fire directly affects them.
- 13) Individual flat doors are a combination of Nominal or notional fire door sets with a combination of timber and composite doors within each block.

- 14) Three separate attempts had been made to gain access to inspect both sides of resident's flat entrance doors. Despite best endeavours access could not be granted to any of the flats within the blocks, an inspection of the external leaf of the door was conducted. Reasonable measures should be put in place to gain access in the future.

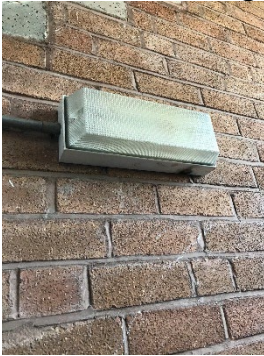
- 1) Emergency lighting is not present within the blocks new conventional lighting is present.

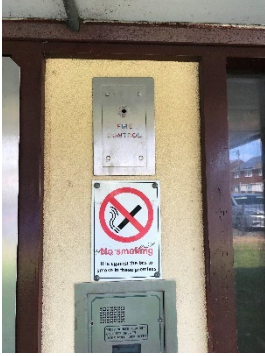
- 1) No smoking signs are displayed around the premises.

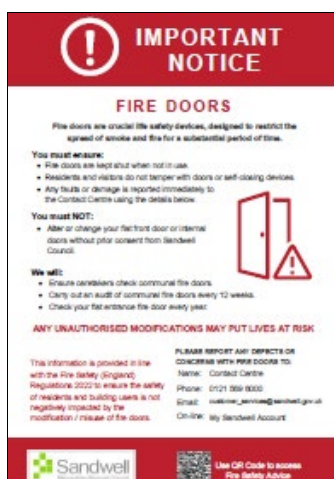
- 6) Fire safety information has been provided as part of tenancy pack.
- 7) Building safety and evacuation notices are not displayed within the blocks.

- 8) Information regarding use of fire doors is provided to residents.

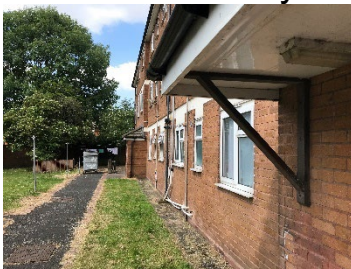
- 2) Refuse containers emptied regularly and stored away from the block in the rear yard area.

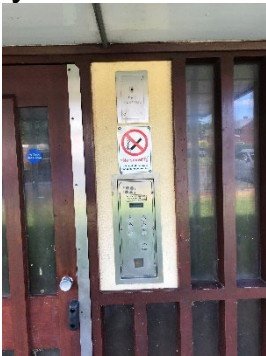
- 1) Regular checks are undertaken by Caretakers / Cleaning Team(s) 365 days per year which helps reduce the risk of arson.
- 2) Restricted access to the premises by means of a door entry system.
