# Fire Risk Assessment

## Alexandra Road

**Flats 38 - 43 & 44 - 49**  
**Alexandra Road,**  
**Tipton,**  
**DY4 8TE.**

**Date Completed: 10/07/2024.**

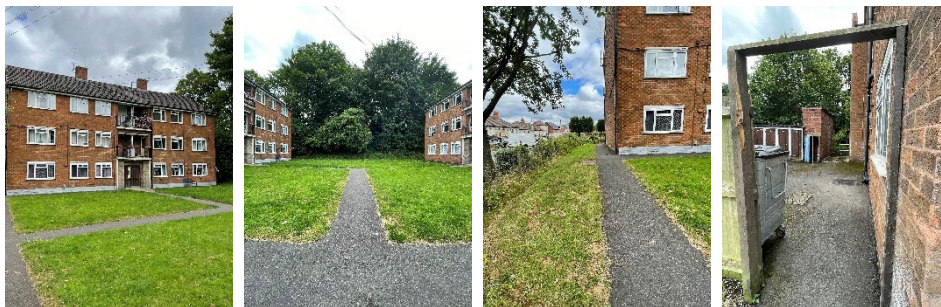
They are of traditional brick, concrete construction, double glazed UPVC window frames surmounted by a pitched roof with interlocking tiles.

Each Flat (first and second Floor only) has individual balcony area to front of block.

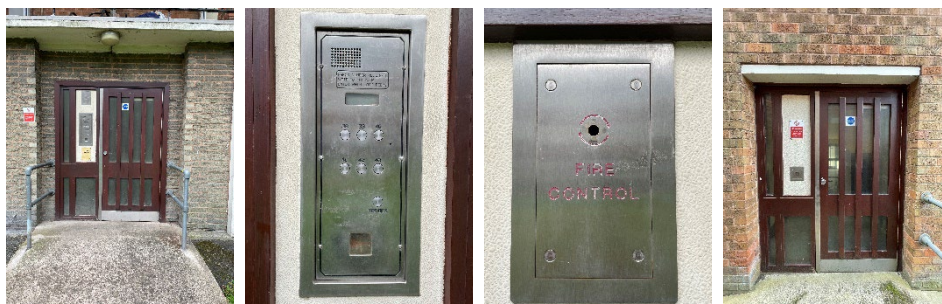
The blocks have two entrances; a main entrance to the front elevation and a further exit located on the rear elevation. Both front and rear entrances have door entry system and fob reader installed to prevent unauthorised access to the building.

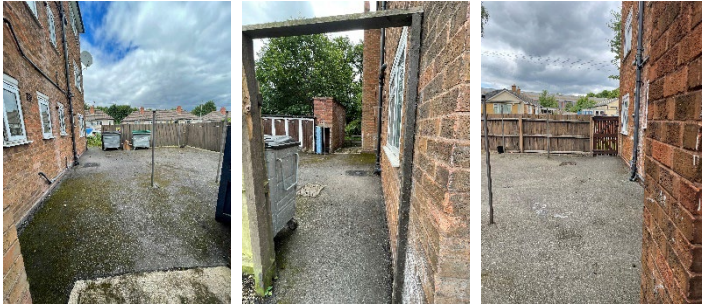
The small rear garden(s) are secured by a section of wooden fencing, hedges with an access gate at the side of the building.

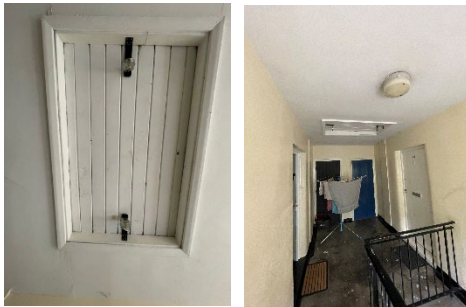
There is access to the loft space from the second floor landing area, this is secured by padlocks.

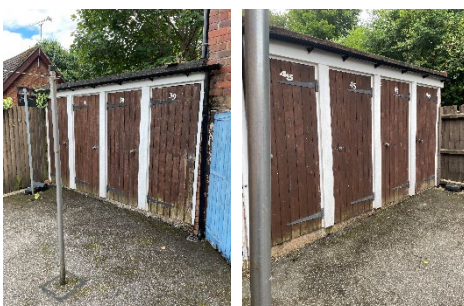
Residents have access to external store cupboards located in the rear gardens.

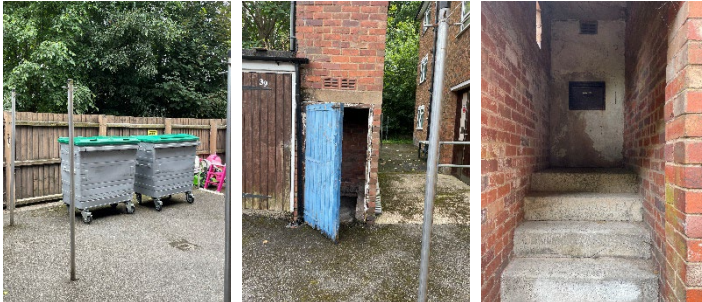
With regard to waste, residents utilise an external bin store located on the rear elevation of the building. It was noted that waste bins had been left in the rear yard with the designated store not utilised.

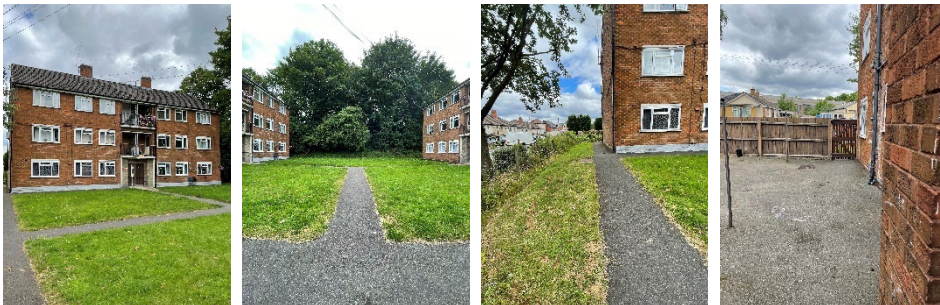
- 1) The external envelope of the premise is predominantly traditional brick, concrete construction, UPVC double glazed window frames surmounted by a pitched tiled roof.

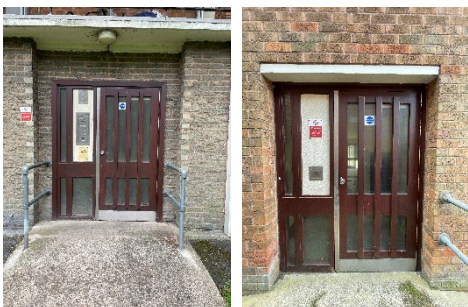
- 2) Access is gained to all flats from the ground floor using the main access door(s) leading to the staircase area.

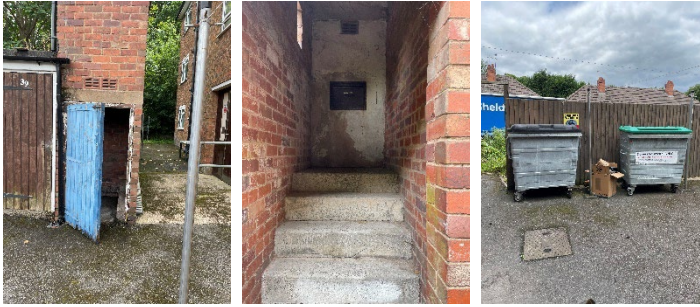
- 3) Access to the bin room(s) is in the rear yard, this area was clean at the time of the assessment.

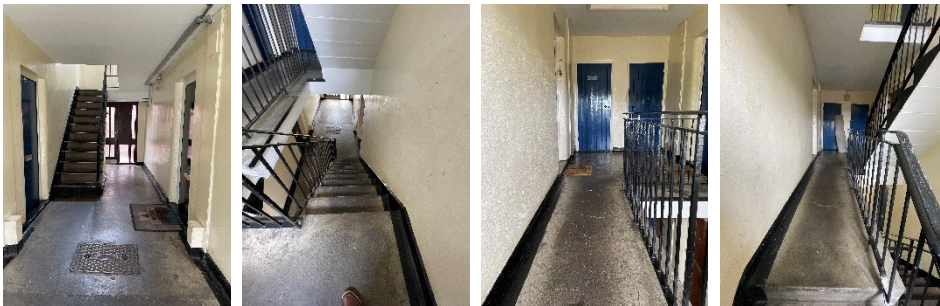
- 1) The building(s) have a single staircase that provides the means of escape. All staircases are of adequate width (at least 900mm) and must be maintained clear to that width as a minimum.

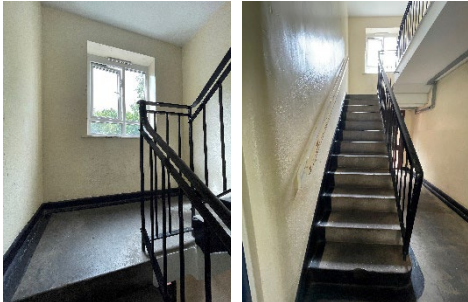
- 6) Automatic smoke ventilation is not commissioned, staircase/landing windows are openable and can be used for mechanical/forced ventilation if necessary.

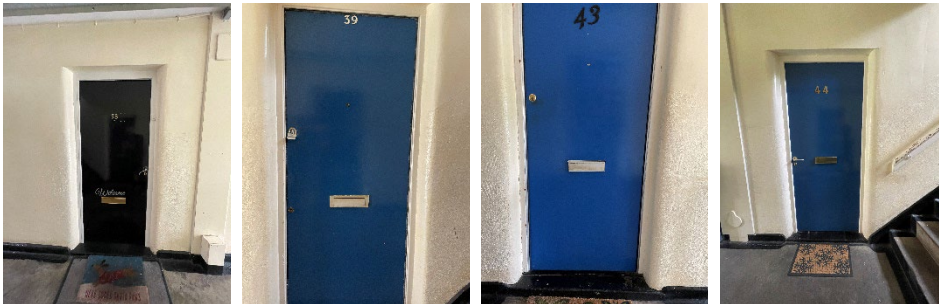
- 7) The means of escape are protected to prevent the spread of fire and smoke with nominal timber front entrance doors.

Most front entrance doors were timber construction, it is not known if doors are fitted with self-closers, letterboxes did not appear to be fitted with intumescent liners.

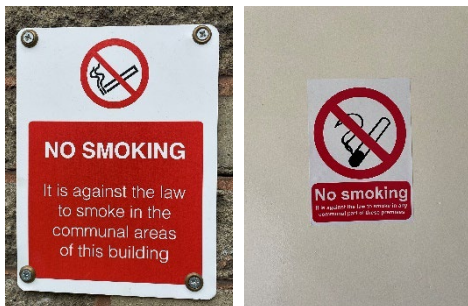
- 1) Communal fire doors display “Fire Door Keep Shut” where appropriate.
- 2) The fire escape routes are self-evident and therefore additional fire action notices are not required.
- 3) No smoking (Smoke Free England) signage is displayed at the front entrance to the premises.
