Fire Risk Assessment

Brunswick Court

**Flats 1 – 6 & 7 – 12 Brunswick Court,
William Green Road,
Wednesbury,
WS10 0HF.**

Date Completed: 08/08/2024.

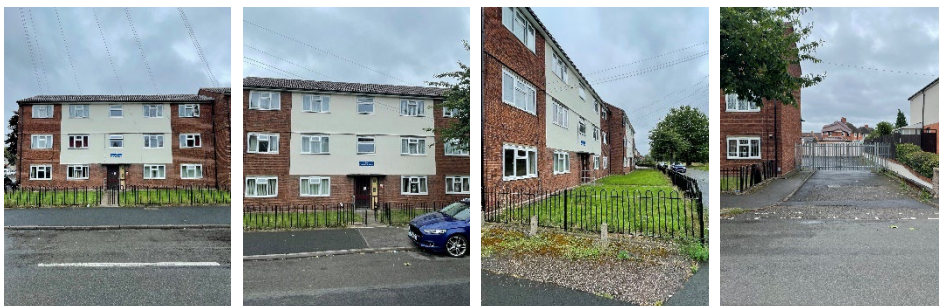
The building is of traditional brick, concrete construction, double glazed UPVC window frames surmounted by a pitched, tiled roof.

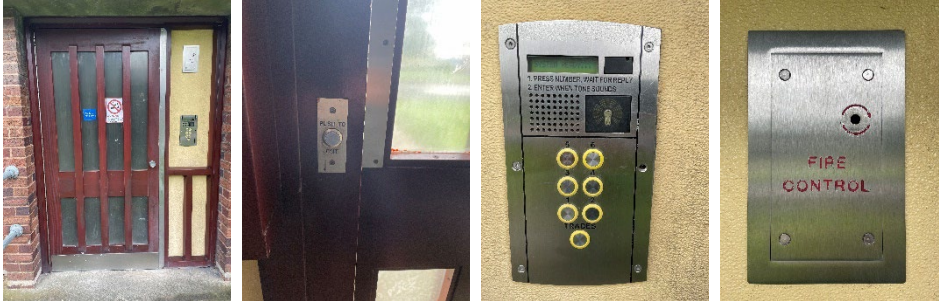
The block has a main entrance to the front elevation and a further exit located on the rear elevation. Both front and rear entrances have door entry system with a fob reader installed. There is a fire service drop key for emergency access.

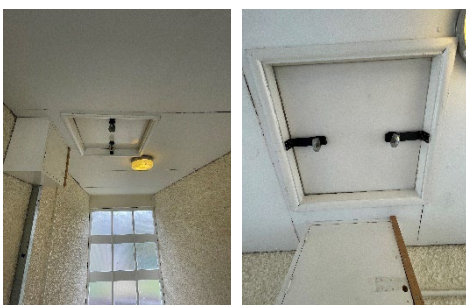
There is access to the loft space from the first floor landing area, the hatch is secured by padlocks.

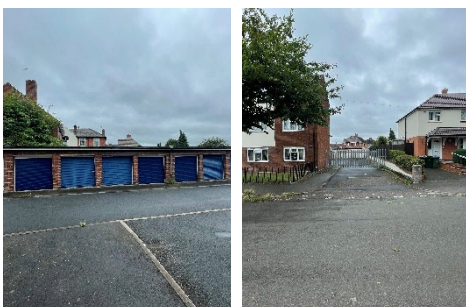
A number of garages are available for use by residents, these are located in the rear gardens and accessed by a driveway at the side of the property.

With regard to waste, residents utilise wheely bins, these are located at the rear of the premise in a secure brick compound.

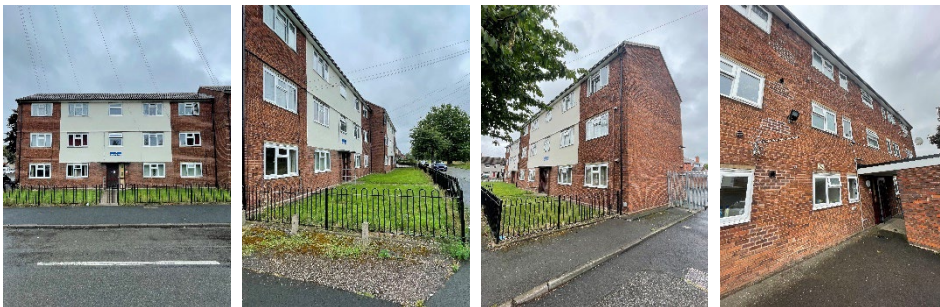
- 1) The external envelope of the premises is predominantly traditional brick, concrete construction, surmounted by a pitched tiled roof.

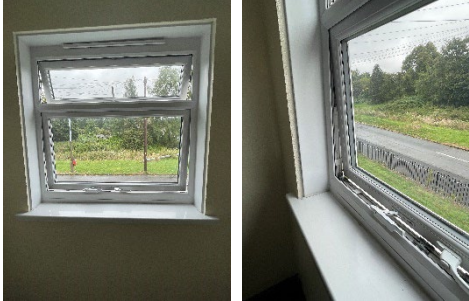
- 3) The staircase windows in the communal area are UPVC double glazed windows, these are openable and could be used to ventilate the communal area in an emergency.

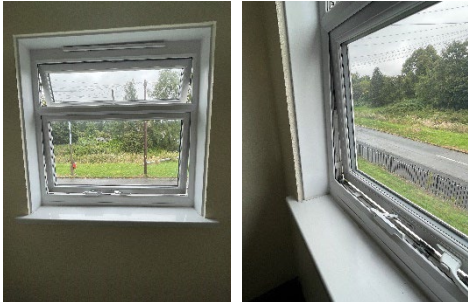
- 4) An automatic smoke ventilation is not commissioned; however, staircase windows are openable and could be used to ventilate the communal area in an emergency.

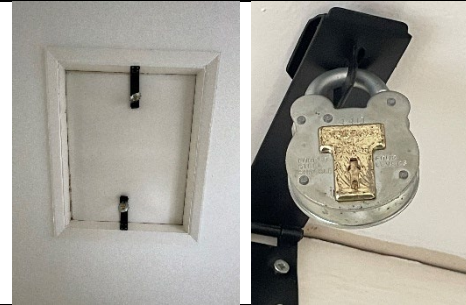
Access to the roof space could not be gained at the time of the assessment. A future date will be agreed where the Assessor will meet the trades team at the premise to carry out a survey of the Roof void.

- 5) Access was not gained to the roof void at the time of the assessment. A future date will be scheduled with the trade team to access the roof void with appropriate equipment. This is to establish whether or not compartmentation is sufficient.
