Fire Risk Assessment

Lancaster House

**1-120, Oldbury Rd,
Rowley Regis, B65 0QF**

Date Completed: 10/04/2024

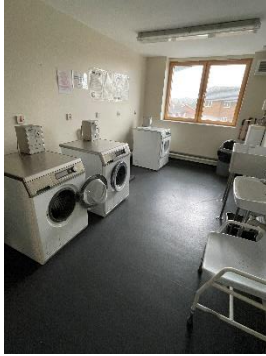
There is a communal laundry room with washing and drying equipment on the 1st floor. Each appliance is annually tested in May and has an isolation switch above. It was noted that there is a wall mounted fan extraction installed and a Co2 portable fire extinguisher adjacent the entrance door. The room has a fob access system.

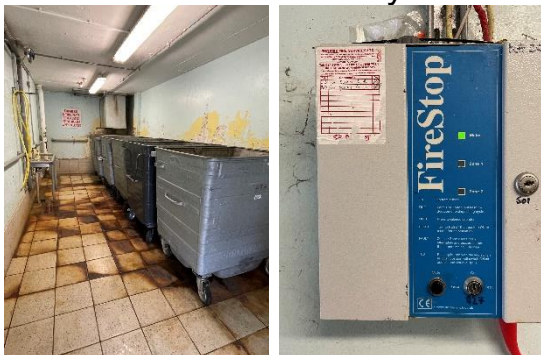
The bin stores are at the rear of the building and are protected with a fire suppression system. The control panels are located on the wall in each store. Each chute is also protected with an automatic closure plate with manual override. The systems were last serviced October 2023

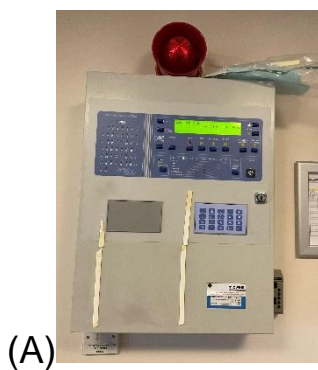
There is a fire alarm panel and detection system within the 1st floor community room (Image A). The system provides detection to the community room only.

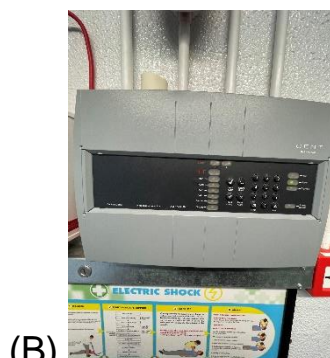
There is a fire alarm panel and detection system to the lower ground floor server room (Image B). The system provides detection to the server room only.

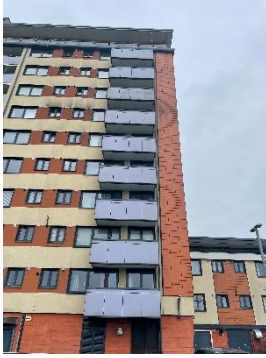
5) Combustible curtains & netting have been installed to the balcony of flat 10.

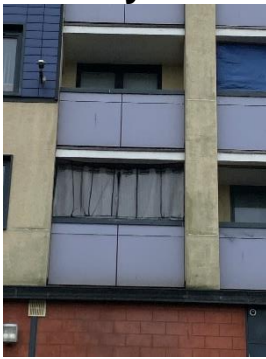
6) Combustible netting appears to have been installed to the balcony of flat 9.

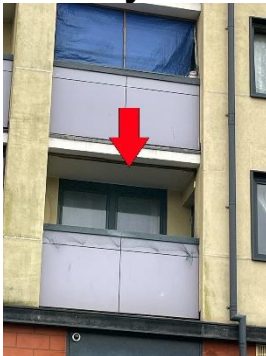
7) Combustible netting appears to have been installed to the balcony of flat 33.

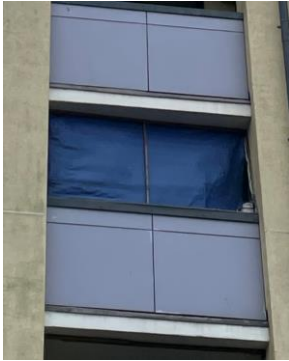
9) Combustible netting appears to have been installed to the balcony of flat 88.

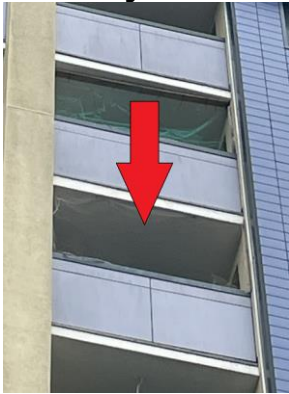
10) Combustible netting appears to have been installed to the balcony of flat 98

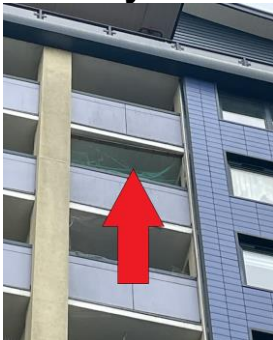
11) Combustible netting appears to have been installed to the balcony of flat 56.

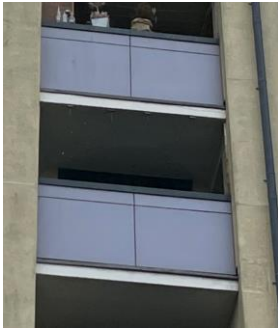
12) Combustible netting appears to have been installed to the balcony of flat 67.

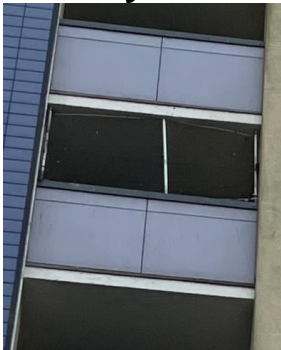
13) Combustible netting appears to have been installed to the balcony of flat 66. It also appears there is some kind of timber storage shed / unit which should be removed.

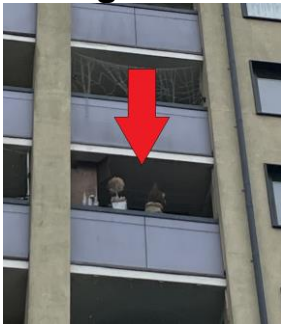
14) Combustible netting appears to have been installed to the balcony of flat 96.

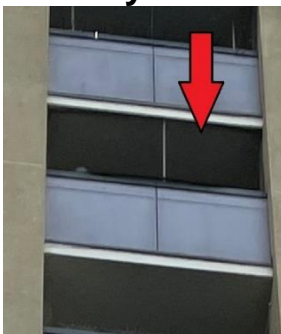
- 15) Combustible netting appears to have been installed to the balcony of flat 106.

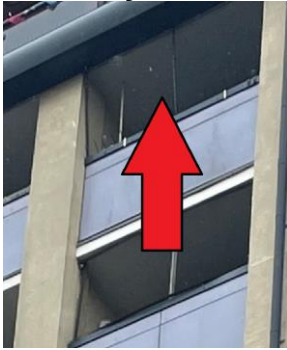
- 16) It appears that combustibles may have been installed to the balcony of flat 118 (top floor).

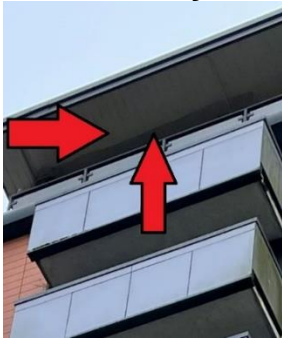
- 17) Decorative string type lighting has been installed to the balcony of flat 76. The material could potentially support the external spread of flame.

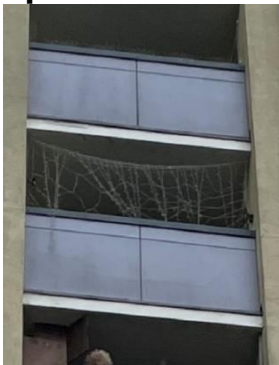
- 18) It appears that combustibles have been installed to the balcony of flat 36.

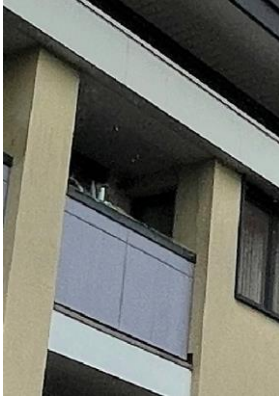
19) It appears that combustibles netting has been installed to the balcony of flat 37.

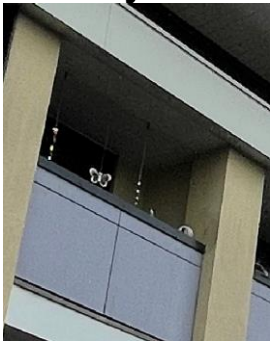
20) It appears that combustibles netting has been installed to the balcony of flat 84.

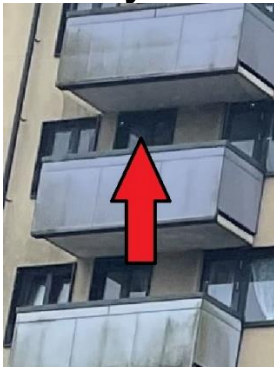
21) It appears that combustibles curtains have been installed to the balcony of flat 1

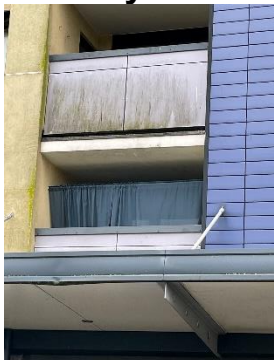
22) It appears that combustible netting has been installed to the balcony of flat 83.

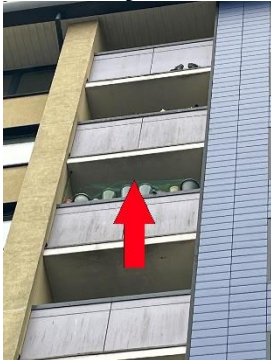
23) It appears that combustible curtains have been installed to the balcony of flat 92.

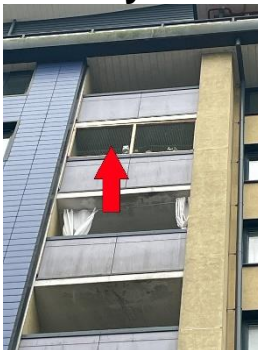
24) It appears that combustible netting has been installed to the balcony of flat 102.

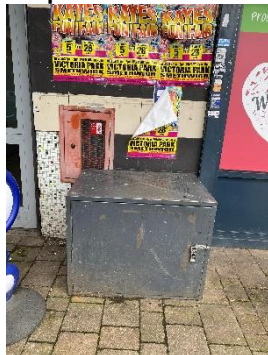
- 18) At the time of the inspection the right-hand side riser inlet was blocked by a steel cabinet belonging to the Londis convenience store. With the assistance of the storekeeper the cabinet was relocated, and appropriate advice was given to ensure the area is kept clear.

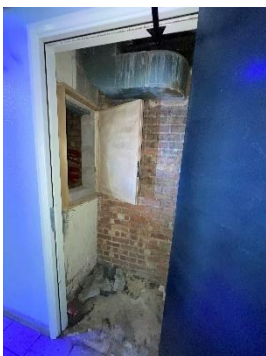
- 11) The fire stopping / compartmentation is subject to a 12-week check by the Fire Safety Rapid Response Team.
- 12) Any remedial works arising from the fire stopping / compartmentation check(s) will be actioned immediately by the Fire Safety Rapid Response Team.
- 13) Lower Ground Floor – door to soil stack shaft in cupboard adjacent the server room requires attention to mortice lock to ensure it can be locked shut.**

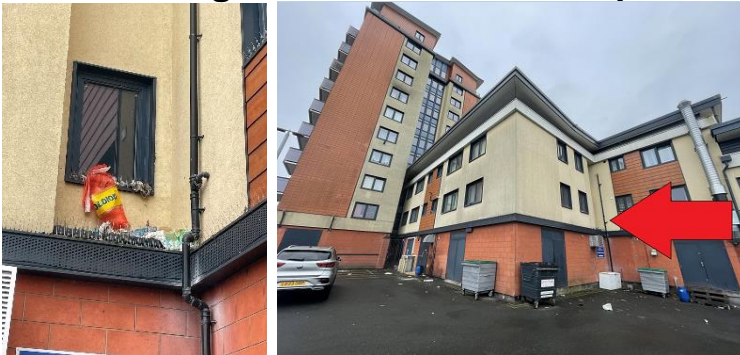
- 1) There is a regular Cleaning Service to the premises **however, there is an accumulation of combustible waste building at first floor level / externally within the anti-pigeon device to the 1st floor wing behind the business premise “Chilli Hut”.**

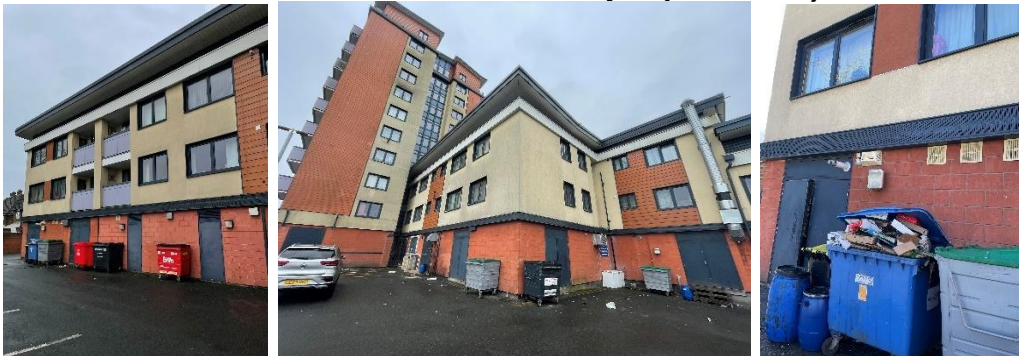
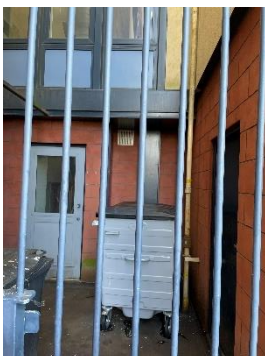
- 4) Regular checks by Caretakers minimise risk of waste accumulation.
- 5) 'Out of Hours' service in place to remove bulk items.
- 6) **A mixture of metal and plastic waste containers for the retail units are stored against the rear of the building with no consideration for safe distances. Waste containers are exposed to the risk of arson and accidental ignition therefore, there is a realistic scenario where a potential fire could spread from any of the waste containers to the flats above by means of heat radiation from flames and / or through ingress of smoke and embers through open windows and doors. It was noted that one waste container was placed against the wall and near to a gas riser (behind gate) however, this particular waste container is at a minimum risk to arson. A suitable area should be identified where all waste containers can be stored safely at a horizontal distance of 6 metres from the building as per the recommended guidance of the Confederation of Fire Protection Associations Europe (CFPA-E)**

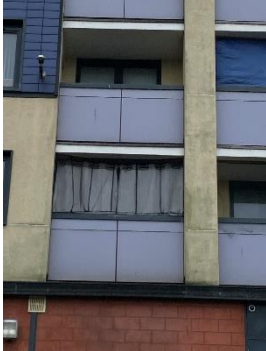
Question/ Ref No	Required Action	Supporting photograph	Priority	Timescale and Person Responsible	Date Completed
6/5	Flat 10 - Remove installed curtains and netting from balcony

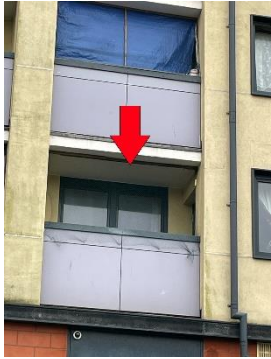
6/6	Flat 9 – Remove installed netting from balcony

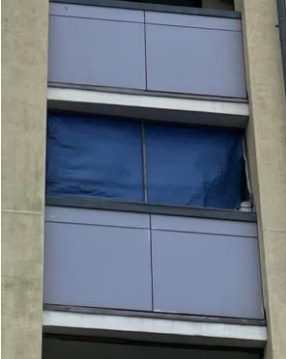
P2	Within 1-3 months Housing Manager	
6/8	Flat 30 – Remove installed screening to balcony.

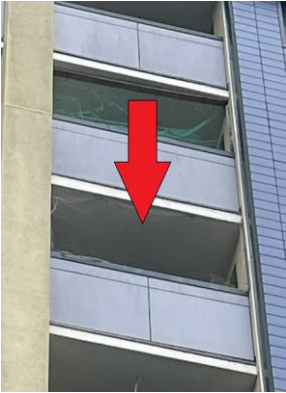
6/9	Flat 88 - Remove installed netting from balcony

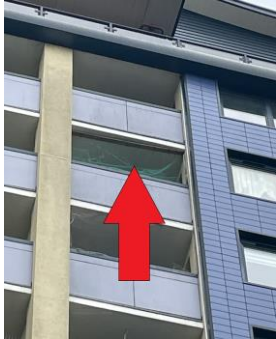
P2	Within 1-3 months Leaseholder Management	
6/10	Flat 98 - Remove installed netting from balcony

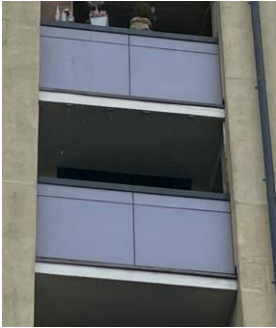
P2	Within 1-3 months Housing Manager	
6/11	Flat 56 - Remove installed netting from balcony

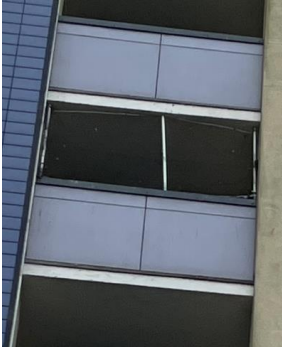
6/12	Flat 67 - Remove installed netting from balcony

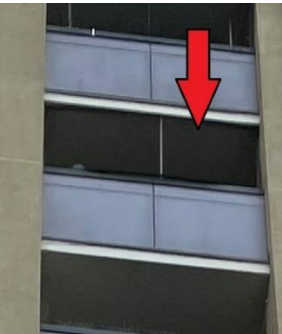
P2	Within 1-3 months Housing Manager	
6/14	Flat 96 - Remove installed netting from balcony

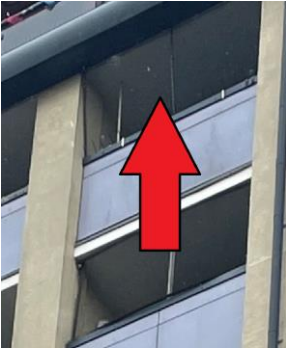
6/15	Flat 106 - Remove installed netting from balcony

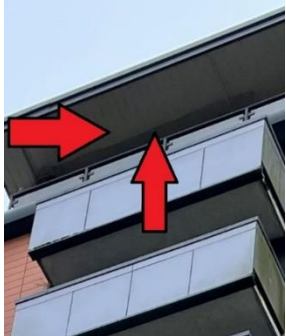
P2	Within 1-3 months Housing Manager	
6/16	Flat 118 - Remove installed netting from balcony

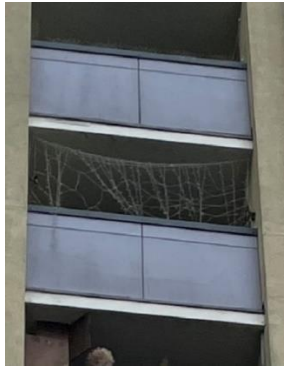
P2	Within 1-3 months Housing Manager	
6/17	Flat 76 - Remove the decorative string lighting that's installed to balcony

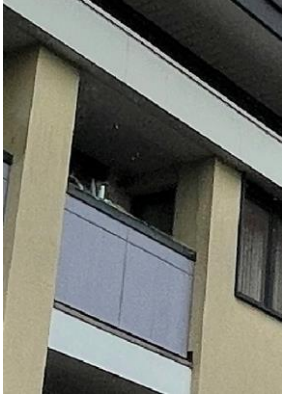
6/18	Flat 36 - Remove installed netting from balcony

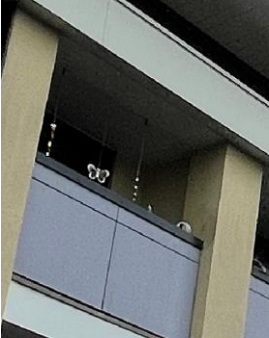
P2	Within 1-3 months Housing Manager	
6/19	Flat 37 - Remove installed netting from balcony

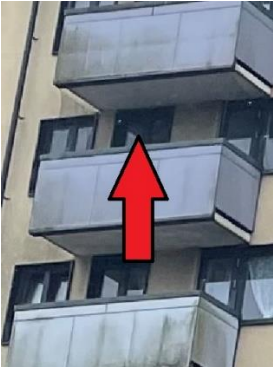
P2	Within 1-3 months Housing Manager	
6/20	Flat 84 - Remove installed netting from balcony

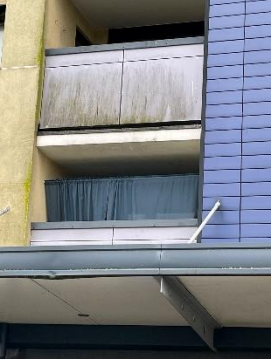
6/21	Flat 1 – Remove curtains that have been installed to balcony

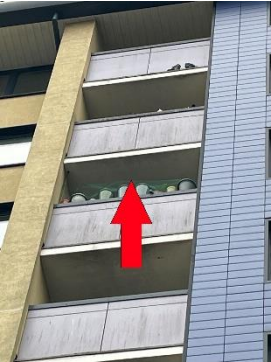
A photograph showing a balcony of Flat 1. The balcony has a grey metal railing and a blue curtain hanging from it. The building facade is yellow and blue.	P2	Within 1-3 months Housing Manager	
6/22	Flat 83 - Remove installed netting from balcony

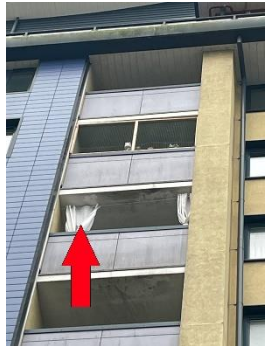
A photograph showing a balcony of Flat 83. The balcony has a grey metal railing and a netting installed. A red arrow points to the netting. The building facade is yellow and blue.	P2	Within 1-3 months Housing Manager	
6/23	Flat 92 - Remove curtains that have been installed to balcony

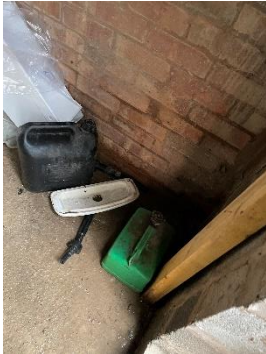
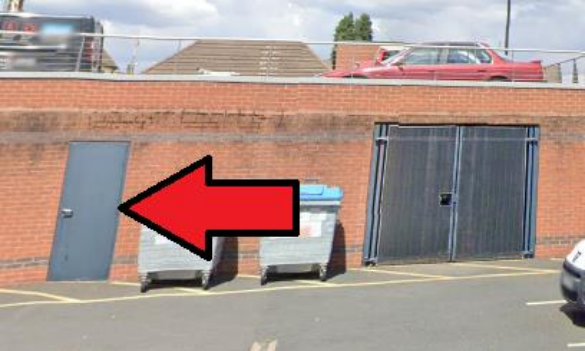
- 7) Two fuel cans were noted in the left side store. Fuel cans should be stored in an appropriate steel container or removed from the building.

18/7	Remove 2 x fuel cans from store or place in suitable metal container.

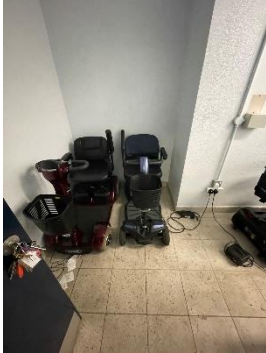
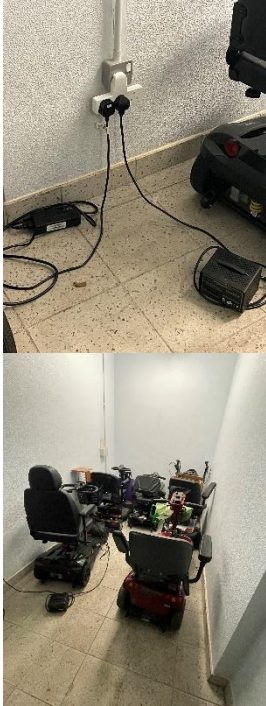
There is storage room to the ground floor lobby which is used by residents to store and charge mobility scooters. It was noted that this room does not have any means of fire detection and is secured by a nominal FD30s door which isn't self-closing.

- 8) There is a room utilised for the storage of resident's mobility scooters. The room is accessed from the ground floor lift lobby via a secured FD30s nominal timber fire door (not self-closing). There was evidence of battery charging with two scooters plugged in to a single gang socket via an extension adaptor. The 13-amp adaptor was noted as not being overloaded (8 amps). Other items such as a folding mattress and a shelving unit were noted in the room. There is no fire detection system to alert residents prior to entering the room nor is there any fire suppression system. Fire & smoke logging in this location could potentially affect the lift lobby should a resident fail to close the door upon discovering a fire.

P1	Within 10 days Repairs	18/04/2024
18/8	Establish a policy for the safe storage and charging of mobility scooters or reduce the risk by installing fire detection or by removing the facility to charge batteries in this room. Also

<p>remove other personal items that are stored in this room.</p>
