Fire Risk Assessment

Nelson House

**1-34, Upper Church Lane,
Tipton, DY4 9PW**

Date Completed: 21/11/2023

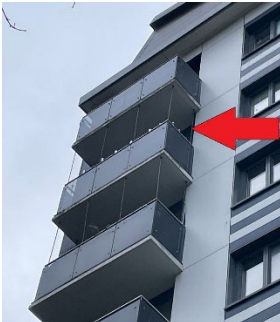
8) Combustible netting has been installed to the balcony of flat 29.

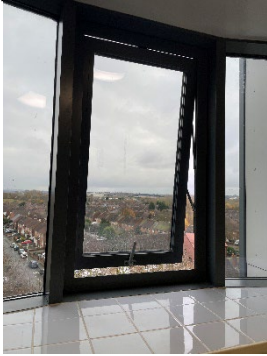
20) Communal windows to each stairwell are openable.

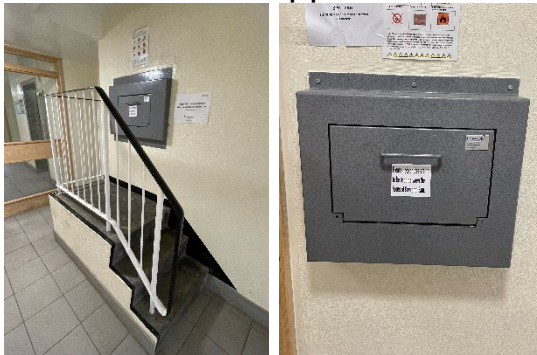
21) The refuse chute hoppers are fitted with intumescent strips and smoke seals. Hoppers are in the rear stairwell.

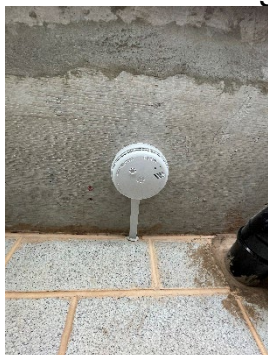
- 3) There is no effective means for detecting an outbreak of fire to communal areas. The reason for this are:
 - I. Such systems may get vandalised.
 - II. False alarms would occur.
 - III. A Stay Put - Unless policy is in place
- 4) Hardwired smoke detection was noted within the area containing resident's storage sheds.

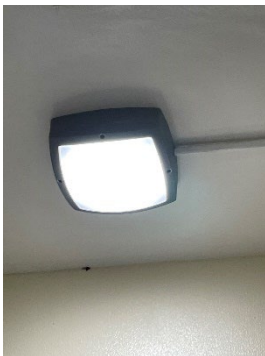
- 1) The premises has a sufficient emergency / escape lighting system in accordance with BS 5266 and has test points strategically located.

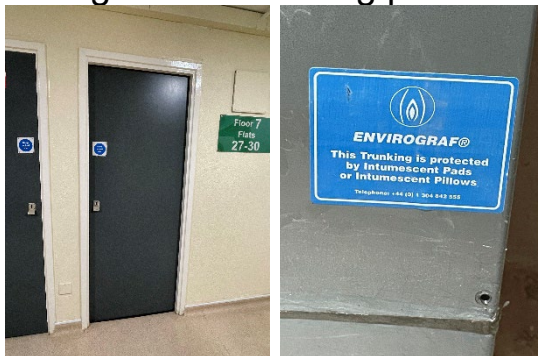
- 3) All communal doors are fitted with automatic closing devices that are checked on a regular basis by Caretaking Teams as part of their checks. Defective closing devices are replaced either by the Caretaking Team(s) or the in-house repairs team(s).
- 4) All communal fire doors are subject to a 12-week check by the Fire Safety Rapid Response Team.
- 5) All service cupboards to communal landings are locked with suited 54 or 138 key mortice locks. It was noted that cabling is run through metal trunking protected by intumescent pads or pillows.

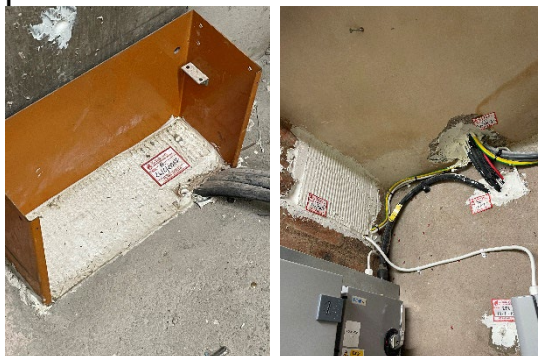
- 6) A variety of methods / materials have been used to achieve fire-stopping including Rockwool, fire rated sponge and intumescent pillows.

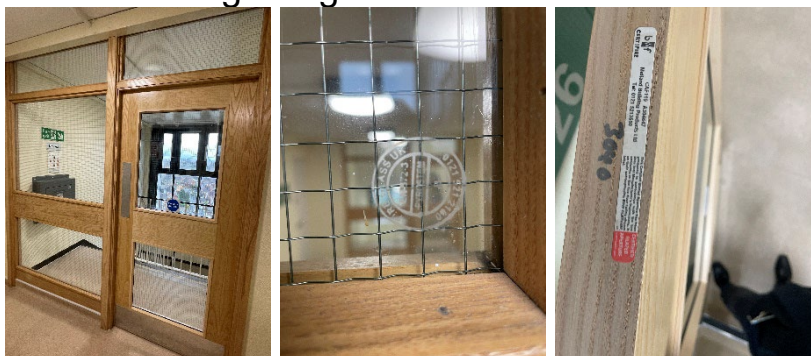
- 10) The communal landing & staircases are protected by use of FD30S timber doors with vision panels and combination frames. Fire resistant glazing has been installed to all vision panels.

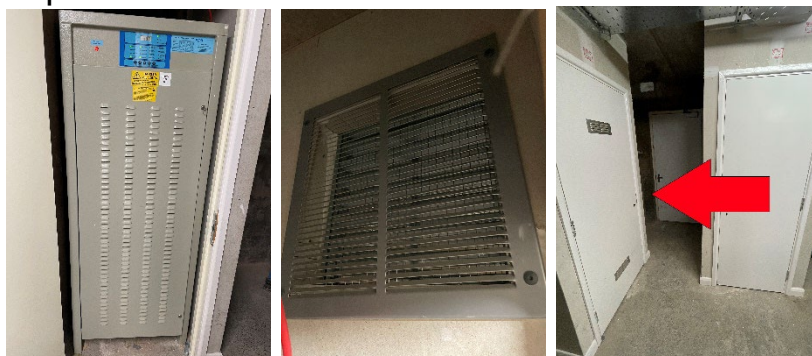
- 11) Central battery unit for the emergency lighting is housed in a cupboard with an FD30s door and vents with intumescent baffles.

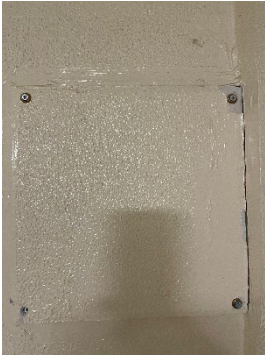
- 12) Access panels to stop taps are fixed to masonry and bedded on Intumescent material.

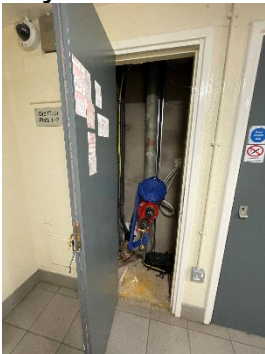
- 1) The dry riser inlet cupboard is in the ground floor lift lobby. It is accessed utilising the key contained in the white box (suited 54 key & mortice lock).

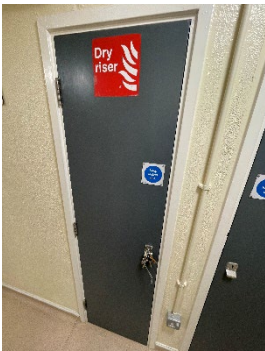
- 2) The riser outlets are available on each floor lobby (1st – 8th) also secured within cupboards by suited 54 key & mortice locks.

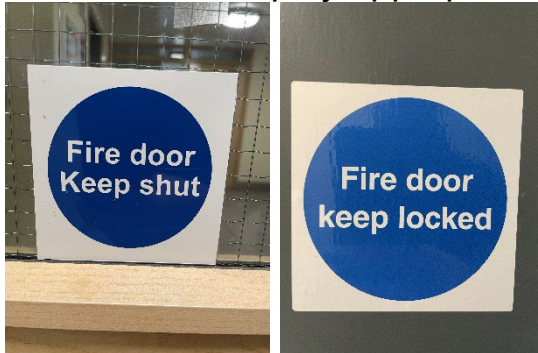
- 1) All fire doors display appropriate signage.

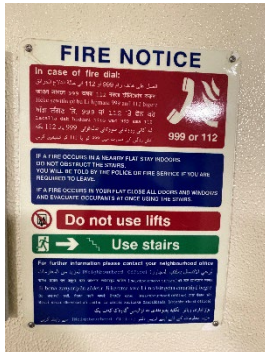
- 2) Fire Action Notices are displayed throughout the building.

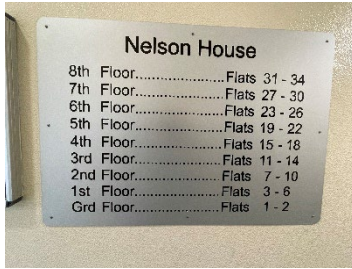
- 4) Signage depicting the floor location of each flat is fitted to the ground floor lobby wall.

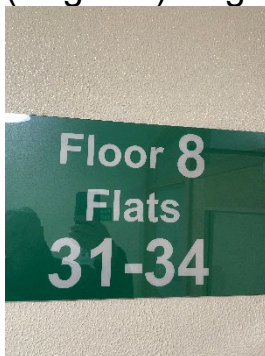
- 5) Photoluminescent wayfinding signage depicting floor level and flat numbers are fitted to the walls on all floors adjacent the lift car's and to the wall of each landing on the communal staircase's. Signage that meets the requirement of ADB and Fire Safety (England) Regulations 2022

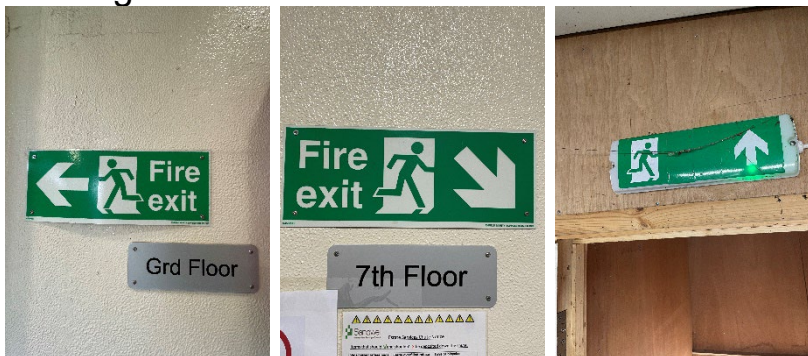
- 6) Directional fire escape signage has been installed throughout the building.

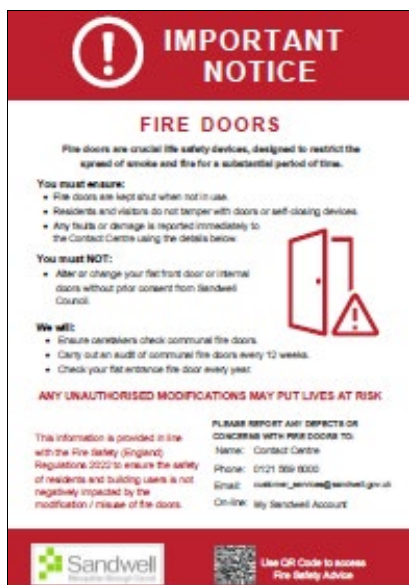
8) Information regarding use of fire doors is provided to residents.

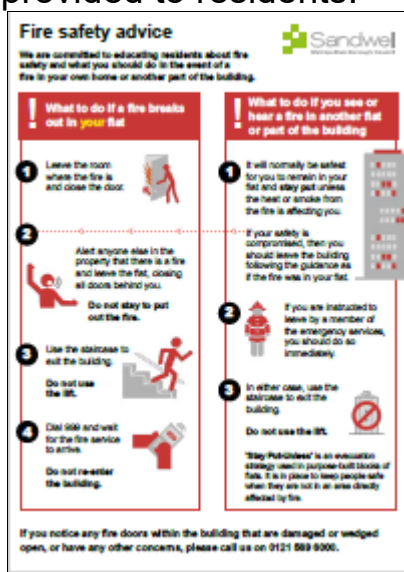
9) Information regarding the Stay Put unless fire evacuation strategy is provided to residents.

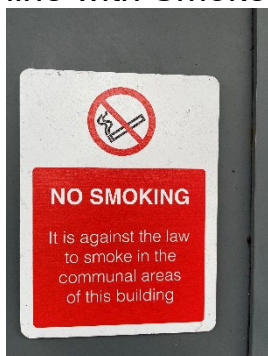
- 1) Smoking is prohibited within any communal parts of the building in line with Smoke Free England legislation.

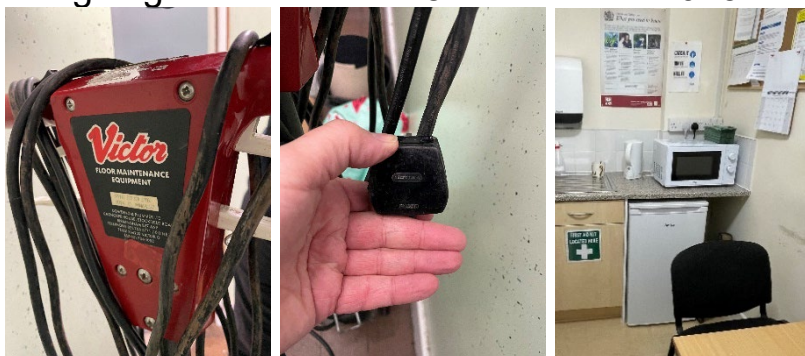
There was no obvious evidence of a recent PAT to the floor buffing machine in the cleaner's cupboard beneath the front stairs or to the kitchen appliances in the welfare room. Confirmation has been received from the caretaking team that the appliances in question are going to be PAT on 28th November 2023.

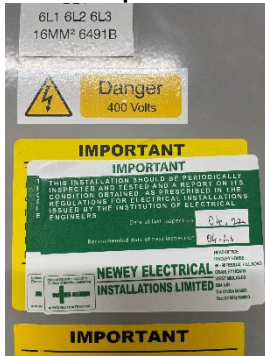
- 4) The fixed electrical installation shall be tested every 5 years. The last inspection was noted as April 2022.

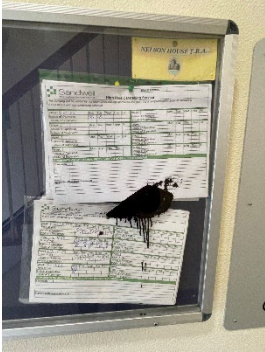
- 1) There is a regular Cleaning Service to the premises.

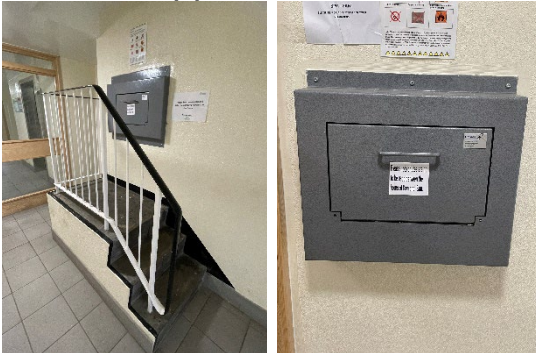
- 2) Refuse hoppers are accessed in each floor of the rear staircase.

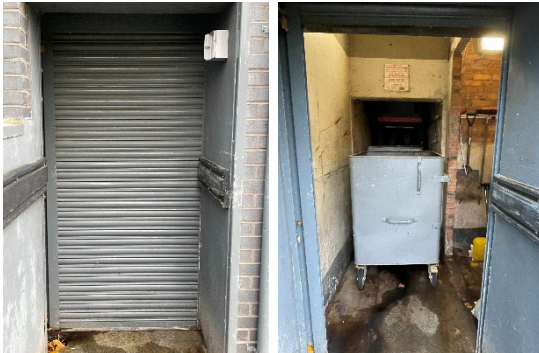
- 3) Refuse containers are located in the bin store to the rear elevation.

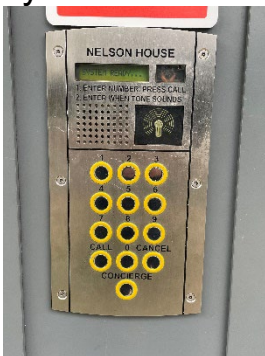
- 1) Regular checks are undertaken by Caretakers / Cleaning Team(s) 365 days per year which helps reduce the risk of arson.
- 2) Restricted access to the premises by means of a door entry system.

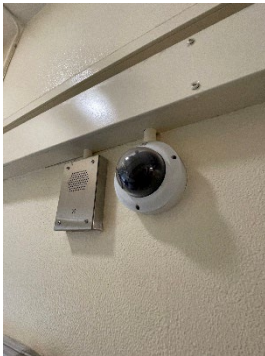
- 3) CCTV has been installed to the front main entrance and within the lobbies.

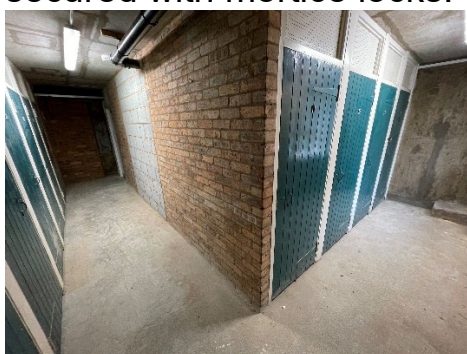
- 6) Residents have access to storage sheds located on the ground floor. The area is accessed via an FD30s nominal door and protected with hardwired smoke detection. All shed doors are secured with mortice locks.

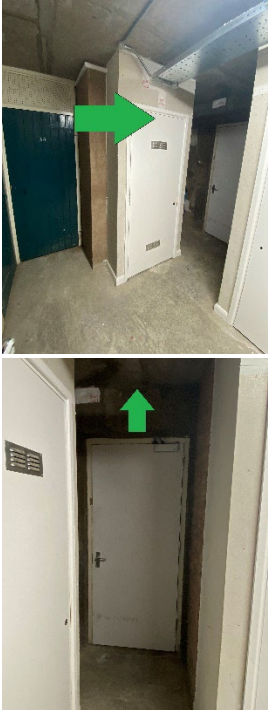
- 8) There are no directional fire escape signs within the resident's storage area on the dry riser side of the building. It is recommended that directional signage is installed above the battery store with a right-hand arrow and above the exit door with an upwards arrow.

| 12/8 | Install 2 x escape signage to the storage room on dry riser side of the building as per the attached images. | | P2 | Within 1-3 months Rapid Response Fire Team | |
