Fire Risk Assessment

Harry Price House

Hartlebury Rd, Oldbury,
B69 1EQ

Date Completed: 05/06/2024.

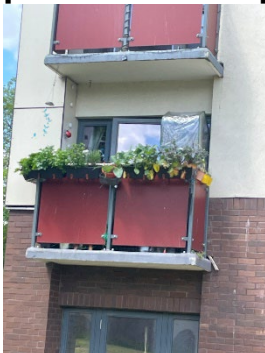
- 5) Flat 7 / 1st floor – plastic greenhouse on balcony has the potential to support the external spread of flame.

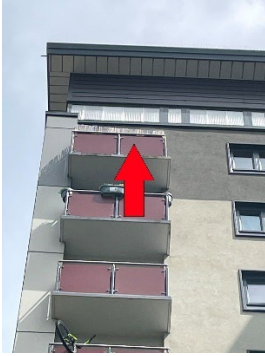
- 6) Flat 63 / 11th floor – Installed screening to balcony has the potential to support the surface spread of flame.

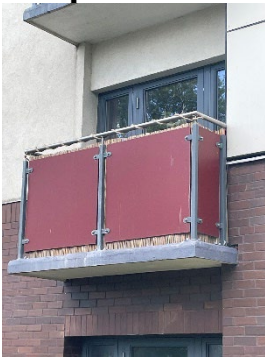
7) Flat 4 / 1st floor – Installed bamboo screening to balcony has the potential to support the surface spread of flame.

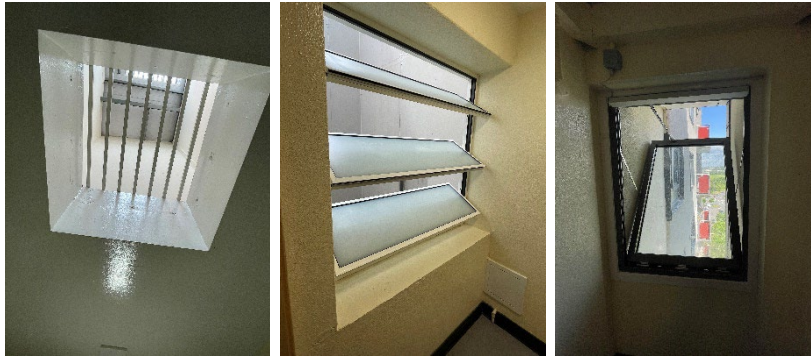
- 9) Automatic smoke ventilation is employed. This is tested, inspected and maintained by a competent procured contractor in accordance with BS7346. The frequency for the maintenance checks are twice per year (April and October) of each calendar year. Communal windows can only be opened by operating the automatic smoke vents.
 - 10) Automatic opening vents have been installed to the head of protected staircase and in each corridor above the ground floor. It was noted that the opening vents in the 12th floor corridors are of a different design to other corridors within the building.
-

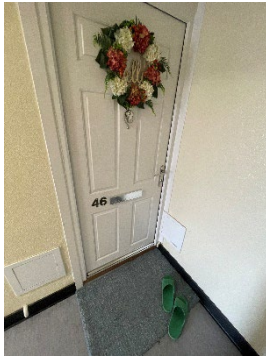
a) **8th floor flat 46 – Combustible decorative wreath on door and shoes in the means of escape.**

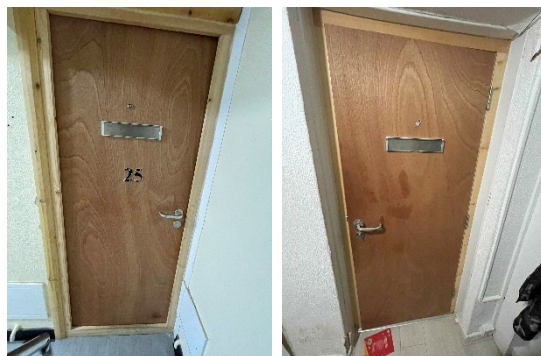
- a) **Flat 25 - Entrance door is a timber 30 minute fire door with combined intumescent strips / cold smoke seals however, the door hasn't been fitted with a self-closing device.**

- 10) Individual flat doors are predominantly nominal FD30s composite fire door sets manufactured by IG doors. Flats 25, 56, 64 & 66 were noted as timber flush fire doors. Flat 25 was accessed and an action (section 7) has been created to install a self-closing device.

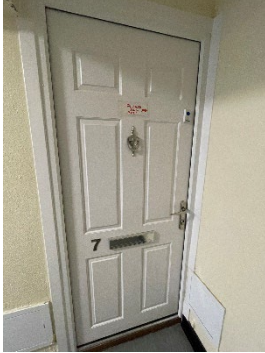
b) Flat 7 – Door was correct.

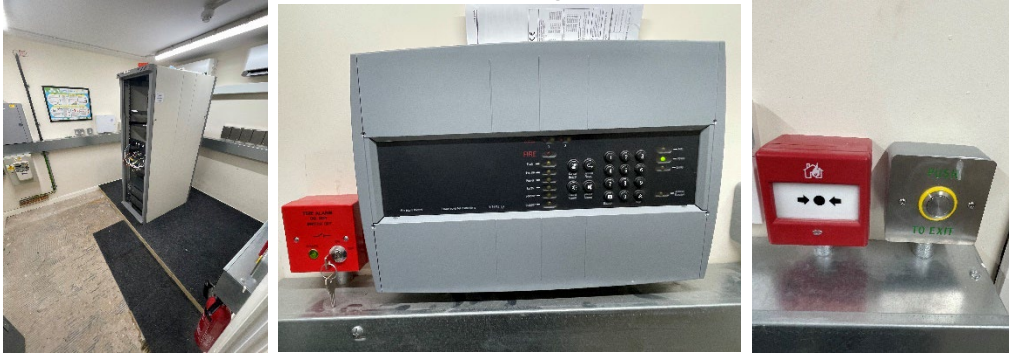
- 5) The server room is equipped with an automatic fire alarm system. The system protects the server room only and incorporates smoke detection and a break glass call point. The system sounds locally only however, there's a separate room temperature monitoring system that is remotely monitored and therefore will raise the alarm in the event of a fire. **Evidence of routine testing and maintenance of the fire alarm system wasn't evident.**

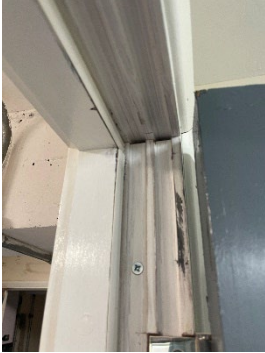
- 6) The door to the server room is a 54mm 60 minute fire door but requires combined intumescent / cold smoke seals.

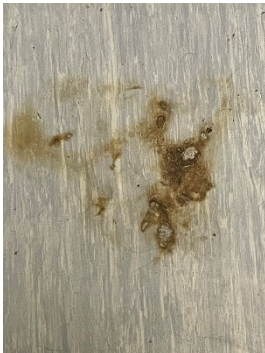
- 3) CCTV is in operation covering the ground floors, lifts and external areas and surrounding areas. The system is monitored 365 days per year by the centralised CCTV control room located at the Sandwell MBC Operations and Development Centre, Roway Lane, Oldbury, B693ES.
- 4) There is some evidence of arson within the building (scorching).

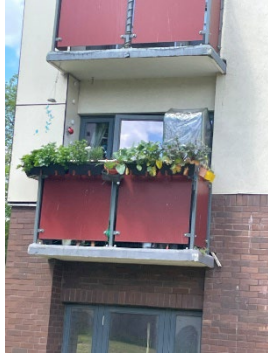
Question/ Ref No	Required Action	Supporting photograph	Priority	Timescale and Person Responsible	Date Completed
6/5	Flat 7 - Remove plastic greenhouse type structure from balcony.

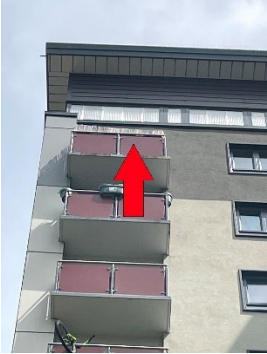
6/6	Flat 63 – Remove screening installed to balcony.

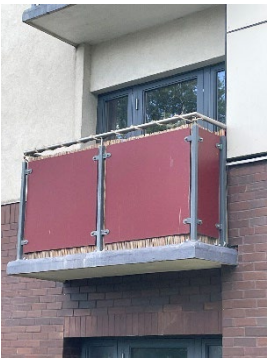
P2	Within 1-3 months Housing Manager	
6/7	Flat 4 – Remove Bamboo screening from balcony

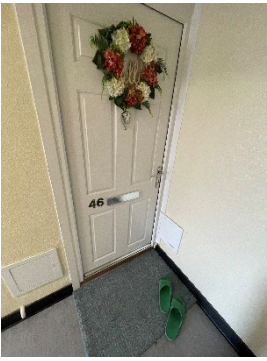
P2	Within 1-3 months Housing Manager	
7/14a	Flat 46 – Remove combustible wreath from fire door.

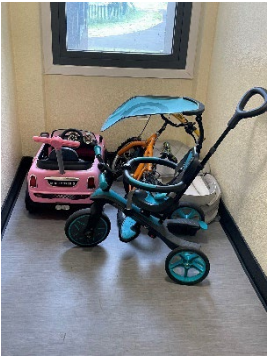
P2	Within 1-3 months Housing Manager	
7/14c	1 st floor near flats 3,4,5 remove children's toys and cot from communal corridor.

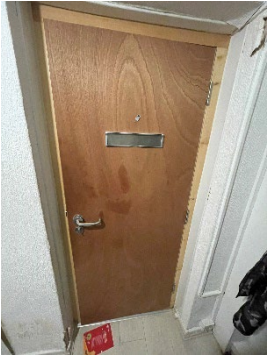
7/19a	Flat 25 / 4 th floor - Install self-closing device to flat entrance door

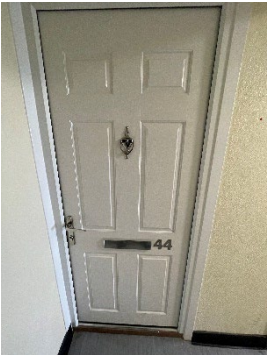
c) Flat 44 – The door fails to positively engage the latch when self-closing.

P2	Within 1-3 months Fire Rapid Response	
7/19c	Flat 44 / 7 th floor – Adjust self-closer to ensure door positively engages latch.

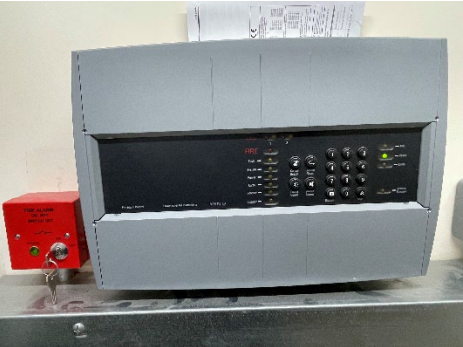
P2	Within 1-3 months Fire Rapid Response	
8/5	Confirm sufficient routine testing & maintenance of fire alarm system takes place.

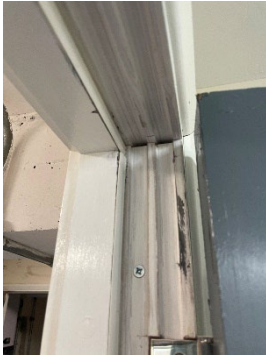
10/6	Install twin intumescent strips to server room door.

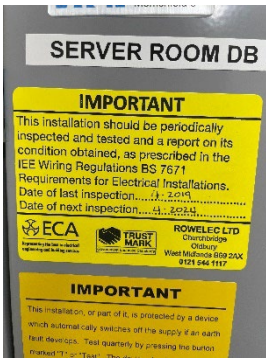
P2	Within 1-3 months Fire Rapid Response	
14/4	Confirm date of last EICR to the landlord's supply is within the last 5 years or has been scheduled for completion
