Fire Risk Assessment

Hamstead House

**Coniston Crescent,
Great Barr, B43 5NT**

Date Completed: 24/04/24

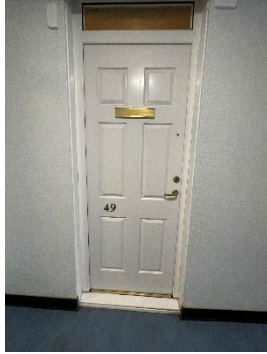
B. Flat 49, door was correct.

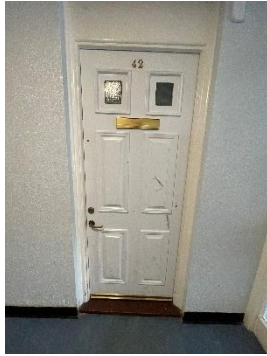
C. Flat 42, door was correct.

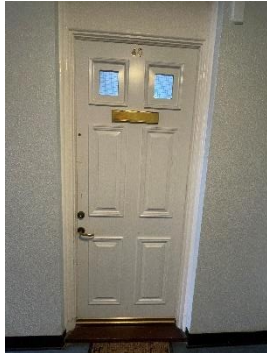
D. Flat 40, door was correct.

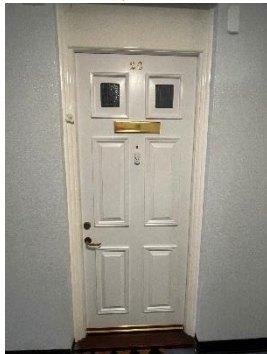
E. Flat 20, door was correct.

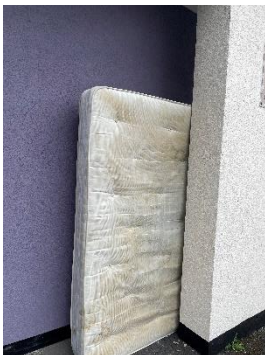
- 3) Regular checks by Caretakers minimise risk of waste accumulation. During the FRA the caretaker removed a mattress that had been discarded against the side of the building.

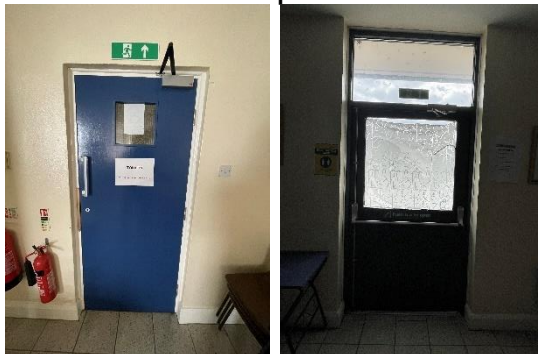
There are 2 exits from the room, one is operated by a push bar and leads to a place ultimate safety, the other is inwards opening and leads to a place of relevant safety (protected communal corridor). Because the inward opening door does not open in the direction of escape the flow rate for this is limited to 60 persons.

After discounting the larger of the two exits and taking into account the floorspace factors, it is recommended that the maximum occupancy level for this community room is 30 persons.

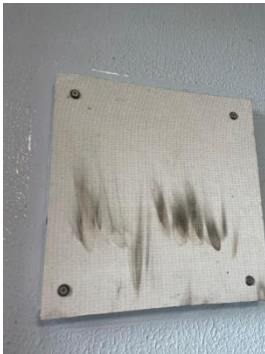
- 3) There is no CCTV system in place.
- 4) There is minor evidence of arson to a stop tap cover.

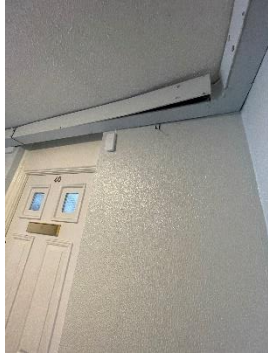
Question/ Ref No	Required Action	Supporting photograph	Priority	Timescale and Person Responsible	Date Completed
7/20	Secure trunking above flat 40 entrance door

P2	Within 1-3 months Electrical Compliance Manager
