Fire Risk Assessment

Thompson Gardens

**1-89, Hales lane,
Smethwick, B67 6RX**

Date Completed: 16/10/2023

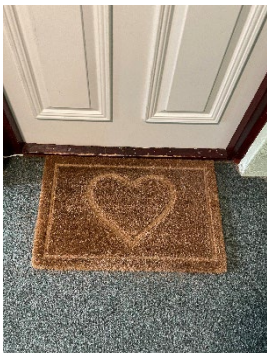
- 14) Individual floor mats were noted outside some flats. Fire rating of the mats is unknown but deemed to be of low risk.

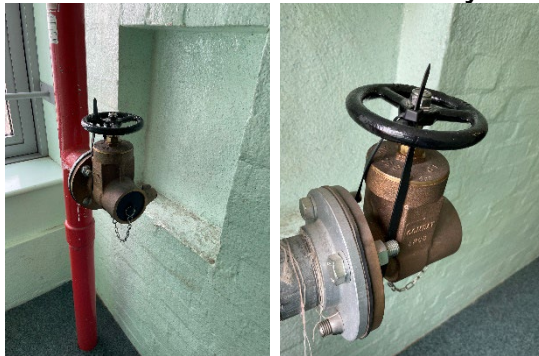
- 16) Dry riser outlets on lobbies are not housed in service cupboards but deliveries are secured by cable tie.

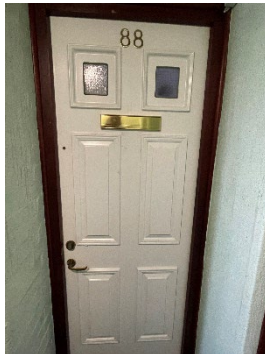
a) Flat 88 – Door was correct.

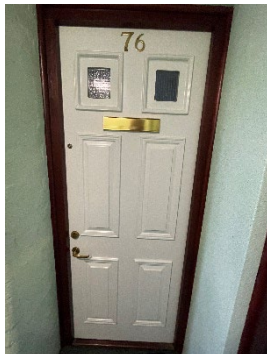
b) Flat 76 – Door was correct.

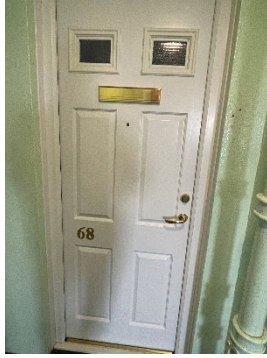
c) Flat 68 – Door was correct.

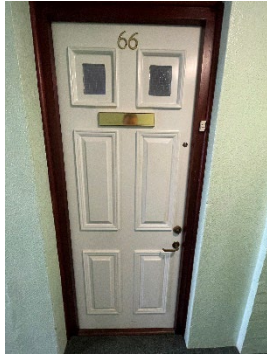
d) Flat 66 – Door was correct.

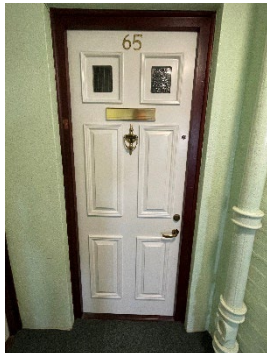
e) Flat 65 - Door was correct.

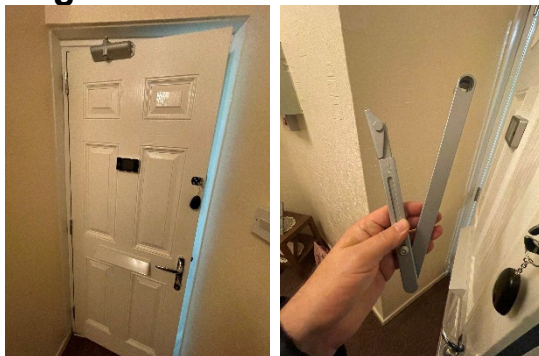
- i) Flat 52 – The arm to the Self-closing device has been disconnected by the tenant. The tenant has retained the original arm.**

| <p>7/21i</p> | <p>Flat 52 floor J (8th) – reinstate connecting arm to self-closer. Tenant has the missing arm.</p> | | <p>P2</p> | <p>Within 1-3 months Fire Rapid Response JM:12141995</p> | <p>01/11/2023</p> |

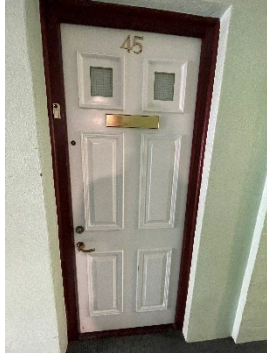
j) Flat 45 – Door was correct.
