Fire Risk Assessment

Paget House

**Sedgley Rd East,
Tipton, DY4 7TU**

Date Completed: 18/06/2024

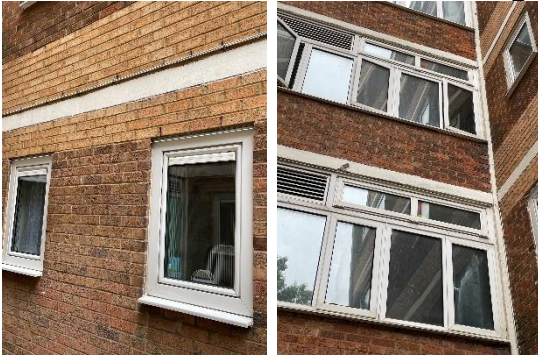
The addition of screening to one balcony and the build-up of combustible waste on another could potentially, support the surface spread of flame in those areas which is an unnecessary risk. Once this is removed the level of risk presented by materials present to the external envelope of this building would become trivial.

3. Only those flats to the left of the main entrance (3 per floor & same side of service cupboards) have access to balconies. Balconies are cantilevered concrete with steel balustrades.

A. Flat 142 (2nd floor) There appears to be a build-up of combustible waste on the balcony. This has the potential to support the external spread of fire.

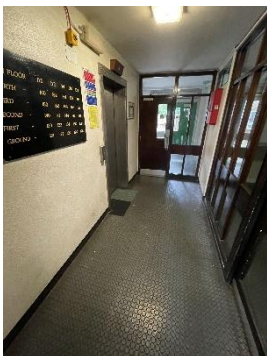
- 2) All corridors are of adequate width (at least 1050mm) and will be maintained clear to that width as a minimum.

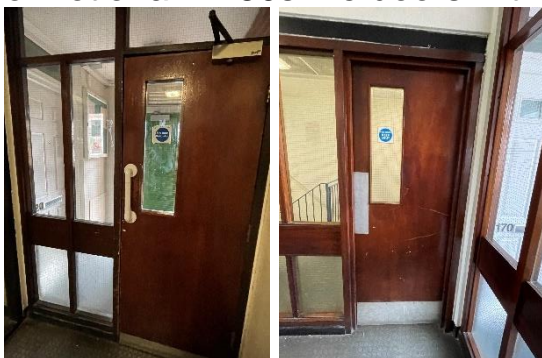
- 4) The means of escape are protected to prevent the spread of fire and smoke.
- 5) The communal lobbies / landing / staircases are protected by use of notional FD30s fire doors with vision panels.

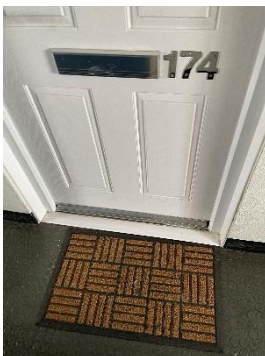
- 18) The fire rating of individual door mats outside flat entrance doors is unknown.

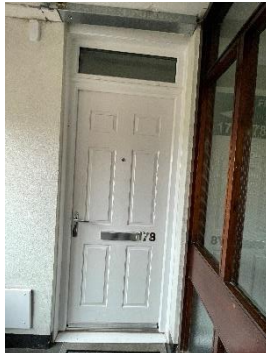
b) Flat 178 – Door is correct.

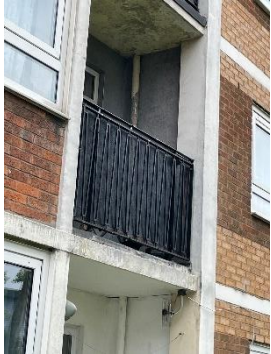
06/03b	Flat 136 – Remove screening installed to balcony.

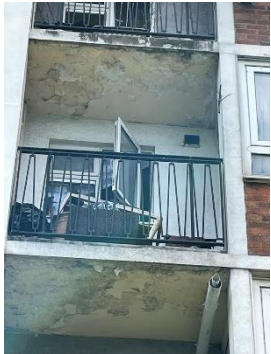
P2	Within 1 to 3 months. Housing Manager
06/03c	Flat 152 - Remove build-up of combustible waste from balcony.

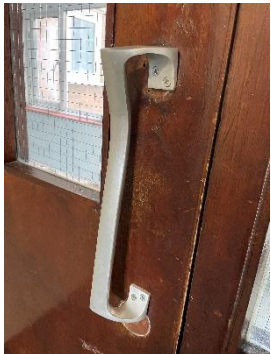
P2	Within 1 to 3 months. Housing Manager
07/06	Repair or replace damaged / crushed aluminium handle to communal door by flat 158 / 3 rd floor.

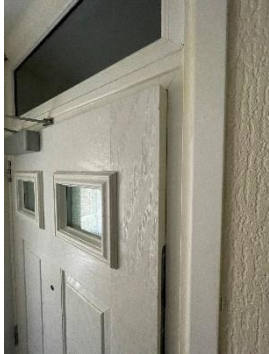
07/21a	Flat 126 - Re-hang entrance door to ensure reliably self-closes. Door fouls frame on slamming edge.
