# Fire Risk Assessment

## Wesley Court

**Southbank Rd, Oldbury,  
Cradley Heath, B64 6LQ**

**Date Completed: 01/07/2024**

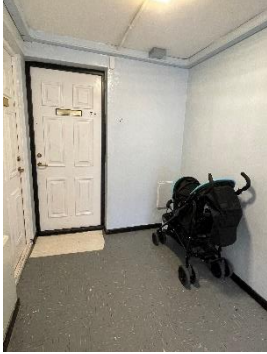
**17) Pushchair in communal corridor outside flats 73, 74, 75.**

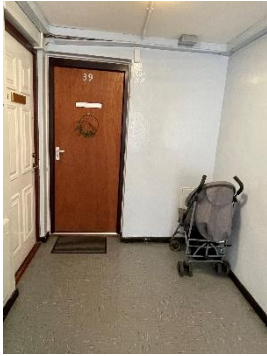
**18) Pushchair in communal corridor outside flats 37,38,39.**

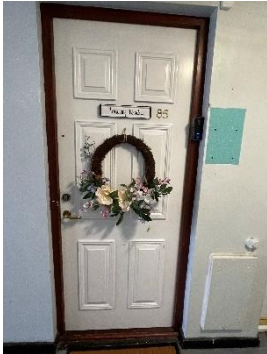
**19) Flat 85 entrance door has a combustible wreath.**

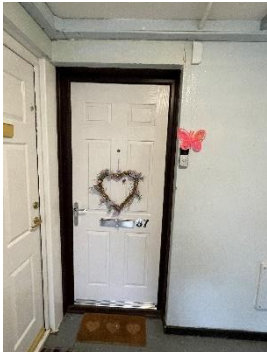
**20) Flat 87 entrance door has a combustible wreath.**

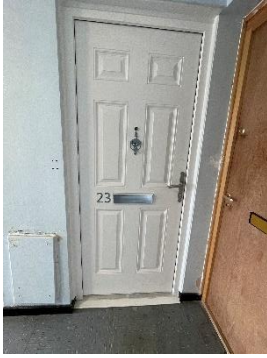
- C. Flat 23 – Door is correct.
-

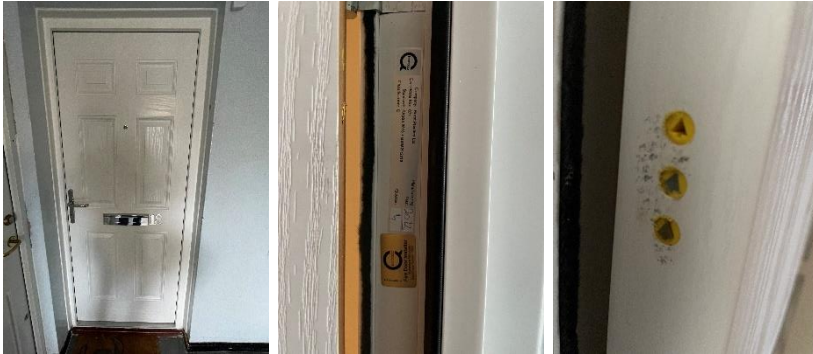
D. Flat 18 – Door is correct.

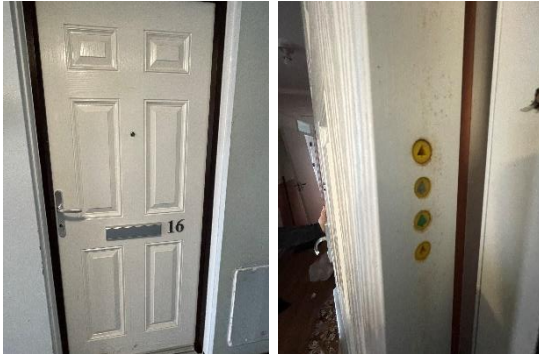
E. Flat 16 – Door is correct.

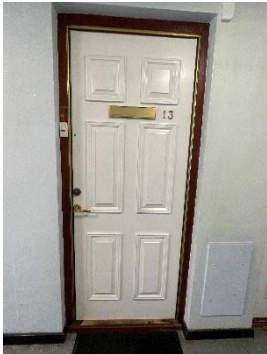
F. Flat 13 – Door is correct.

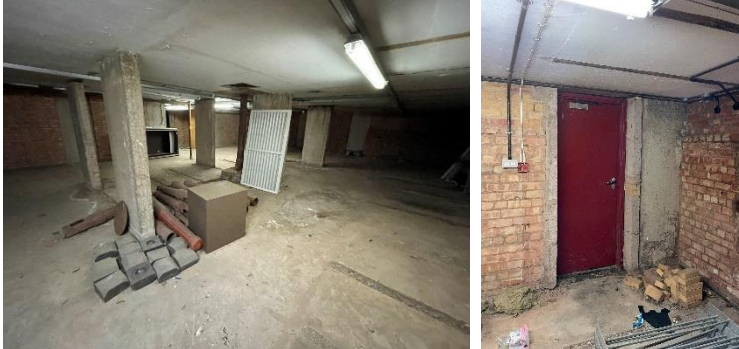
- 7) The fire escape routes generally do not use directional fire signage in accordance due to simplicity of layout, however there is a directional fire escape sign above the final exit door at the bottom of the protected stairwell and to the caretaker's office door.

**Furthermore, it would be beneficial if directional fire escape signage was installed to the basement area because direct sight of an exit is not possible from all areas.**

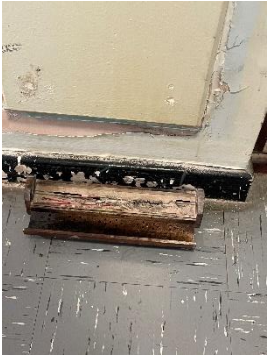
- 16) Incense sticks were found burning within a timber box in a 7<sup>th</sup> floor corridor adjacent flats 43, 44, 45. A significant amount of smoke was observed along with burning to the timber box they were housed within. Also, noted was a significant amount of staining to the nearby walls and flat entrance doors. The incense sticks and burning box were removed by the assessor and extinguished before handing the box to the caretaker.**

<p>07/16</p>	<p>Tenants of flat 43 to be instructed to cease the burning of incense sticks within the communal corridor. <b>Note – This action was also raised on the previous FRA dated October 2022</b></p>

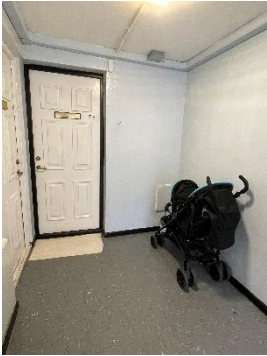
<p>P2</p>	<p>Within 3 months of action plan Housing Manager.</p>	
<p>07/17</p>	<p>Flats 73, 74, 75 Pushchair should not be stored within the communal corridor.</p>

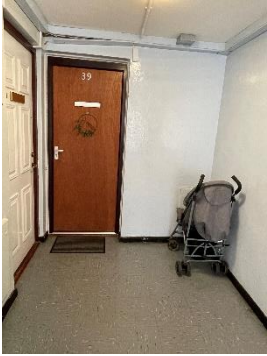
<p>P2</p>	<p>Within 3 months of action plan Housing Manager.</p>	
<p>07/18</p>	<p>Flats 37, 38, 39 Pushchair should not be stored within the communal corridor.</p>

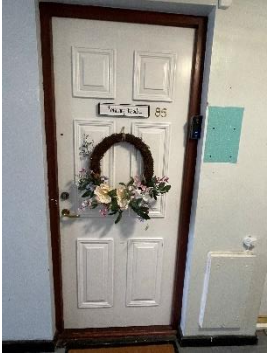
07/19	Flat 85 to remove wreath from entrance door.

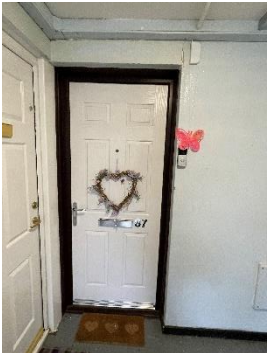
P2	Within 3 months of action plan Housing Manager.	
07/20	Flat 87 to remove wreath from entrance door.

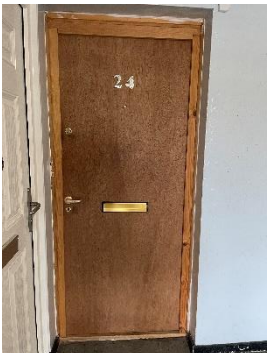
P2	Within 3 months of action plan Housing Manager.	
07/27b	Flat 24 – Adjust self-closing device to ensure door positively engages on catch.

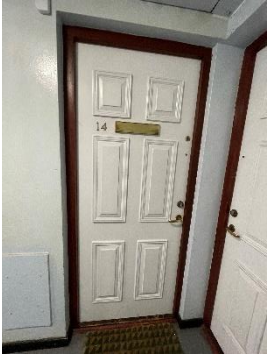
07/27g	Flat 14 – Adjust self-closing device to ensure door positively engages on catch

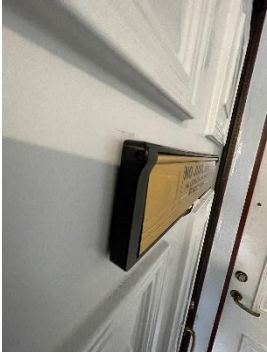
P2	Within 3 months of action plan Fire Rapid Response	
07/27h	Flat 11 – Secure loose letterbox to entrance door.

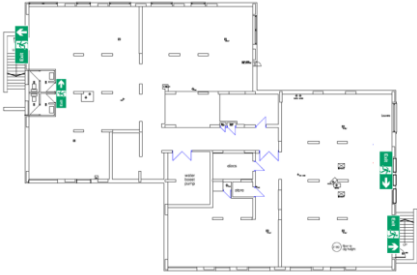
12/7	Install directional exit signage to basement as per the plan.

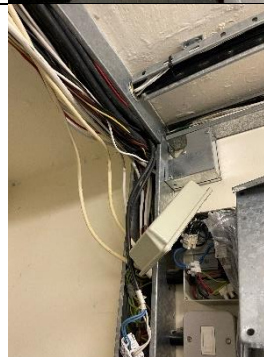
Cabling within some service cupboards is generally untidy and not contained with trunking. Cabling could be installed within trunking as part of any future refurbishment project.

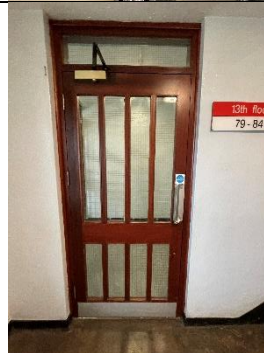
- 9) The communal landings / staircase and corridors are protected by use of notional self-closing 44mm 30-minute timber fire doors with vision panels. It is recognised that these doors do not meet today's benchmark of a certified FD30s fire door install however, because they were installed at the time of the building's construction and to the standard of that time they are deemed as acceptable so long as the doors are free of damage and function as they were intended to do so. It has been recognised that all of the landing / staircase and corridor notional doors in this block have been upgraded with combined intumescent strips & cold smoke seals to enhance their original design and minimise departures from today's standards. Were minor shortcomings have been identified actions have been created for corrective works.

Upgrade all notional communal fire doors to certified FD30s should be considered as part of a future refurbishment project.
